Channel Mitigation Monitoring Sheets I, II, III, AND IV
Monitoring Data Record

Project Title: R-5206 COE Action ID: 2015-00451
Stream Name: UT to Blanton Branch – Permit Site 5 DWR Number: 2015-0216
City, County and other Location Information: The project is located on Cope Creek Rd, SR 1449 just off US 74 in Jackson County, NC.
Date Construction Completed: Final Planting: April 10, 2018 Monitoring Year: (3) of 3
Ecoregion: Southern Crystalline Ridges and Mountains 8 digit HUC unit 06010203
USGS Quad Name and Coordinates: Sylva North 35.390942°, -83.185654°

Length of Project: 277 linear feet
Urban or Rural: Rural Watershed Size: 0.65 sq. miles
Monitoring DATA collected by: M. Green Date: 7-11-20

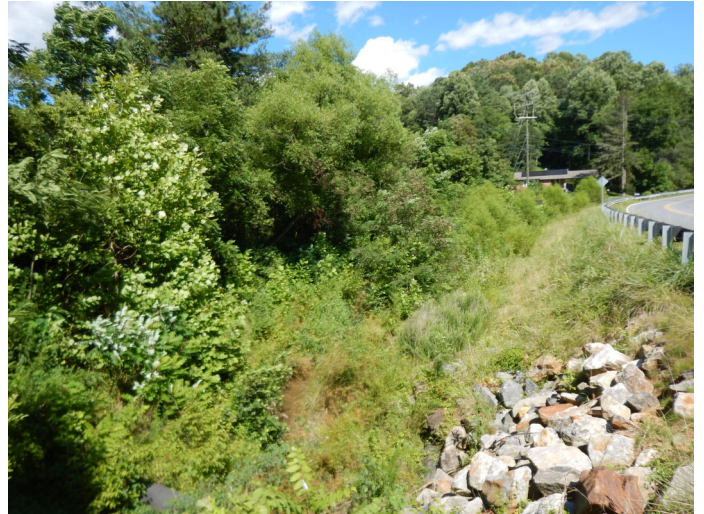
The UT to Blanton Branch onsite stream mitigation is stable for the Year 3 evaluation. No instability was noted along the stream and all structures were functioning properly. A wrack line was noted within the floodplain during the monitoring evaluation indicating a bankfull event had occurred. NCDOT proposes to discontinue monitoring the channel stability at the UT to Blanton Branch Mitigation Site.

Overview photo looking upstream
