ANNUAL REPORT FOR 2020

U-2525B UT to North Buffalo Creek - Site #4
Guilford County
TIP No. U-2525B
USACE Action ID: SAW-2005-21386
DWR Project #: 20130918 v.8

Prepared By:
Environmental Analysis Unit & Roadside Environmental Unit
North Carolina Department of Transportation
December 2020

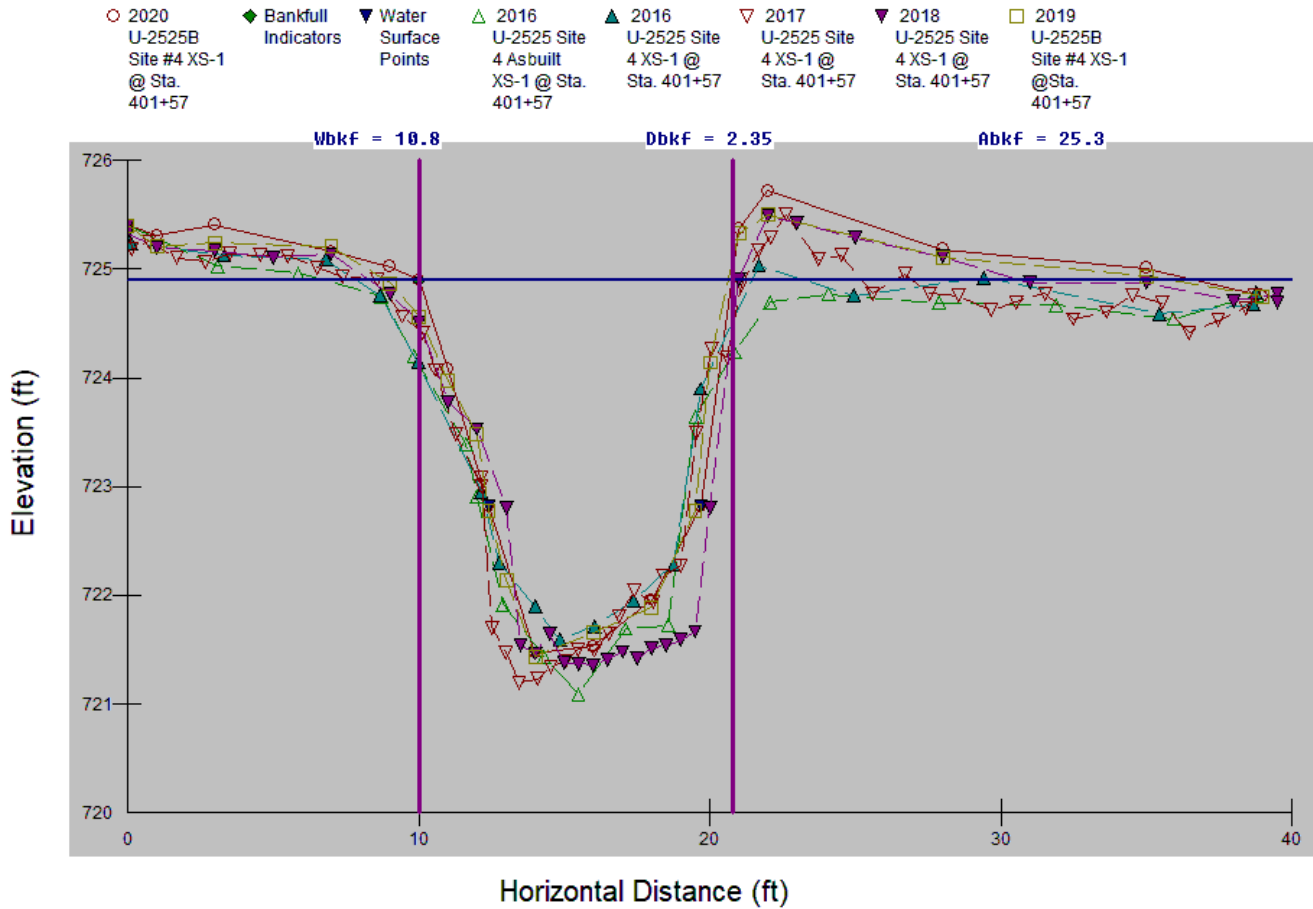
2020 U-2525B Site #4 XS-1 @ Sta. 401+57

Site 4: Cross-Section #1 (Pool) Abbreviated Morphological Summary						
	As-built	2016	2017	2018	2019	2020
Bankfull Width (ft)	8.28	8.35	7.91	9.95	9.13	10.76
Bankfull Mean Depth (ft)	1.11	1.18	1.42	2.56	1.52	2.35
Bankfull Cross Sectional Area (ft²)	9.19	9.88	11.25	25.50	13.86	25.33
Maximum Bankfull Depth (ft)	1.72	1.77	1.89	4.24	2.59	3.43

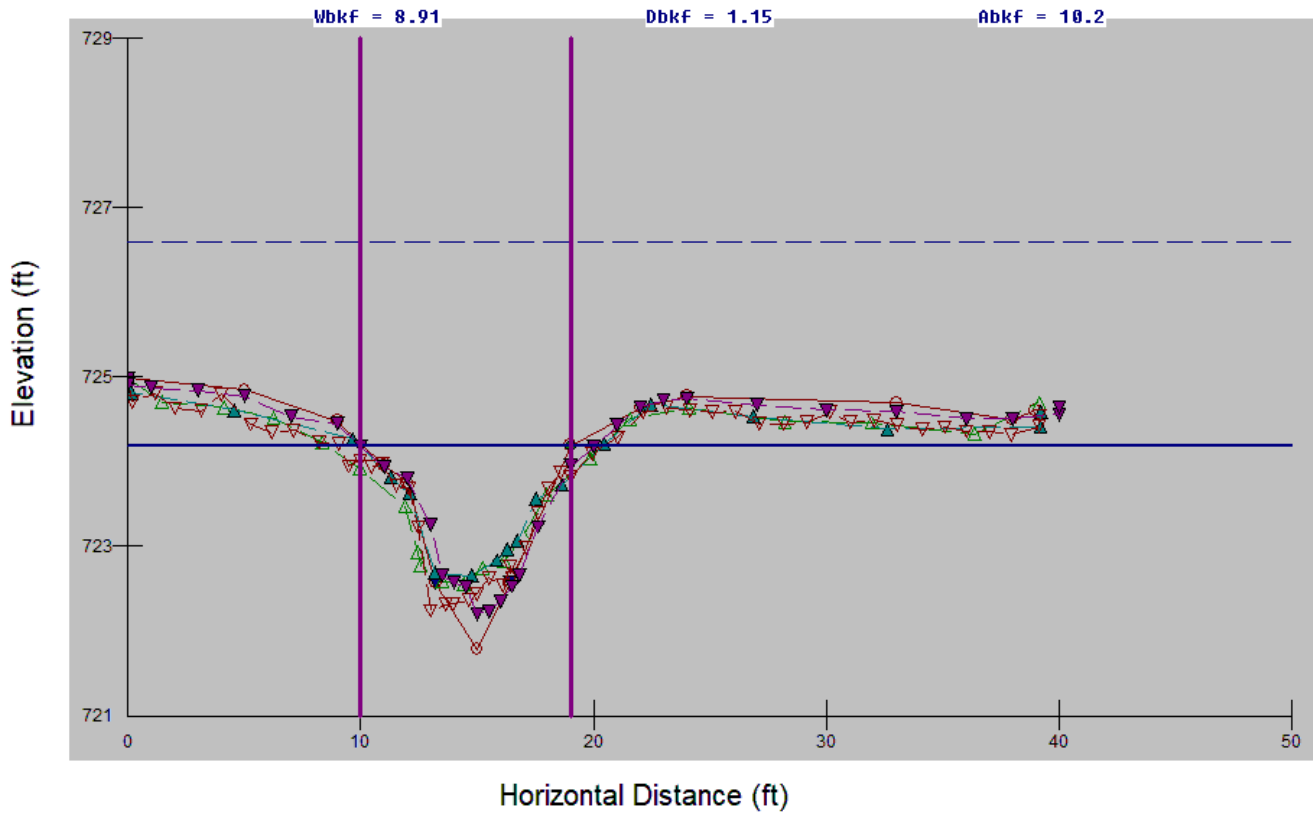
2020 U-2525B Site #4 XS-2 @ Sta. 402+04 (original)

Site 4: Cross-Section #2 (Riffle) Abbreviated Morphological Summary						
	As-built	2016	2017	2018	2019*	2020
Bankfull Width (ft)	11.4	11.1	11.9	12.2	10.15	8.91
Bankfull Mean Depth (ft)	0.81	0.84	0.89	1.02	1.00	1.15
Width/Depth Ratio	14.07	13.26	13.34	11.97	10.15	7.75
Bankfull Cross Sectional Area (ft²)	9.23	9.37	10.6	12.47	10.15	10.24
Maximum Bankfull Depth (ft)	1.58	1.61	1.97	2.25	2.04	2.41
Width of the Floodprone Area (ft)	39	39	39	40	40	39
Entrenchment Ratio	3.43	3.52	3.30	3.27	3.94	4.38

*2019 morphology data based off different right end pin location.

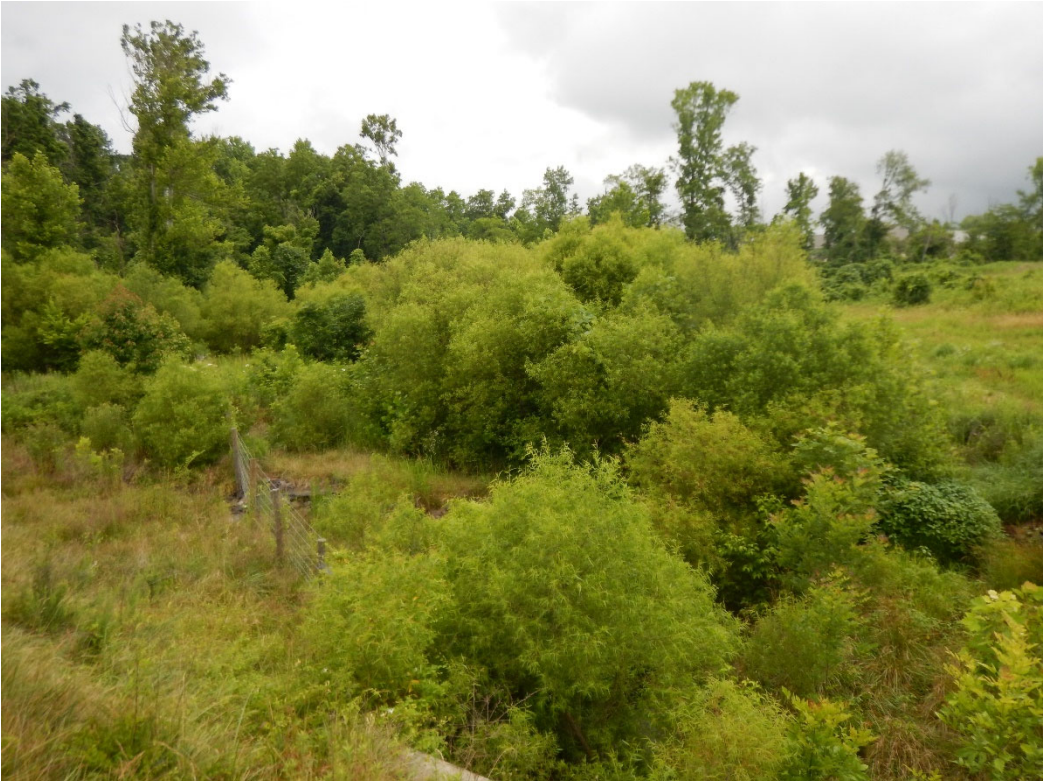
Overview looking upstream from culvert inlet at I-840.

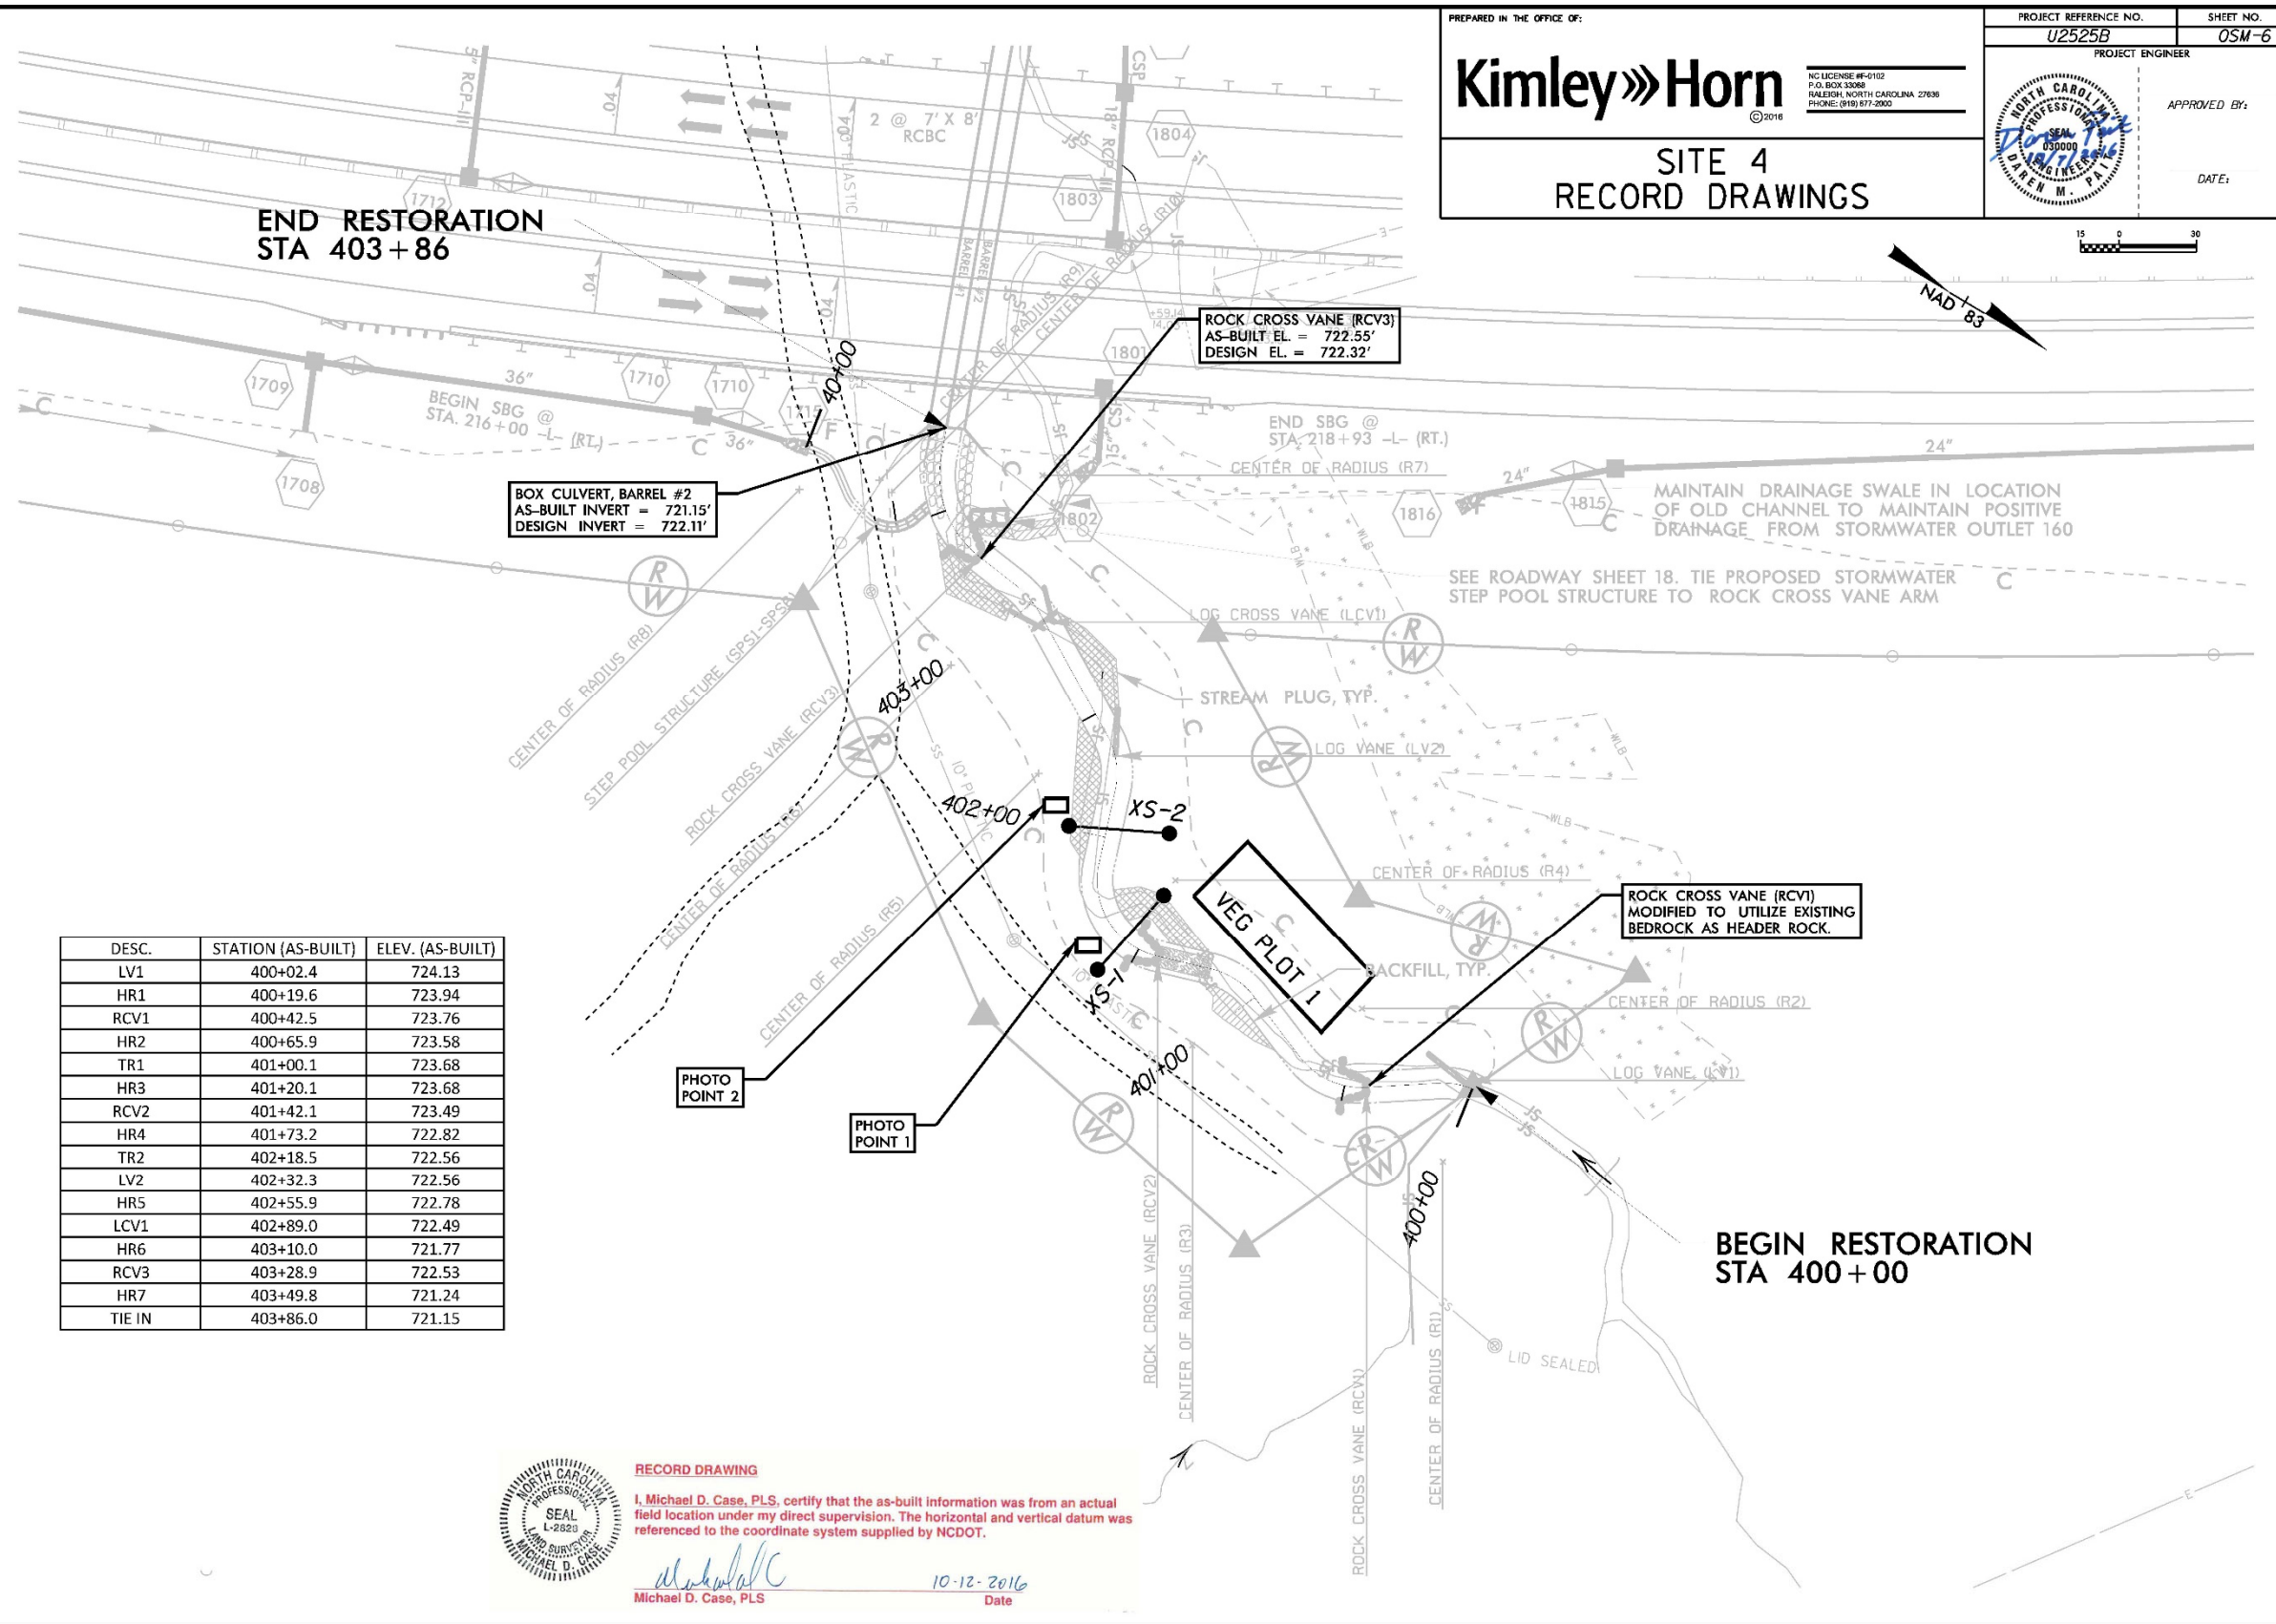
**SITE 4
RECORD DRAWINGS**

**BOX CULVERT, BARREL #2
AS-BUILT INVERT = 721.15'
DESIGN INVERT = 722.11'**

**ROCK CROSS VANE (RCV3)
AS-BUILT EL. = 722.55'
DESIGN EL. = 722.32'**

**ROCK CROSS VANE (RCV1)
MODIFIED TO UTILIZE EXISTING
BEDROCK AS HEADER ROCK.**

MAINTAIN DRAINAGE SWALE IN LOCATION
OF OLD CHANNEL TO MAINTAIN POSITIVE
DRAINAGE FROM STORMWATER OUTLET 160
