Channel Mitigation Monitoring Sheets I, II, III, AND IV  
Monitoring Data Record

Project Title: U-2579B COE Action ID: SAW-2008-03183  
Stream Name: Permit Sites 3A and 3B DWR Number: 2014-0090v2  
City, County and other Location Information: Temporary impact Sites 3A and 3B are located at the intersection of the Winston-Salem Northern Beltway and US 158 (Reidsville Road)  
Date Construction Completed: Streambank reforestation completed in March 2019  
Monitoring Year: ( 2 ) of 2  
Ecoregion: Southern Outer Piedmont 8-digit HUC unit 03040101  
USGS Quad Name and Coordinates: Walkertown 36.148420°, -80.153487°

# Sites 3A and 3B

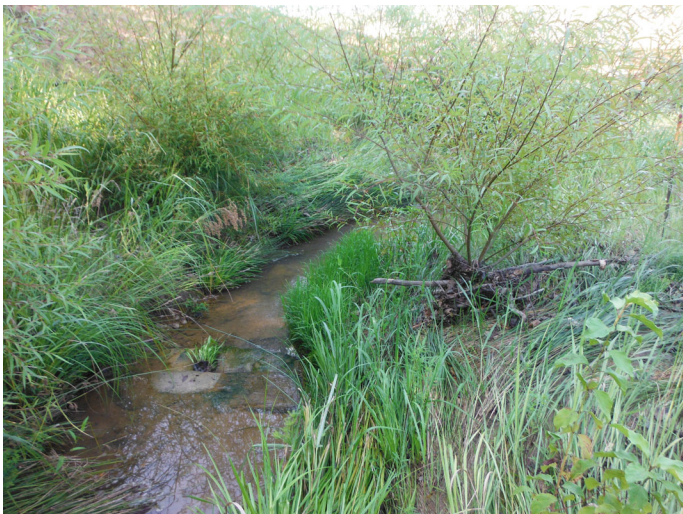
Sites 3A and 3B temporary impact streams are stable for the Year 2 evaluation. No instability was noted along the streams. A wrack line was visible within the floodplain indicating a bankfull event had occurred. NCDOT proposes to discontinue monitoring channel stability at the Sites 3A and 3B temporary impact streams.

Bankfull event - Wrack line evidence
