Channel Mitigation Monitoring Sheets I, II, III, AND IV  
Monitoring Data Record

Project Title: U-2579B COE Action ID: SAW-2008-03183  
Stream Name: UT to Fisher Branch – Permit Site 20 DWR Number: 2014-0090v2  
City, County and other Location Information: The mitigation site is located on the Winston-Salem Northern Beltway Eastern Section just south of Hastings Mill Rd.  
Date Construction Completed: Streambank reforestation completed on March 1, 2018  
Monitoring Year: ( 3 ) of 5  
Ecoregion: Southern Outer Piedmont 8 digit HUC unit 03040101  
USGS Quad Name and Coordinates: Winston-Salem East 36.100238°, -80.135216°

# UT to Fisher Branch Mitigation Site

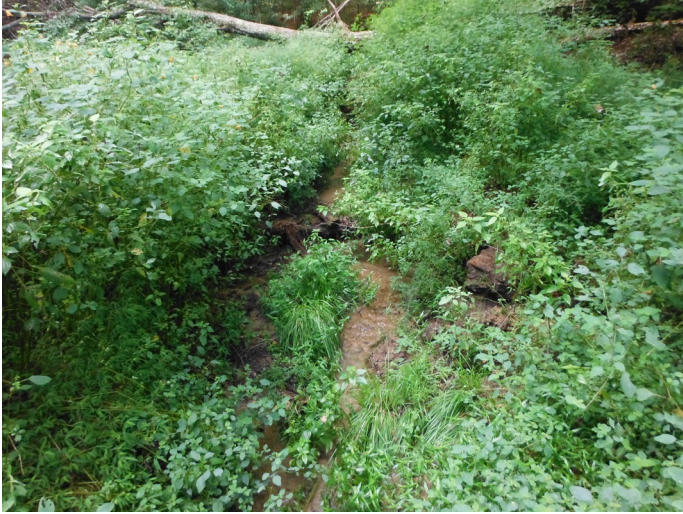
PP #1 Upstream

**Planted vegetation is lacking upstream of PP#1 and also a small area within the left buffer at PP#3.**

Estimated causes, and proposed/required remedial action: **A supplemental planting is scheduled for these areas in the 2020-2021 planting window. See attached map of supplemental planting areas.**

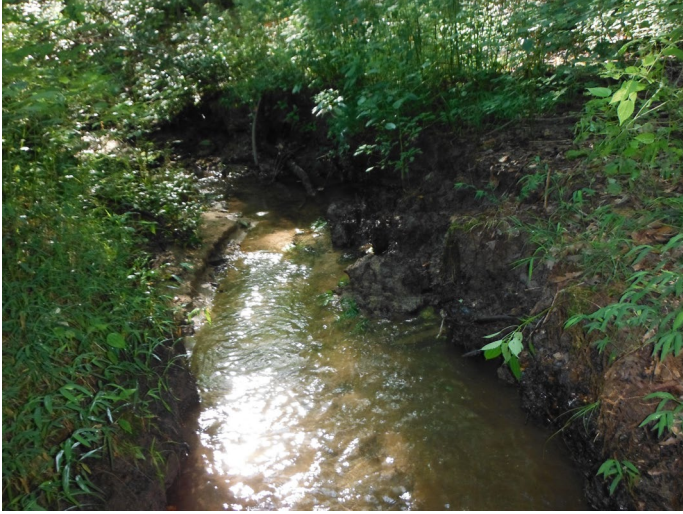
The UT to Fisher Branch onsite stream mitigation site is stable for the Year 3 evaluation from just downstream of PP#1 to the inlet of the box culvert. There are portions of the stream from the beginning of the site to just downstream of PP#1 where the banks are eroding and sloughing off. Some sections of the channel have started to form a new bankfull bench and are stabilizing. A supplemental planting is schedule, as mentioned in Section 2 of this report for these areas where erosion is occurring and planted vegetation is lacking. NCDOT will continue to monitor channel stability at the UT to Fisher Branch Mitigation Site in 2021.

Bank erosion upstream of PP#1

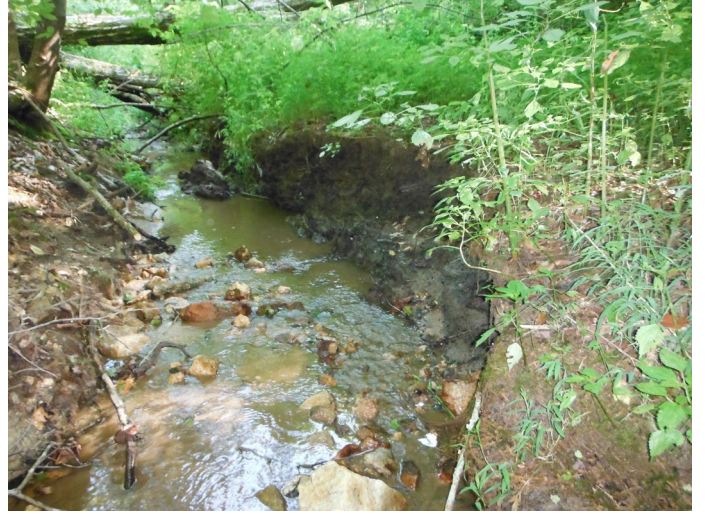
Bank erosion upstream of PP#1
