Monitoring Data Record

Project Title: Martin Site (B-3045 WM) COE Action ID: 200632527285
 Stream Name: Little Peters Creek DWQ Number: 06-869
 City, County and other Location Information: The mitigation area is located approx. 0.5 mile east of the intersection of Creasy Road and NC 704 in Stokes County.
 Date Construction Completed: June 20, 2007, Streambank Reforestation Completed 2-28-08
 Monitoring Year: (5) of 5
 Ecoregion: _____ 8 digit HUC unit 03010103
 USGS Quad Name and Coordinates: _____

Year 5 Summer – July 2012

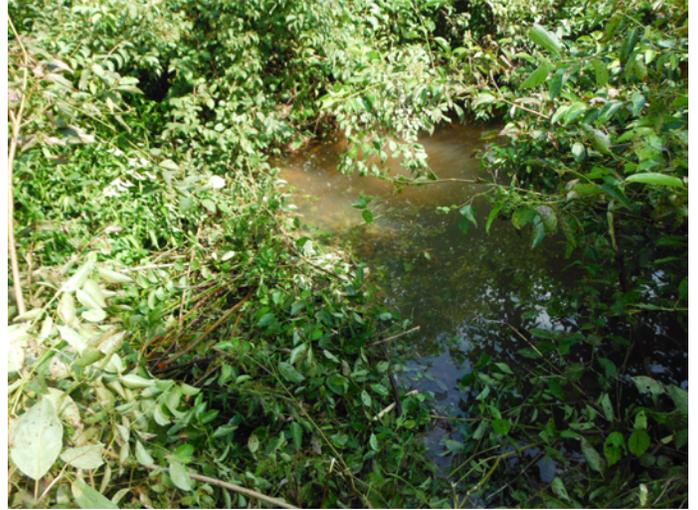
Little Peters Creek stream restoration project is stable for the Year 5 Summer evaluation. A beaver dam was noted between photo point #3 and photo point #4. USDA will be contacted to remove the beavers and dam from the site. A bankfull event had occurred since the last monitoring evaluation. There were six bankfull events visually documented over the 5-year monitoring period. The bankfull events did occur during separate monitoring years as required by the permit conditions. NCDOT proposes to discontinue channel stability monitoring at this stream restoration project.

Beaver dam located b/t PP#3 and PP#4
