Monitoring Data Record

Project Title: B-3126 (Br. #90 over Gunpowder Creek on SR 1718
 COE Action ID: 2007-1591-214 DWQ Number: 070583
 Stream Name: Tributary to Gunpowder Creek
 City, County and other Location Information: Caldwell County, Bridge #90 over
Gunpowder Creek on SR 1718(Deal Mill Road) near Granite Falls.
 Date Construction Completed: 3/11/09 Monitoring Year: (3) of 5
 Ecoregion: _____ 8 digit HUC unit 03050101
 USGS Quad Name and Coordinates: Granite Falls N 35.84415, W 81.43603

This is the Year 3 Summer evaluation for the Tributary to Gunpowder Creek. The minor bank scouring along the right bank at Sta. 0+90 noted previously has stabilized and re-vegetated. See photo of Sta. 0+90 below. There were three crossvanes that had water piping under them within the step pool area noted during this and previous evaluations.

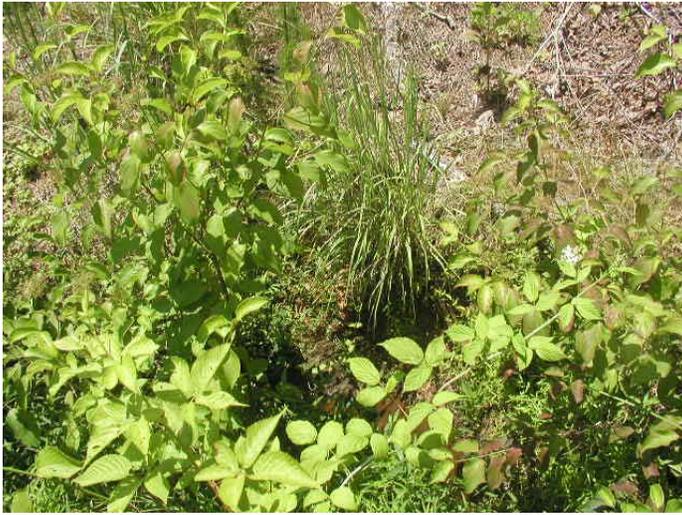
Minor bank scouring along right bank @ Sta. 0+90-NSD-

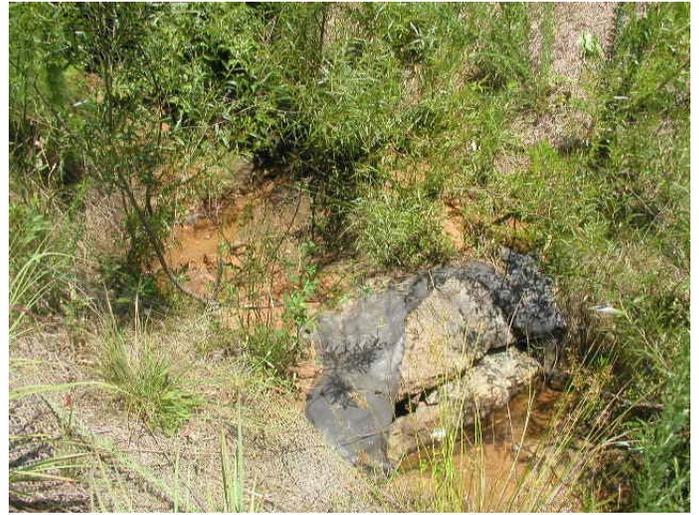
| Date 6/16/11 | Sta. 2+40 -NSD- (additional photo) | Sta. 2+50 -NSD- (additional photo) | Sta. 3+10 -NSD- (additional photo) | Station Number | Station Number |
|--|--|--|--|---|---|
| Is water piping through or around structure? | Water piping under crossvane | Water piping under crossvane | Water piping under last crossvane | | |

Water piping under crossvane @ Sta. 2+40-NSD-

A site visit was conducted on June 16, 2011 with the regulatory agencies and NCDOT personnel present. It was determined at the meeting that the three crossvanes needed to be repaired. NEU staff is currently working with the division to repair these crossvanes. NCDOT will continue to monitor this stream relocation.

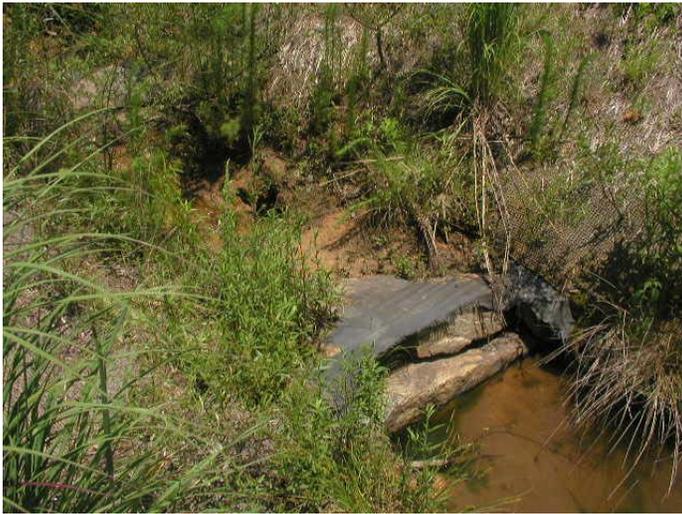
Water piping under crossvane @ Sta. 2+50-NSD-

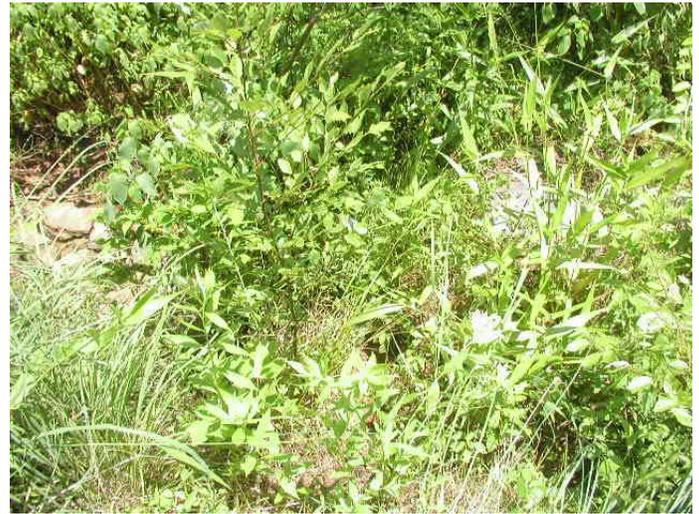
Water piping under crossvane @ Sta. 3+10-NSD-
