Monitoring Data Record

Project Title: B-3126 (Br. #90 over Gunpowder Creek on SR 1718
 COE Action ID: 2007-1591-214 DWQ Number: 070583
 Stream Name: Tributary to Gunpowder Creek
 City, County and other Location Information: Caldwell County, Bridge #90 over
Gunpowder Creek on SR 1718 (Deal Mill Road) near Granite Falls.
 Date Construction Completed: 3/11/09 Monitoring Year: (4) of 5
 Ecoregion: _____ 8 digit HUC unit 03050101
 USGS Quad Name and Coordinates: Granite Falls N 35.84415, W 81.43603

Year 4 Winter – January 2012

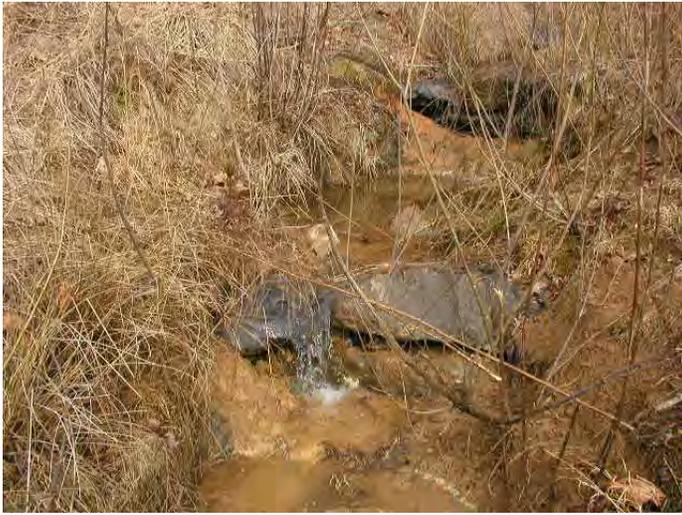
Date	Sta. 2+40	Sta. 2+50	Sta. 3+10	Station	Station
1/10/12	-NSD- (additional photo)	-NSD- (additional photo)	-NSD- (additional photo)	Number	Number
Structure Type	Crossvane	Crossvane	Crossvane		
Is water piping through or around structure?	Water is flowing over top of the crossvane	Water piping under crossvane	Water piping under last crossvane		
Head cut or down cut present?					
Bank or scour erosion present?					
Other problems noted?

Water flowing over crossvane @ Sta. 2+40-NSD-

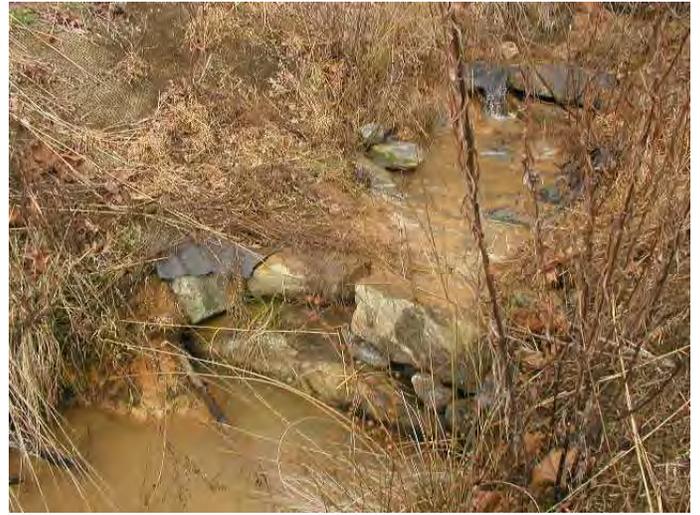
This is the Year 4 Winter evaluation for the Tributary to Gunpowder Creek. There were three crossvanes that had water piping under them within the step pool area noted during previous evaluations. A site visit was conducted on June 16, 2011 with the regulatory agencies and NCDOT personnel present. It was determined at the meeting that the three crossvanes needed to be repaired. On two separate occasions in December 2011 and in January 2012, NCDOT attempted to repair the crossvanes. After the repairs were completed water was flowing over top of the crossvane at Sta. 2+40, but the crossvanes at Sta. 2+50 and Sta. 3+10 were still experiencing water piping under these crossvanes. NCDOT will continue to monitor this stream relocation.

Water piping under crossvane @ Sta. 2+50-NSD-

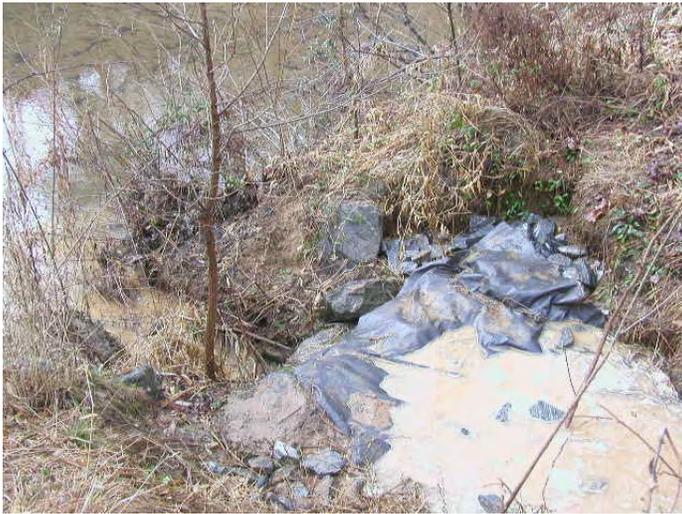
Water piping under crossvane @ Sta. 3+10-NSD-
