Monitoring Data Record

Project Title: B-3856 (Br. #335 over Mud Creek) COE Action ID: 2007-1871-345

Stream Name: UT's to Mud Creek (Sites 1 & 3) DWQ Numbers: 070798

Visual Monitoring Yearly: (3) of 3

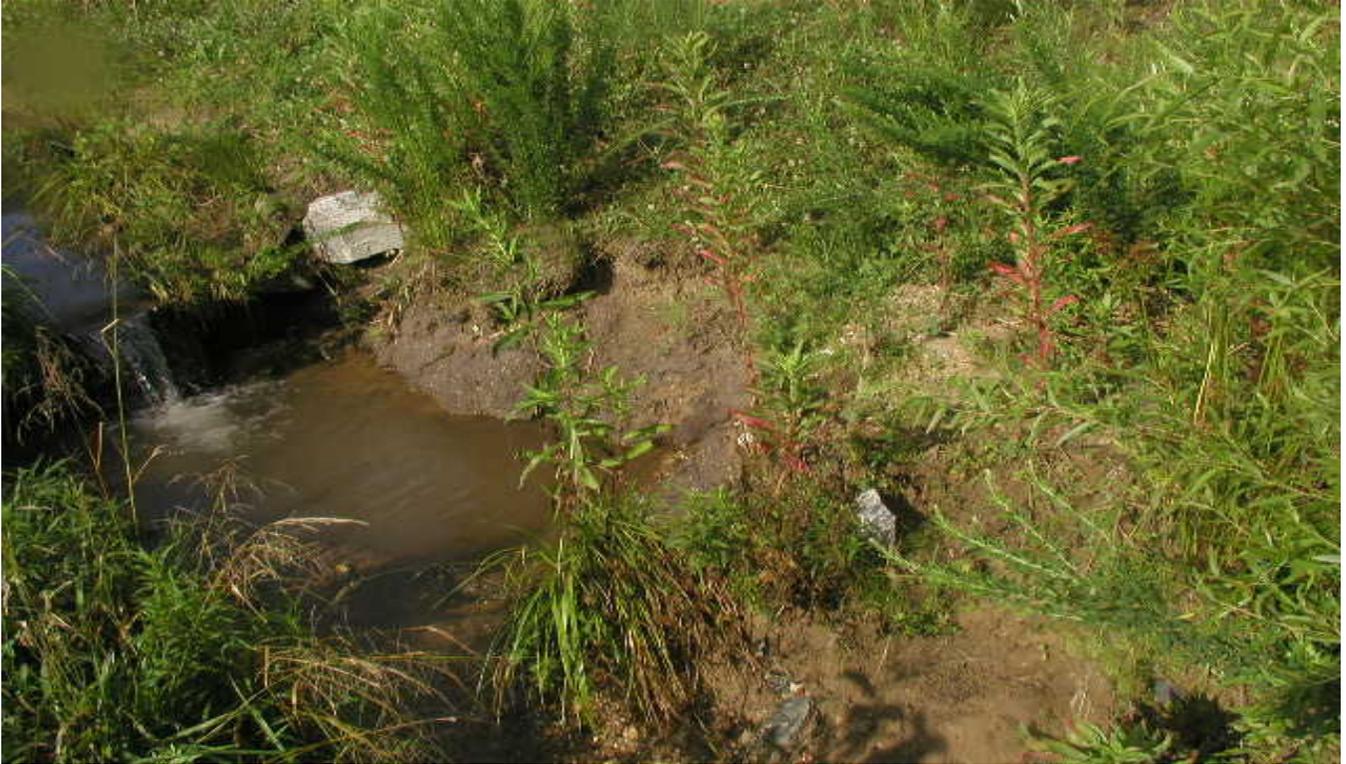
This is the 3rd year of monitoring for the Unnamed Tributaries to Mud Creek. Site 1 is stable for this evaluation but does have some bare areas along the left bank downstream of PP#3 due to livestock grazing from the adjacent landowner from last year. NCDOT removed the livestock, fencing, and made some hand repairs to this area in mid-May 2011. Site 3 appears to be stable throughout the entire length of the stream relocation. NCDOT has completed three years of monitoring and is proposing to discontinue channel stability monitoring.

Date Inspected	Station Number	Station Number	Station Number	Station Number	Station Number
6/29/11	13+00-L- Downstream of Photo Point #3 @ Site 1				
Structure Type	.				
Is water piping through or around structure?					
Head cut or down cut present?					
Bank or scour erosion present?					
Other problems noted?	Bare areas along left bank downstream of PP#3

Site 1 (Bare areas along the left bank downstream of PP#3)
