Monitoring Data RecordProject Title: B-4183COE Action ID: 2011-00417 DWQ Number: 20110060Stream Name: Crooked Creek and Middle Fork CreekCity, County and other Location Information: Madison County, replaced Br. #29 over Middle Fork Creek and Br. #28 over Crooked Creek on SR 1526 adjacent to US 19Date Construction Completed: Completed Planting on 11-26-12 Monitoring Year: ( 3 ) of 5Ecoregion: \_\_\_\_\_ 8 digit HUC unit 06010105USGS Quad Name and Coordinates: 35.85350, -82.48853**Rosgen Classification:**Length of Project: 107' Urban or Rural: Rural Watershed Size: \_\_\_\_\_Monitoring DATA collected by: M. Green & J. Young Date: 6/17/14

Year 3 – June 2014

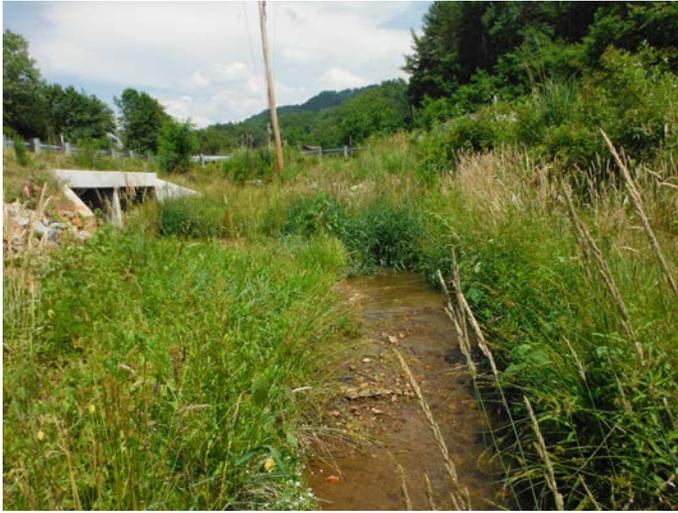
Photo Point #1 (Upstream)

The Crooked Creek stream relocation is stable for the Year 3 evaluation. The right bank of Middle Fork Creek at the confluence of Crooked Creek and Middle Fork Creek is also stable for the Year 3 evaluation. NCDOT will continue to monitor the channel stability at the Crooked Creek and Middle Fork Creek sites.

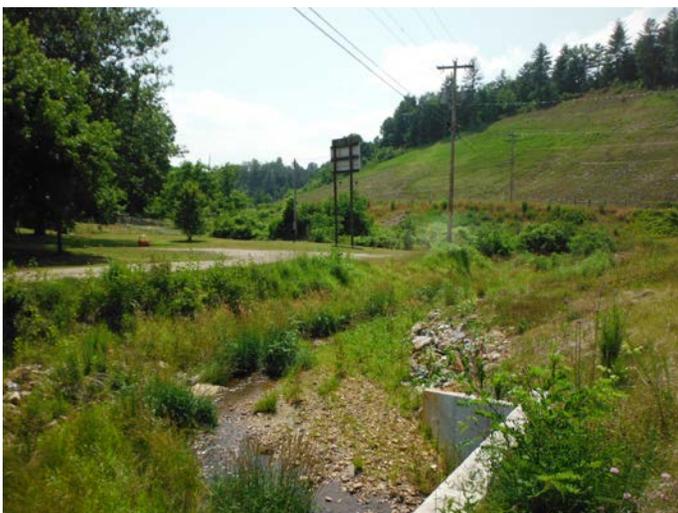
Overview Photo Looking Downstream of Crooked Creek from Crooked Creek Rd

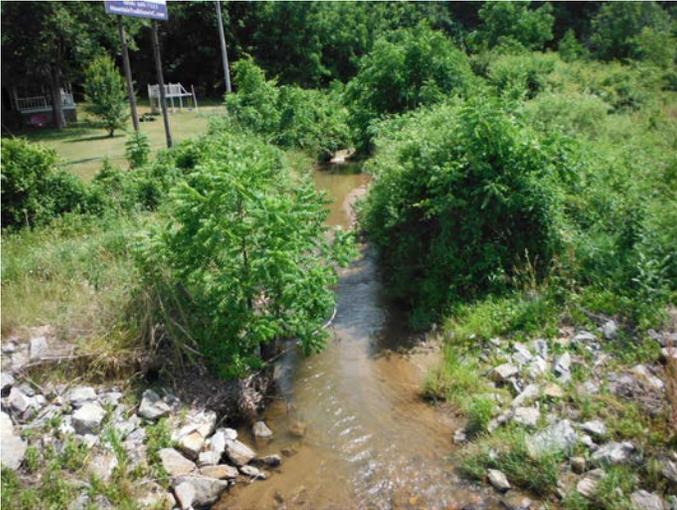
Overview Photo Looking Downstream of Middle Fork Creek from Crooked Creek Rd
