Channel Mitigation Monitoring Sheets I, II, III, AND IV

Monitoring Data Record

Project Title: B-4191 (Br. No. 82 over Jacktown Creek on NC 226)
COE Action ID: SAW-2009-0707 DWQ Number: 20090385
Stream Name: Jacktown Creek
City, County and other Location Information: McDowell County, Bridge #82 over Jacktown Creek on NC Highway 226, approx. 0.2 miles south of I-40 adjacent to McDowell Technical Community College.
Date Construction Completed: 3/29/12 Monitoring Year: (3) of 5
Ecoregion: _____ 8 digit HUC unit 03050105
USGS Quad Name and Coordinates: Marion West 35.655352, -81.959133

Year 3 Summer - June 2014

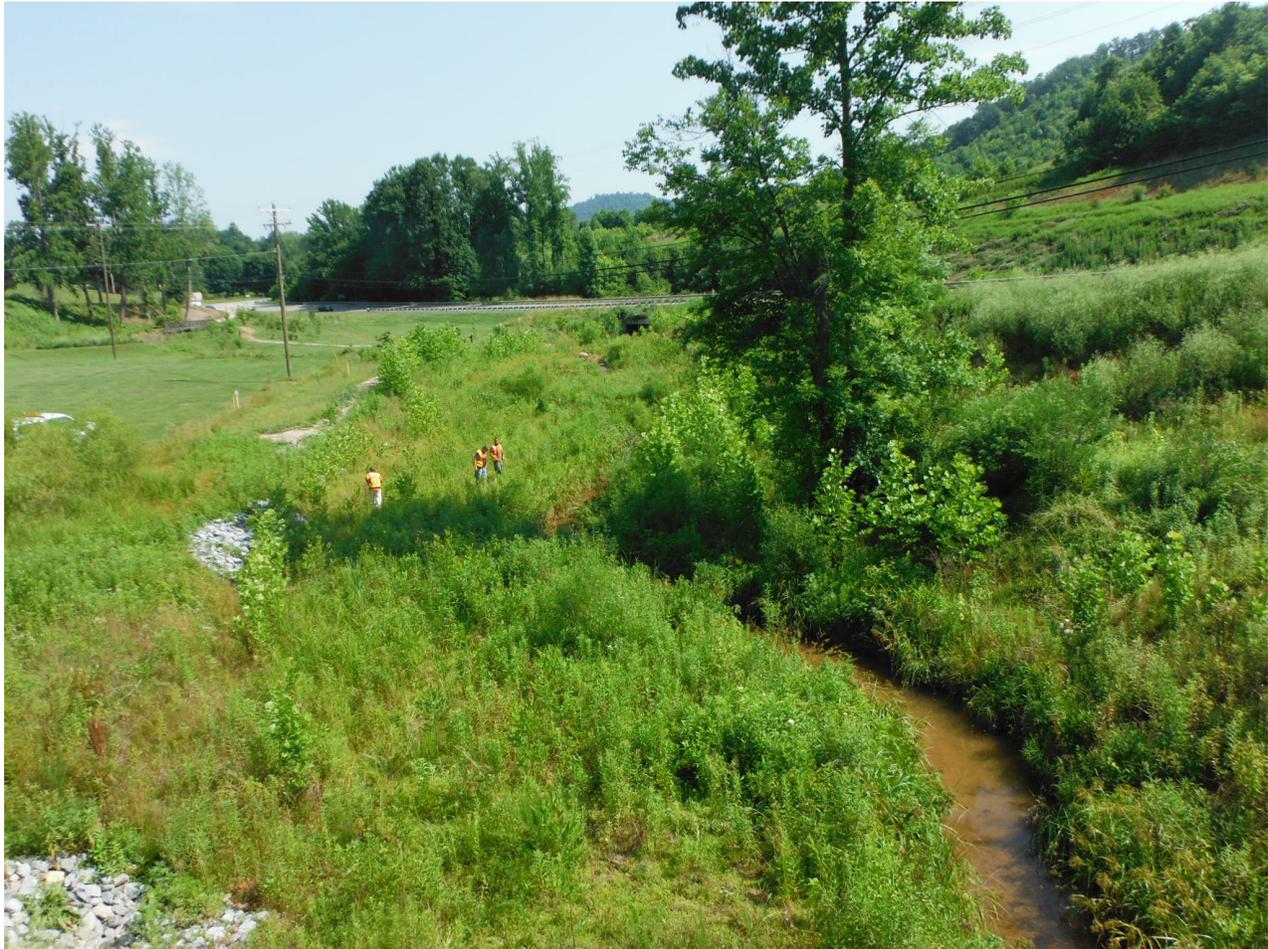
Overview Photo Looking Upstream from SR 1832

The Jacktown Creek stream restoration site is stable for the Year 3 Summer evaluation. A bankfull event was noted during an additional site visit on 5/7/14. See the bankfull dates throughout the monitoring period below and how the bankfull events were noted. This site has met the bankfull requirement of two bankfull events must occur over the five year monitoring period. NCDOT will continue to monitor channel stability at the Jacktown Creek stream restoration site.
