Channel Mitigation Monitoring Sheets I, II, III, AND IV

Monitoring Data Record

Project Title: B-4191 (Br. No. 82 over Jacktown Creek on NC 226)

Year 3 Winter - January 2014

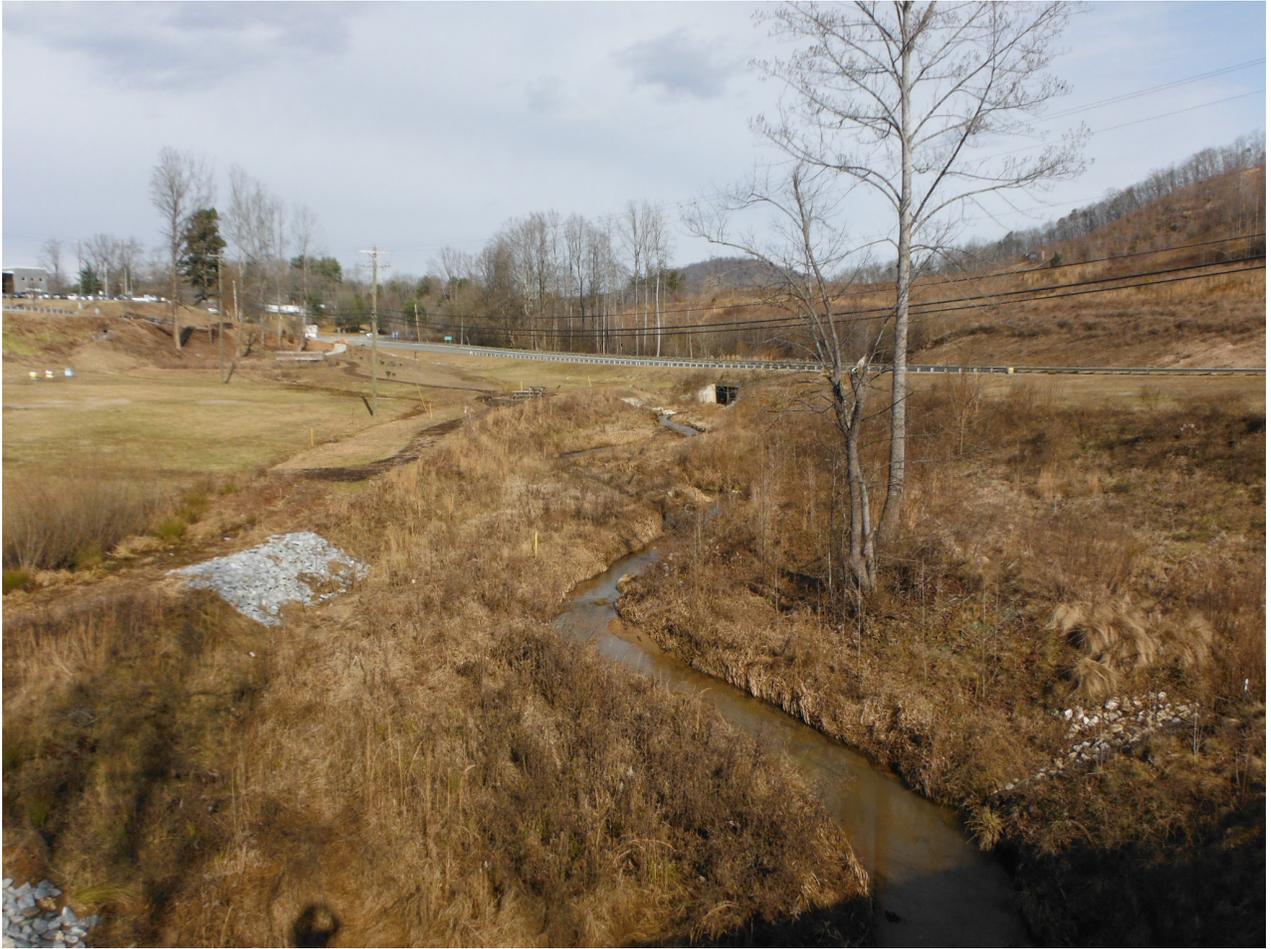
Overview Photo Looking Upstream from SR 1832

The Jacktown Creek stream restoration site is stable for the Year 3 Winter evaluation. Debris and sediment deposited onto the floodplain indicates that a bankfull event has occurred onsite since the last monitoring evaluation. NCDOT will continue to monitor channel stability at the Jacktown Creek stream restoration site.
