Channel Mitigation Monitoring Sheets I, II, III, AND IV

Monitoring Data Record

Project Title: B-4191 (Br. No. 82 over Jacktown Creek on NC 226)

COE Action ID: SAW-2009-0707 DWQ Number: 20090385

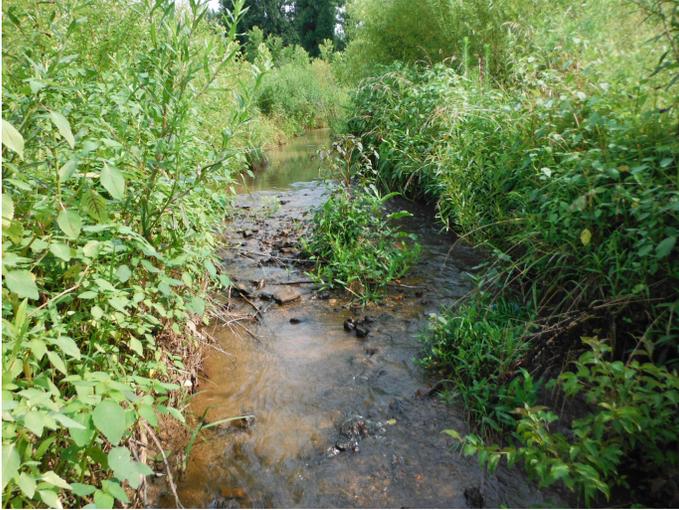
The Jacktown Creek stream restoration site is stable for the Year 4 Summer evaluation, except for, some left bank erosion at Sta. 12+50. A mid-channel bar was also observed at Sta. 11+00 but this area remains stable at this time. See the bankfull dates throughout the monitoring period below and how the bankfull events were noted. This site has met the bankfull requirement of two bankfull events must occur over the five year monitoring period. NCDOT will continue to monitor channel stability at the Jacktown Creek stream restoration site. A consultant has been scoped to design remedial action plans to repair the left bank at Sta. 12 +50.

Sta. 11+00 (mid-channel bar)

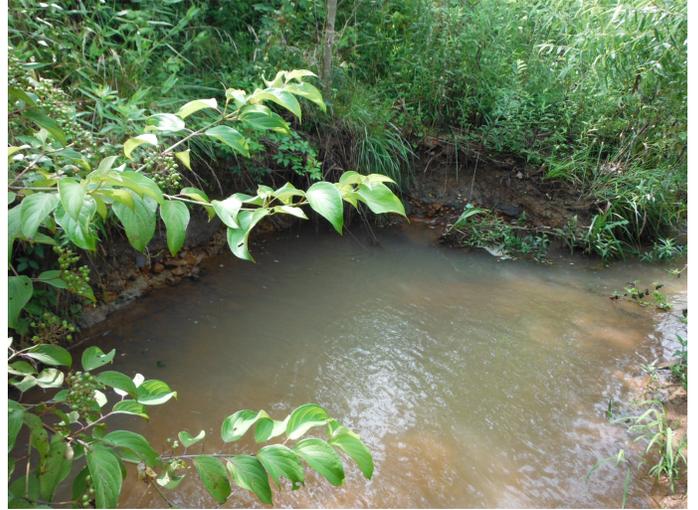
Sta. 12+50 (left bank erosion)

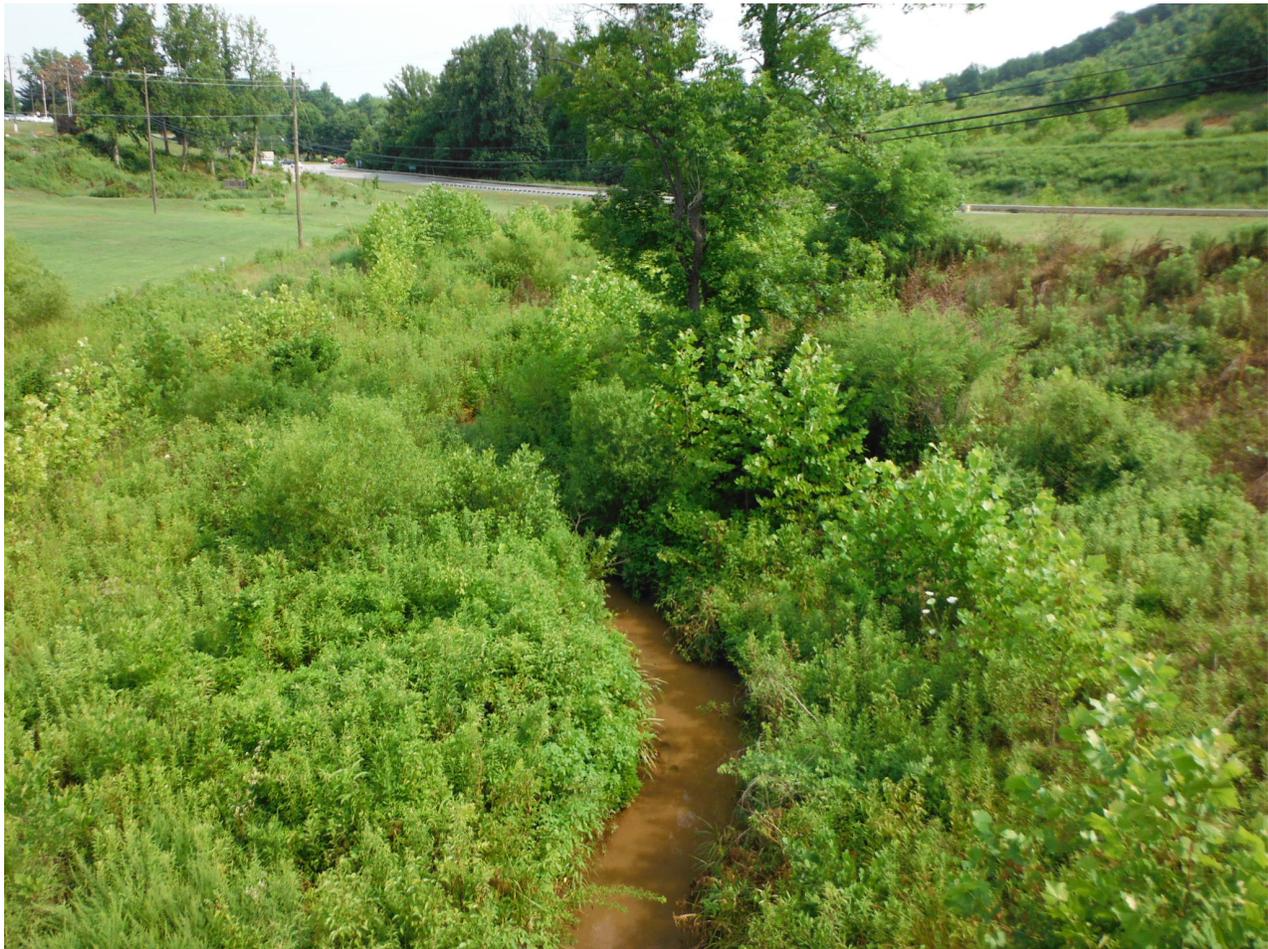
Overview Photo Looking Upstream from SR 1832
