Channel Mitigation Monitoring Sheets I, II, III, AND IV

Monitoring Data Record

Project Title: B-4191 (Br. No. 82 over Jacktown Creek on NC 226)

Stream Name: Jacktown Creek

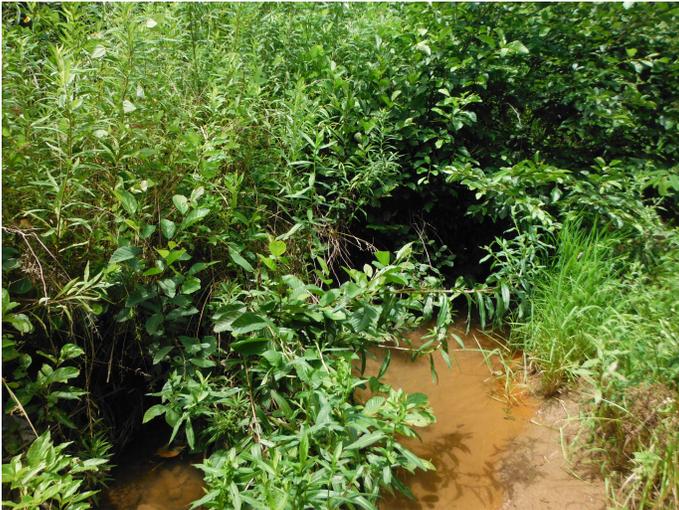
Photo Point #2 (Upstream)

A small area of kudzu was noted within the east buffer adjacent to Photo Point #2.

Estimated causes, and proposed/required remedial action: NCDOT applied a herbicide application on the kudzu on 7/11/16.

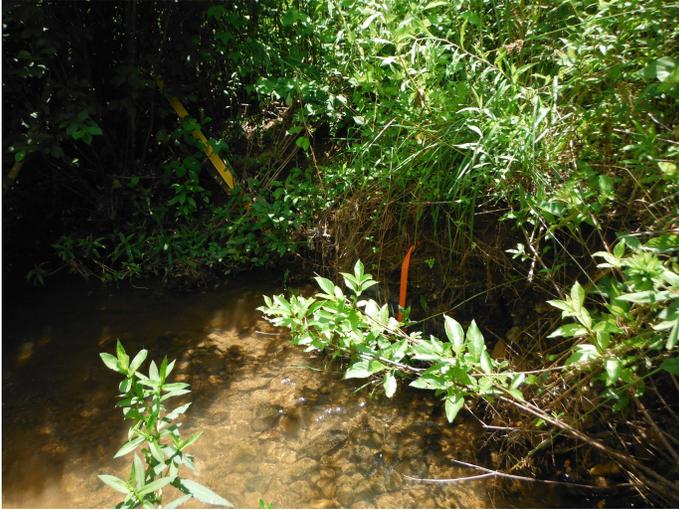
The Jacktown Creek stream restoration site is stable for the Year 5 Summer evaluation, except for, some right bank erosion at Sta. 11+90 and left bank erosion at Sta. 12+50. Bank pins were set at both locations. See the bank full dates throughout the monitoring period below and how the bankfull events were noted. This site has met the bankfull requirement of two bankfull events must occur over the five year monitoring period. NCDOT proposes to discontinue channel stability monitoring. NCDOT will schedule a field close out meeting in 2017 and at this time the bank pins will be evaluated to see if further bank erosion has occurred.

Bank Pin #1 (Sta. 11+90 right bank erosion)

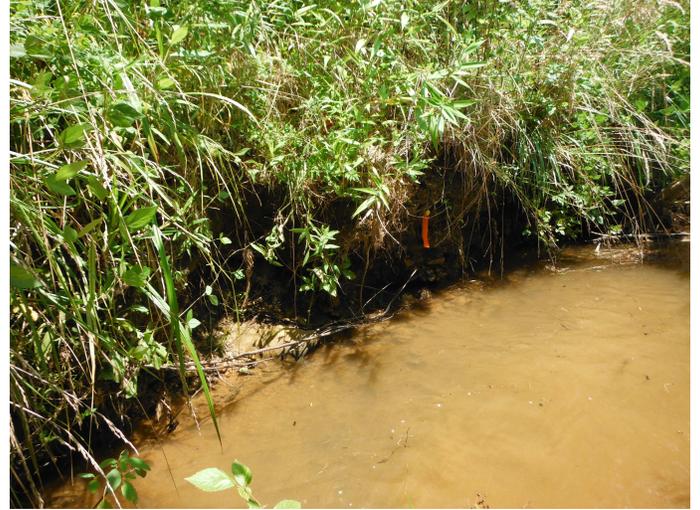
Bank Pin #2 (Sta. 12+50 left bank erosion)
