Monitoring Data Record

Project Title: I-2511CB (I-85 Widening) COE Action ID: 200221534  
Stream Name: Town Creek (Site 5) DWQ Number: 040271  
City, County and other Location Information: Rowan County, I-85 Widening (-TI-PINC Sta. 20+35)  
Date Construction Completed: Water turned on 12/6/06, Stream reforestation completed 12/13/06  
Monitoring Year: ( 2 ) of 5  
Ecoregion: \_\_\_\_\_ 8 digit HUC unit 03040103  
USGS Quad Name and Coordinates: \_\_\_\_\_

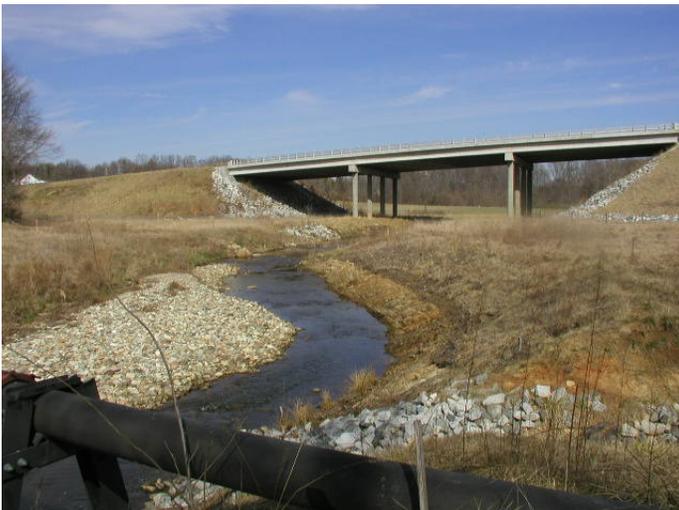
(Overview looking downstream of buffer area)

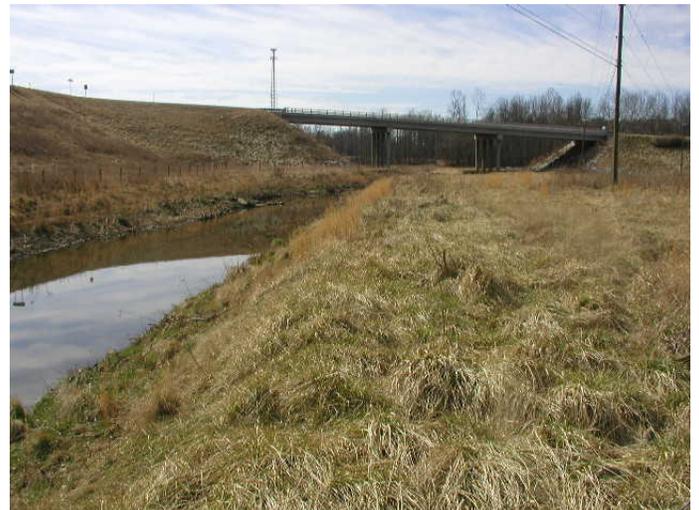
(Overview looking upstream of buffer area)
