Monitoring Data Record

Project Title: I-2511CB (I-85 Widening) COE Action ID: 200221534
Stream Name: Town Creek (Site 5) DWQ Number: 040271
City, County and other Location Information: Rowan County, I-85 Widening (-TI-PINC Sta. 20+35)
Date Construction Completed: Water turned on 12/6/06, Stream reforestation completed 12/13/06
Monitoring Year: (3) of 5
Ecoregion: _____ 8 digit HUC unit 03040103
USGS Quad Name and Coordinates: _____

Town Creek

Year 3 Winter – March 2010

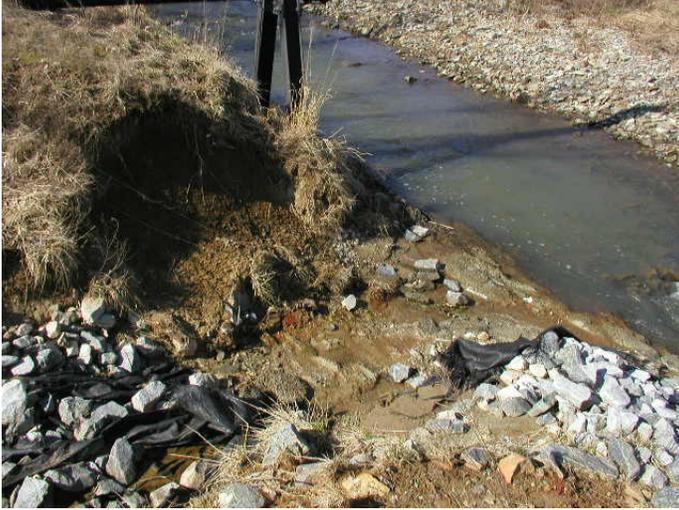
The Town Creek stream relocation is stable for the Year 3 Winter evaluation, except for some bank erosion on the left bank in front of a rock structure at Sta. 16+50. Some bank erosion was also noted on the right bank at Sta. 13+00 where a drainage ditch exits into the stream relocation. NCDOT plans to live stake these eroded areas to help stabilize the streambanks. A bankfull event has occurred since the last monitoring evaluation. NCDOT will continue to monitor this stream relocation.

Erosion on right bank @ -TI- PINC Sta. 13+00

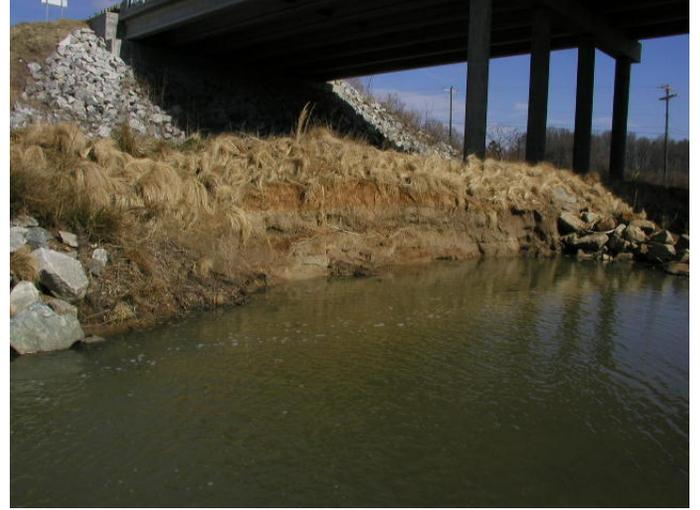
Erosion on left bank @ -TI- PINC Sta. 16+50
