ANNUAL REPORT FOR 2006

**Unnamed Tributaries to Doby Creek Mitigation Site
Mecklenburg County
TIP No. I-3803A**

Prepared By:
Natural Environment Unit & Roadside Environmental Unit
North Carolina Department of Transportation
December 2006

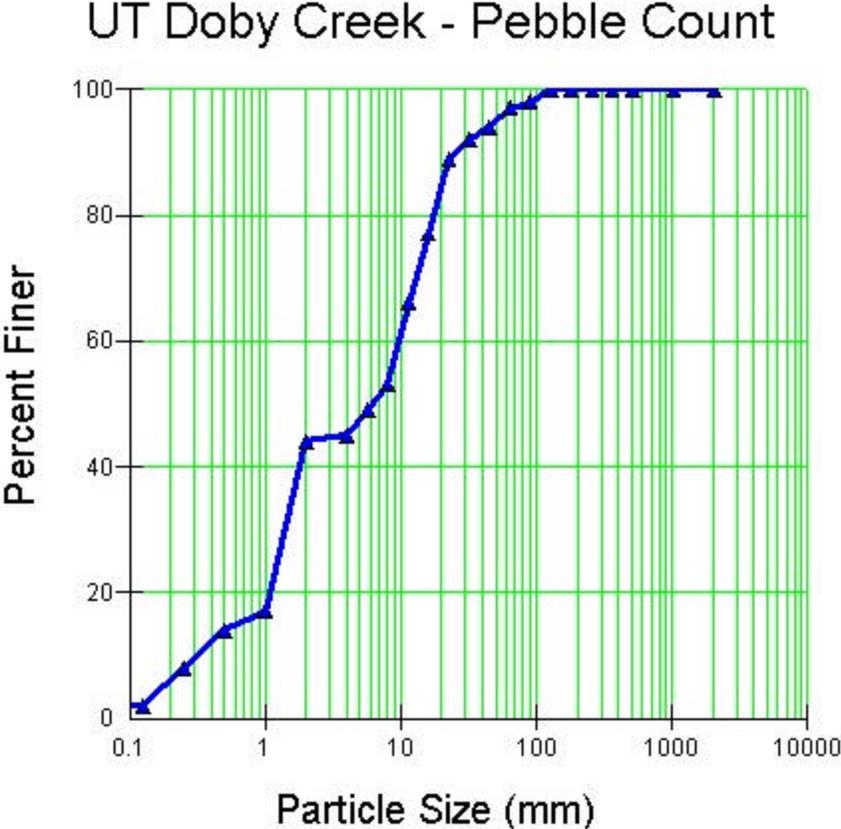
Pebble counts were also taken at each cross section as a means to determine the bed material at each cross section location. However, only pebble counts taken at riffle sections will be utilized to classify the stream. No existing data was available for UT to Doby Creek. The pebble counts taken during the 2006 monitoring period noted that the D_{50} (50 percent of the sampled population is equal to or finer than the representative particle diameter) for the riffle sections of UT to Doby Creek was approximately 6.27mm, which is indicative of a gravel-bed stream.

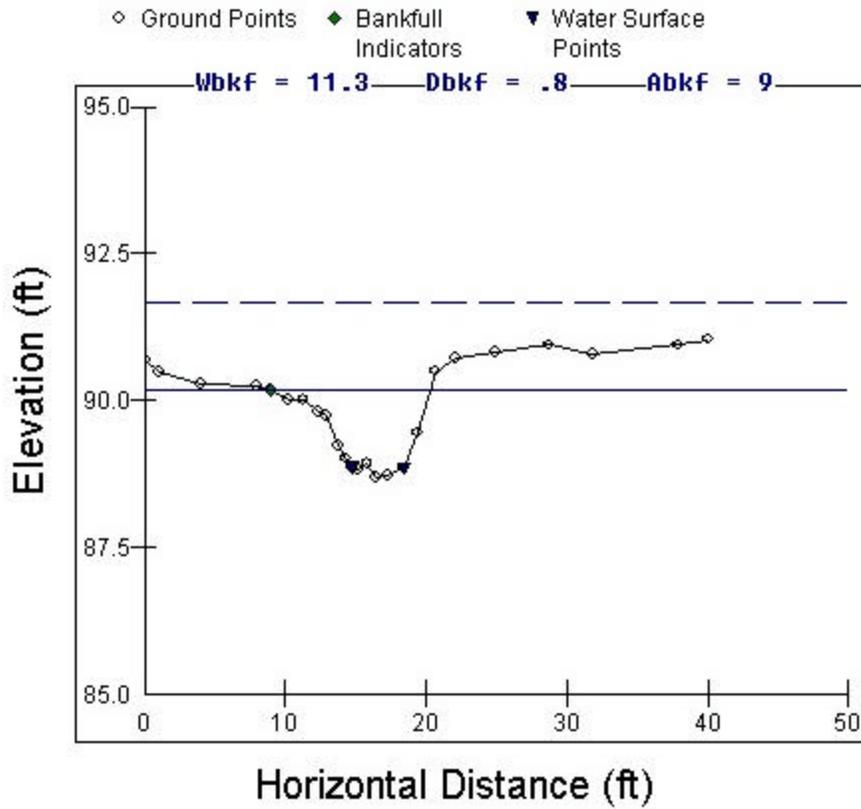
Riffle Cross Section #1

Based on comparisons of design cross section data and 2006 monitoring data, both cross sections appear stable with little or no active bank erosion. Graphs of the cross sections are presented in Appendix A. Future survey data will vary depending on actual location of rod placement and alignment, however, this information should remain similar in appearance.

Cross-Section #1 (Riffle) Abbreviated Morphological Summary					
	2006	2007	2008	2009	2010
Bankfull Cross Sectional Area (ft ²)	9.05				
Maximum Bankfull Depth (ft)	1.49				
Width of the Floodprone Area (ft)	40.1				
Bankfull Mean Depth (ft)	0.8				
Width/Depth Ratio	14.15				
Entrenchment Ratio	3.54				
Bankfull Width (ft)	11.32

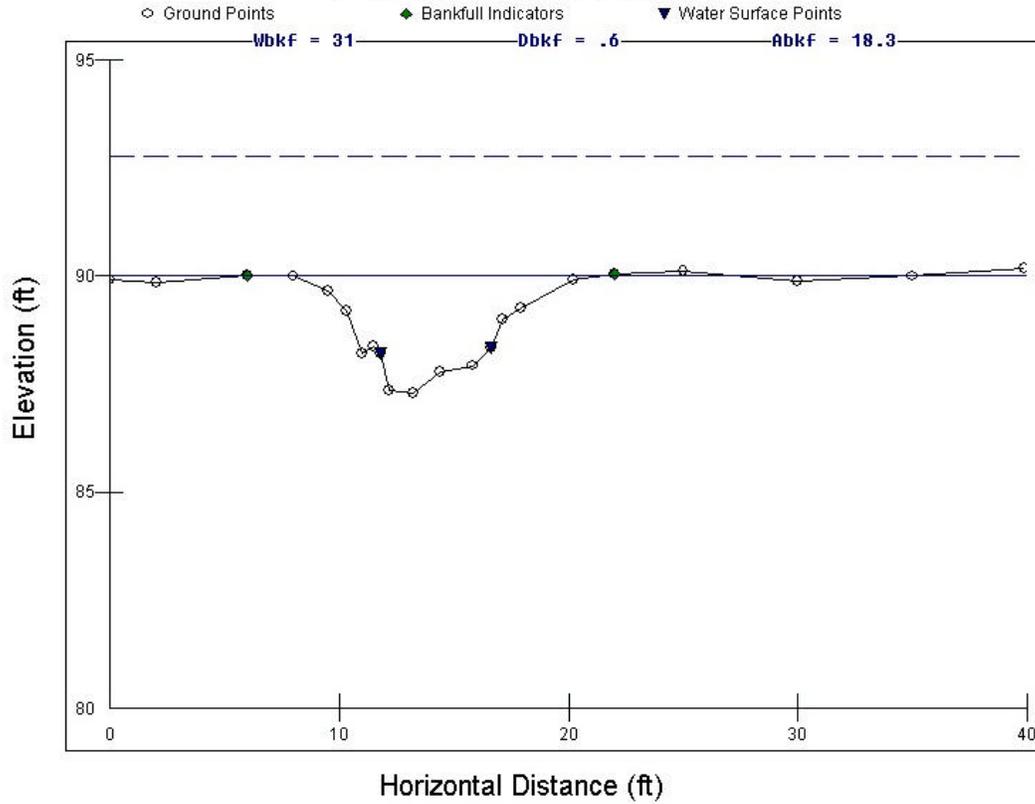
Pool Cross Section #2

2006	2007	2008	2009	2010
Bankfull Cross Sectional Area (ft²)	16.85				
Maximum Bankfull Depth (ft)	2.75				
Bankfull Mean Depth (ft)	1.06				
Bankfull Width (ft)	15.85
