ANNUAL REPORT FOR 2010

**Unnamed Tributaries to Doby Creek Mitigation Site
Mecklenburg County
TIP No. I-3803A**

Prepared By:
Natural Environment Unit & Roadside Environmental Unit
North Carolina Department of Transportation
December 2010

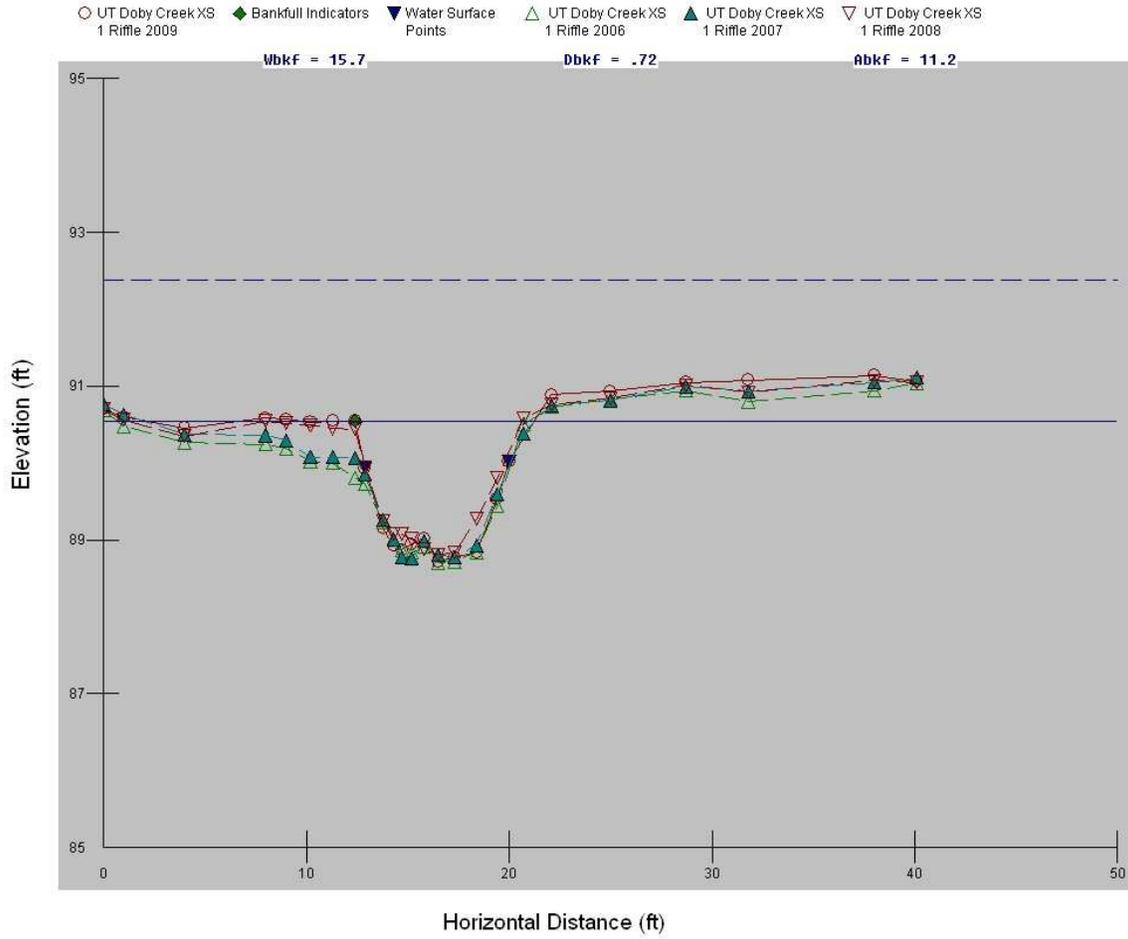
UT Doby Creek XS 1 Riffle

Based on comparisons of the monitoring data, both cross sections appear stable with little or no active bank erosion. It was noted on the graph for cross section #2 pool that some of the sediment deposited into the channel from last year has moved downstream. The beaver dam located on the restoration project at photo point #3 has been removed by NCDOT Maintenance

Cross-Section #1 (Riffle) Abbreviated Morphological Summary					
	2006	2007	2008	2009	2010
Bankfull Cross Sectional Area (ft ²)	9.05	9.46	9.7	10.97	12.89
Maximum Bankfull Depth (ft)	1.49	1.54	1.7	1.83	2.01
Width of the Floodprone Area (ft)	40.1	40.1	40.1	40.1	40.1
Bankfull Mean Depth (ft)	0.8	0.82	0.8	1.04	0.94
Width/Depth Ratio	14.15	14.09	14	10.17	14.54
Entrenchment Ratio	3.54	3.47	3.5	3.79	2.93
Bankfull Width (ft)	11.32	11.55	11.6	10.58	13.67

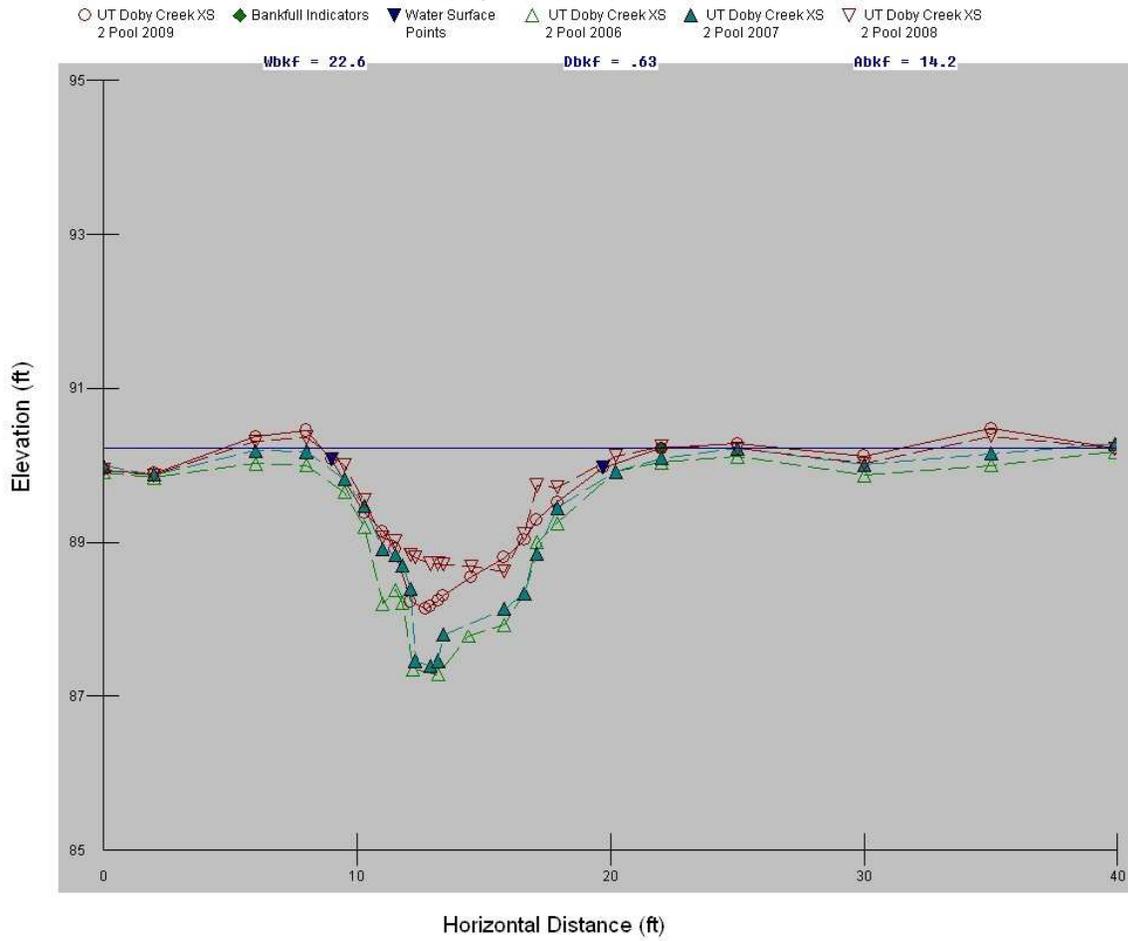
UT Doby Creek XS 2 Pool

Cross-Section #2 (Pool) Abbreviated Morphological Summary*					
	2006	2007	2008	2009	2010
Bankfull Cross Sectional Area (ft ²)	16.85	15.09	11.01	12.89	15.91
Maximum Bankfull Depth (ft)	2.75	2.7	1.62	2.09	2.34
Bankfull Mean Depth (ft)	1.06	1.11	0.82	0.96	0.99
Bankfull Width (ft)	15.85	13.63	13.5	13.38	16

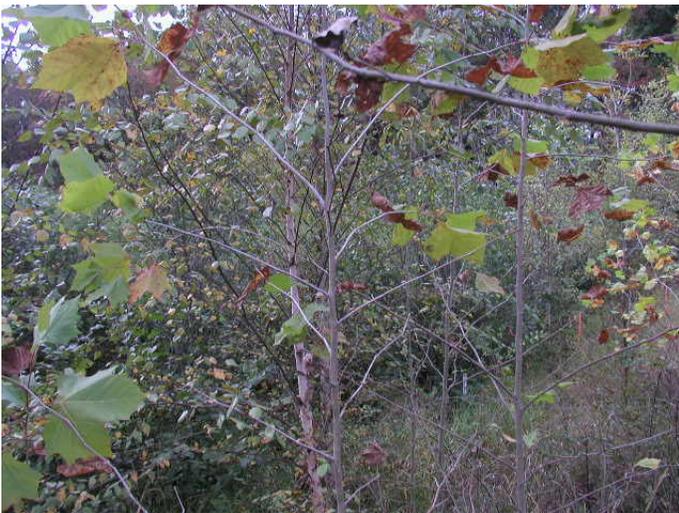
Photo Point #1 (Vegetation Plot 2)

Site Notes: Other vegetation noted: *Juncus* sp., cattail, woolgrass, and various grasses. There was some missing planted vegetation within vegetation plot #2 due to the beaver activity but other hardwood vegetation (i.e. black willow and tag alder) were still abundant.

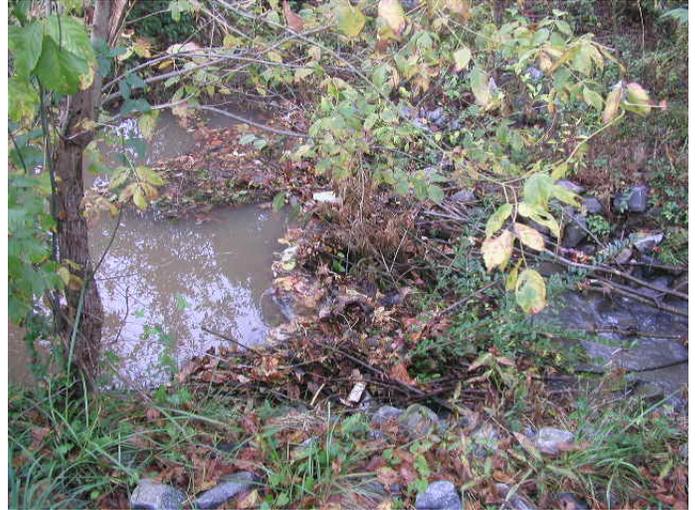
There is also an additional beaver dam located downstream of photo point #3 outside the scope of the restoration project. USDA has been contacted to remove the beavers and the beaver dams. Debris deposited onto the floodplain suggests that a bankfull event has occurred on site since the last monitoring evaluation in 2009. Graphs of the cross sections are presented in Appendix A. Future survey data will vary depending on actual location of rod placement and alignment; however, this information should remain similar in appearance. A representative pebble count was not taken in 2010 due to high water from beaver activity.

Beaver dam located downstream of Photo Point #3 off of the restoration project

The UT to Doby Creek mitigation site has met the required monitoring protocols for the fifth formal year of monitoring. The channel and structures throughout the stream are stable at this time. NCDOT has contracted USDA to remove the beavers and the dam located downstream of photo point #3 off of the restoration project. A longitudinal profile survey was not conducted along the stream at the UT to Doby Creek Mitigation Site in 2010 due to extensive growth along the channel. The heavy vegetation growth made it impossible to complete the longitudinal survey without cutting down many of the desired species along the channel. NCDOT contacted the resource agencies in November 2010 to request that the profile not be completed for the fifth year of monitoring. It was agreed at that time that as long as the stream remained stable that the longitudinal profile monitoring could be ceased and that a site review would be requested at the end of the monitoring period.

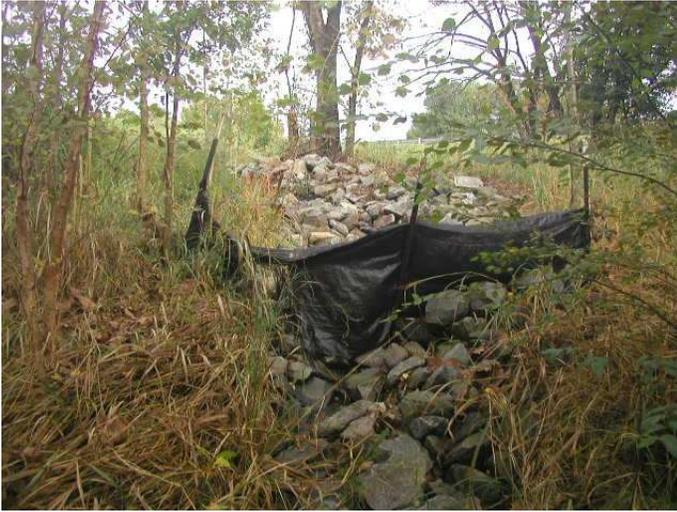
Drainage Ditch Repaired
