Monitoring Data Record

Project Title: I-40 Slope Stabilization COE Action ID: SAW-2012-00546  
 Stream Name: UT's to Hominy Creek DWQ Number: 20120309  
 City, County and other Location Information: Site is located on Holder Branch Rd adjacent to US 19/23 (Asheville Highway) east of Canton, NC in Haywood County  
 Date Construction Completed: Planting completed on 2/6/14 Monitoring Year: ( 1 ) of 5  
 Ecoregion: \_\_\_\_\_ 8 digit HUC unit 06010105  
 USGS Quad Name and Coordinates: 35.538800, -82.796083

# UT's to Hominy Creek

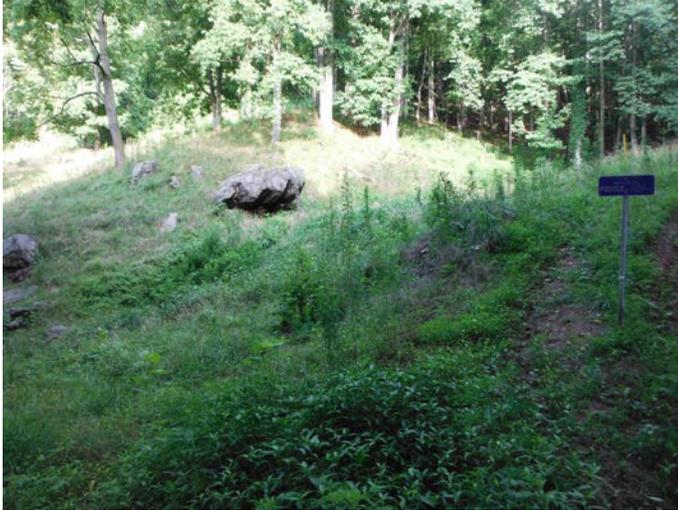
Overview photo looking at Stream SE

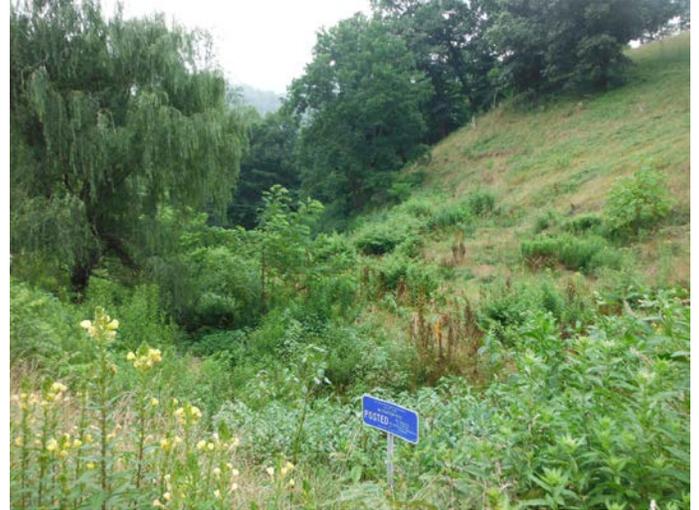
Overview photo looking at Stream SA

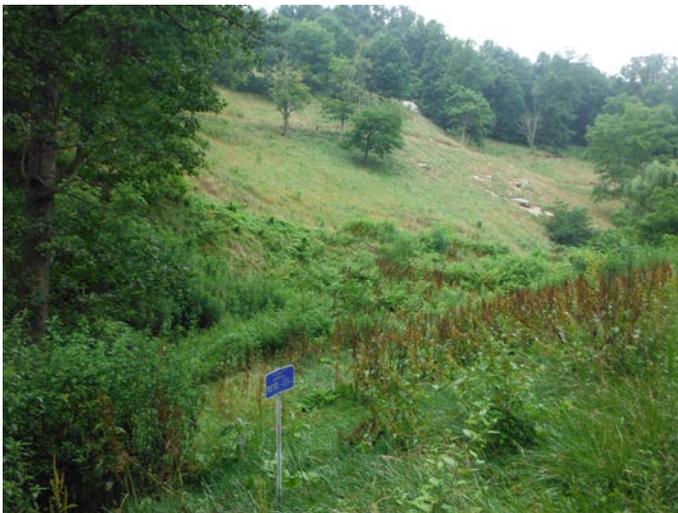
Overview photo looking at Stream SA
