Monitoring Data Record

Project Title: R-210A (Site 10) COE Action ID: 1993-0-0570

City, County and other Location Information: US 1 (Vass Bypass) in Moore County
(Sta. 51+70 to 52+20)

Date Construction Completed: July 2003 Monitoring Year: (4) of 5

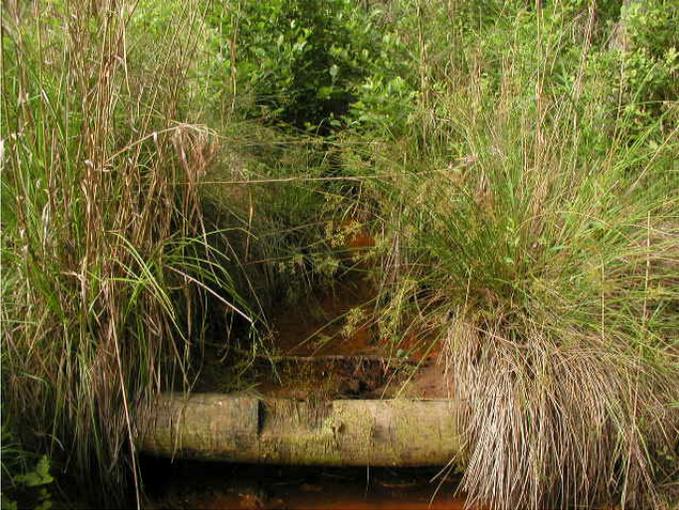
Photo 1 taken from PP# 1 looking upstream

The stream is stabilized for the 4th year of monitoring. At the time of the monitoring evaluation water was piping under the log vane structure in Photo 1. NCDOT will continue to monitor this stream relocation.

6/4/08	Sta. 51+80 Photo 1	Station Number	Station Number	Station Number	Station Number
Structure Type	Log Vane				
Is water piping through or around structure?	Water is piping under the log vane				
Head cut or down cut present?					
Bank or scour erosion present?					
Other problems noted?
