ANNUAL REPORT FOR 2011

**Unnamed Tributary to Little Jacob
Swamp Mitigation Site
Robeson County
TIP No. R-0513WM**

Prepared By:
Natural Environment Unit & Roadside Environmental Unit
North Carolina Department of Transportation
November 2011

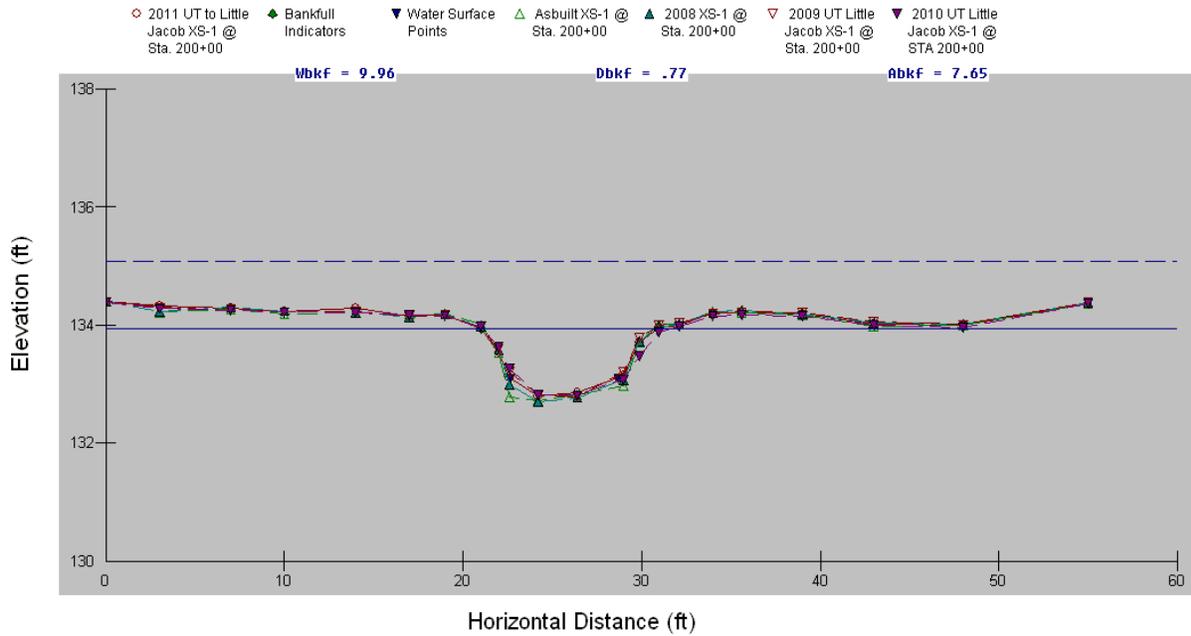
2011 UT to Little Jacob XS-1 @ Sta. 200+00

Cross-Section #1 (Riffle) Abbreviated Morphological Summary					
	2008	2009	2010	2011	2012
Bankfull Width (ft)	10.0	10.04	10	9.96	
Bankfull Mean Depth (ft)	0.84	0.78	1.01	0.77	
Width/Depth Ratio	11.9	12.87	9.9	14.17	
Bankfull Cross Sectional Area (ft²)	8.44	7.80	10.1	7.65	
Maximum Bankfull Depth (ft)	1.26	1.20	1.36	2.17	
Width of the Floodprone Area (ft)	55	55	55	55	
Entrenchment Ratio	5.5	5.48	5.5	4.51

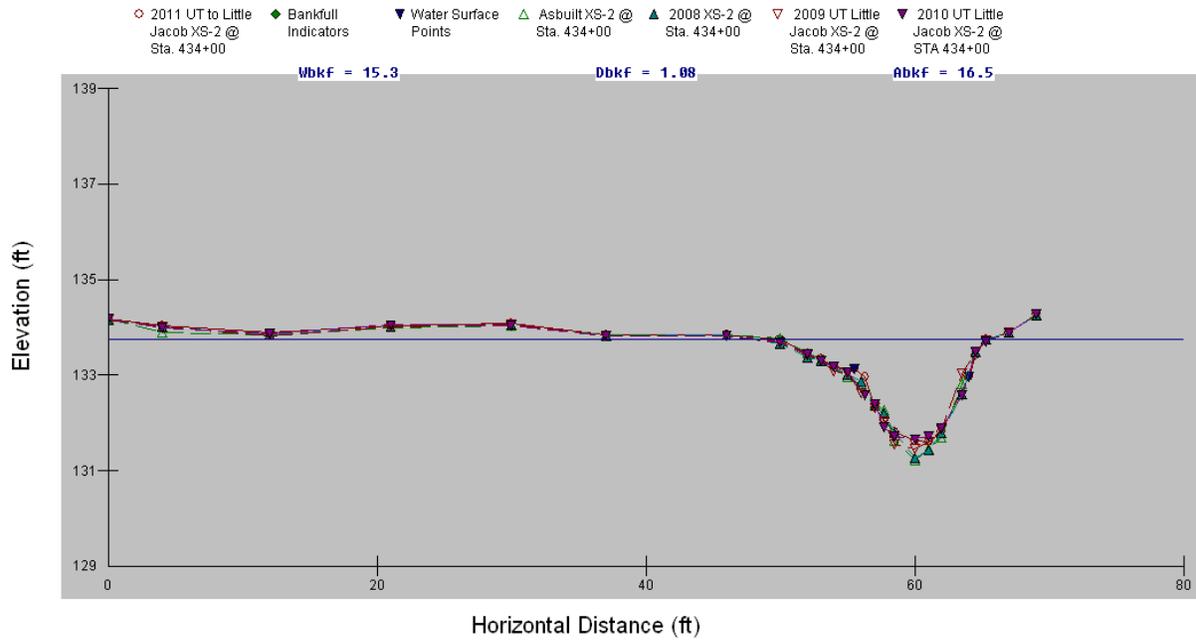
2011 UT to Little Jacob XS-2 @ Sta. 434+00

Cross-Section #2 (Pool) Abbreviated Morphological Summary*					
	2008	2009	2010	2011	2012
Bankfull Cross Sectional Area (ft ²)	16.17	16.01	15.98	16.50	
Maximum Bankfull Depth (ft)	2.39	2.22	2.03	2.17	
Bankfull Mean Depth (ft)	1.08	1.06	1.05	1.08	
Bankfull Width (ft)	15.03	15.14	15.23	15.30

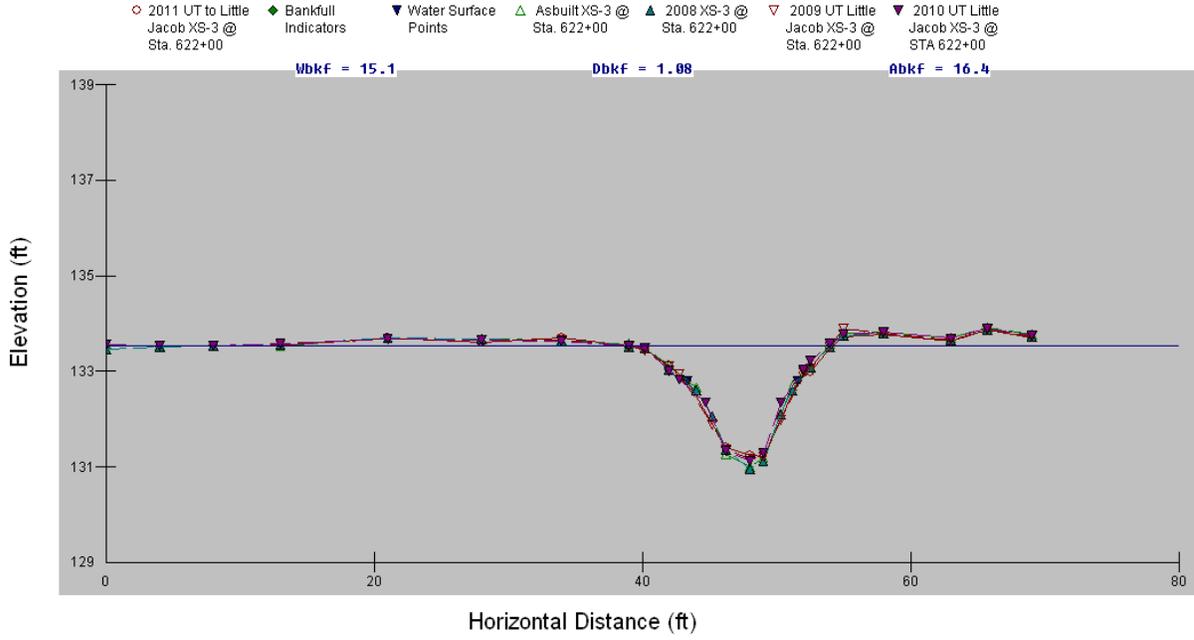
2011 UT to Little Jacob XS-3 @ Sta. 622+00

Cross-Section #3 (Pool) Abbreviated Morphological Summary*					
	2008	2009	2010	2011	2012
Bankfull Cross Sectional Area (ft ²)	16.78	16.76	16.06	15.10	
Maximum Bankfull Depth (ft)	2.56	2.35	2.41	2.30	
Bankfull Mean Depth (ft)	0.8	1.12	1.08	1.08	
Bankfull Width (ft)	21.0	15	14.87	15.13

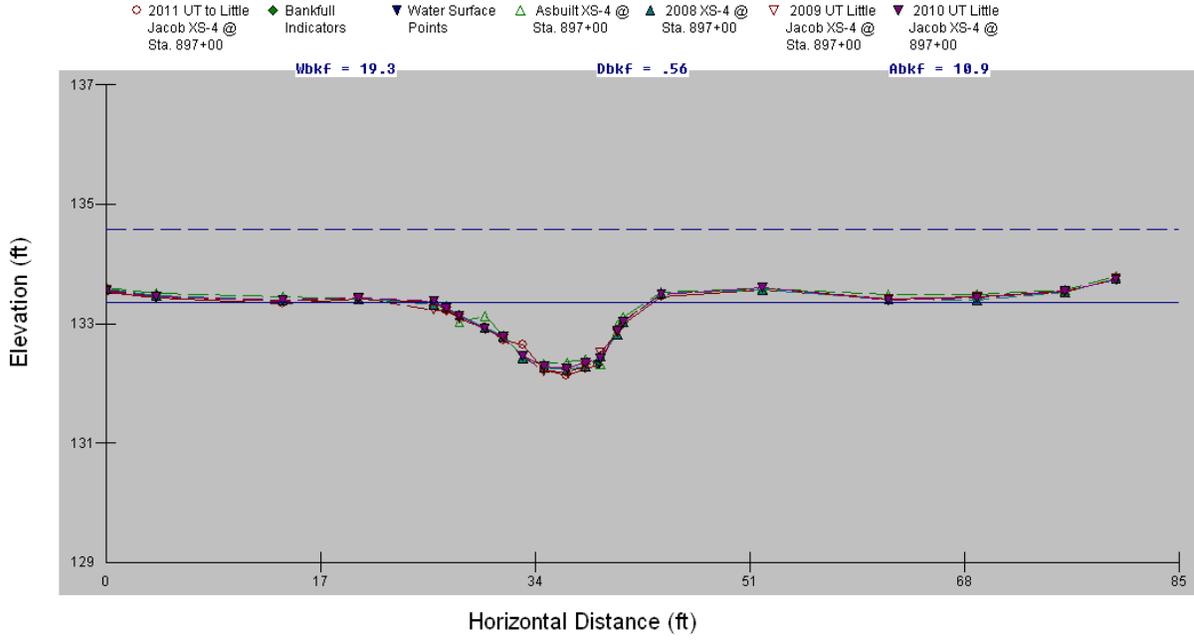
2011 UT to Little Jacob XS-4 @ Sta. 897+00

Cross-Section #4 (Riffle) Abbreviated Morphological Summary					
	2008	2009	2010	2011	2012
Bankfull Width (ft)	16.84	16.27	17.28	19.30	
Bankfull Mean Depth (ft)	0.60	0.55	0.64	0.56	
Width/Depth Ratio	28.07	29.58	27	27.54	
Bankfull Cross Sectional Area (ft ²)	10.16	8.94	11.06	10.90	
Maximum Bankfull Depth (ft)	1.09	1.04	1.14	1.22	
Width of the Floodprone Area (ft)	80	80	80	80	
Entrenchment Ratio	4.75	4.92	4.63	4.61

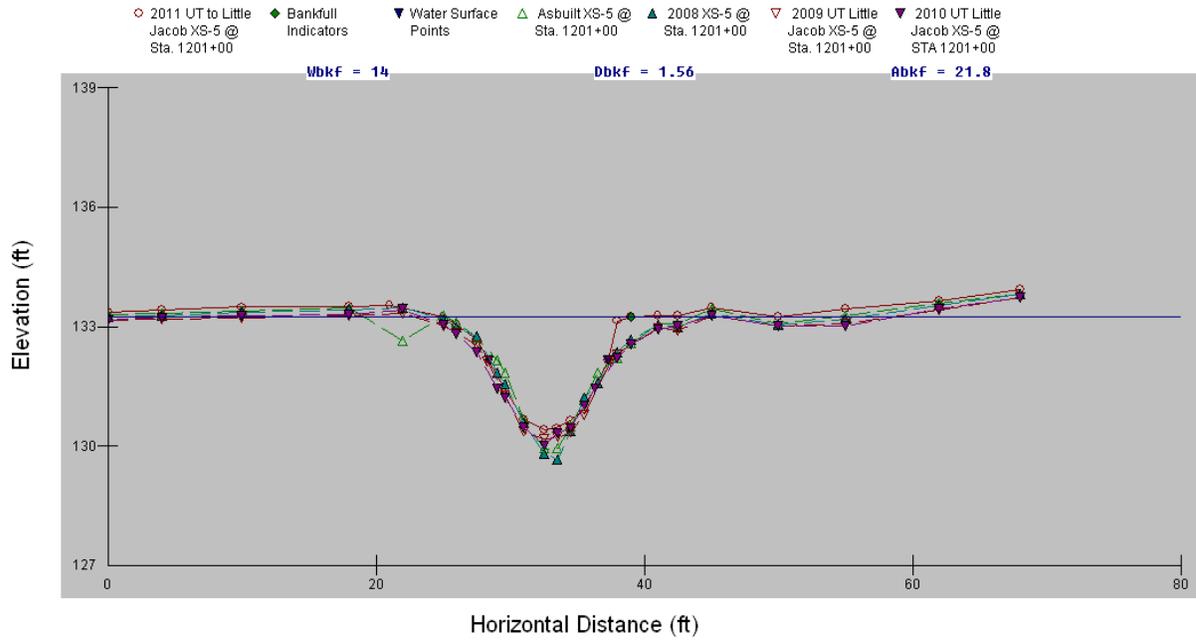
2011 UT to Little Jacob XS-5 @ Sta. 1201+00

Cross-Section #5 (Pool) Abbreviated Morphological Summary*					
	2008	2009	2010	2011	2012
Bankfull Cross Sectional Area (ft ²)	22.13	20.88	27.68	21.84	
Maximum Bankfull Depth (ft)	3.39	2.73	3.24	2.84	
Bankfull Mean Depth (ft)	1.24	1.42	1.38	1.56	
Bankfull Width (ft)	8.91	14.74	20	14.0

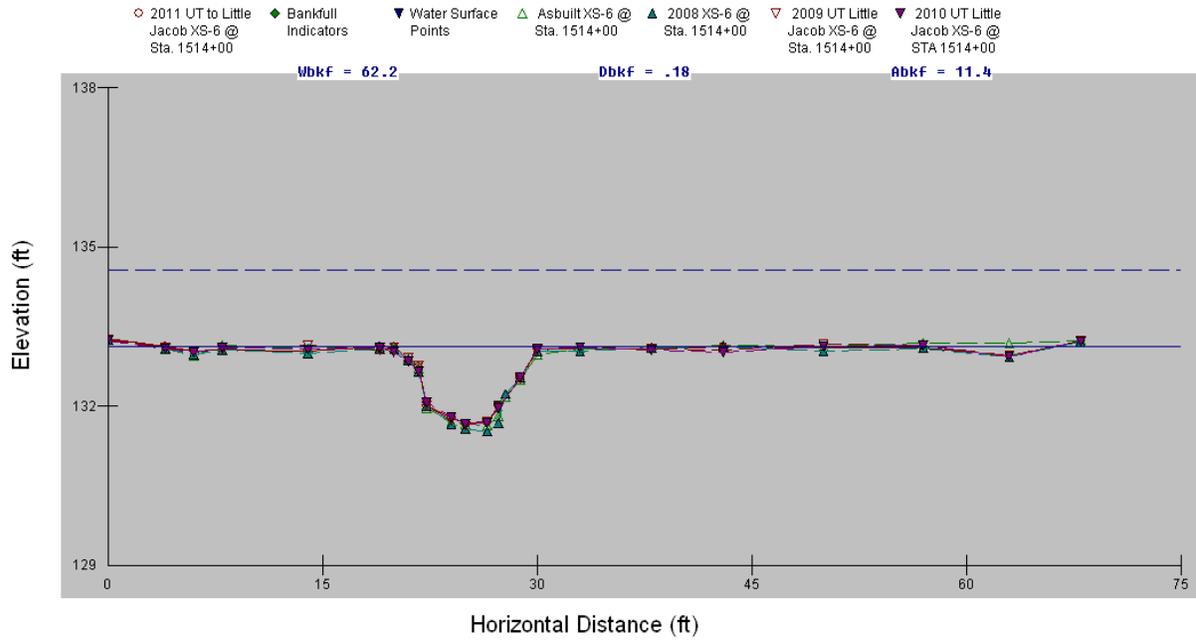
2011 UT to Little Jacob XS-6 @ Sta. 1514+00

Cross-Section #6 (Riffle) Abbreviated Morphological Summary					
	2008	2009	2010	2011	2012
Bankfull Width (ft)	9.8	9.75	11.0	10.0	
Bankfull Mean Depth (ft)	0.91	0.88	0.82	0.91	
Width/Depth Ratio	10.77	11.08	13.41	10.99	
Bankfull Cross Sectional Area (ft ²)	8.94	8.56	9.05	9.13	
Maximum Bankfull Depth (ft)	1.51	1.42	1.44	1.45	
Width of the Floodprone Area (ft)	68	68	68	68	
Entrenchment Ratio	6.94	6.97	6.18	6.8

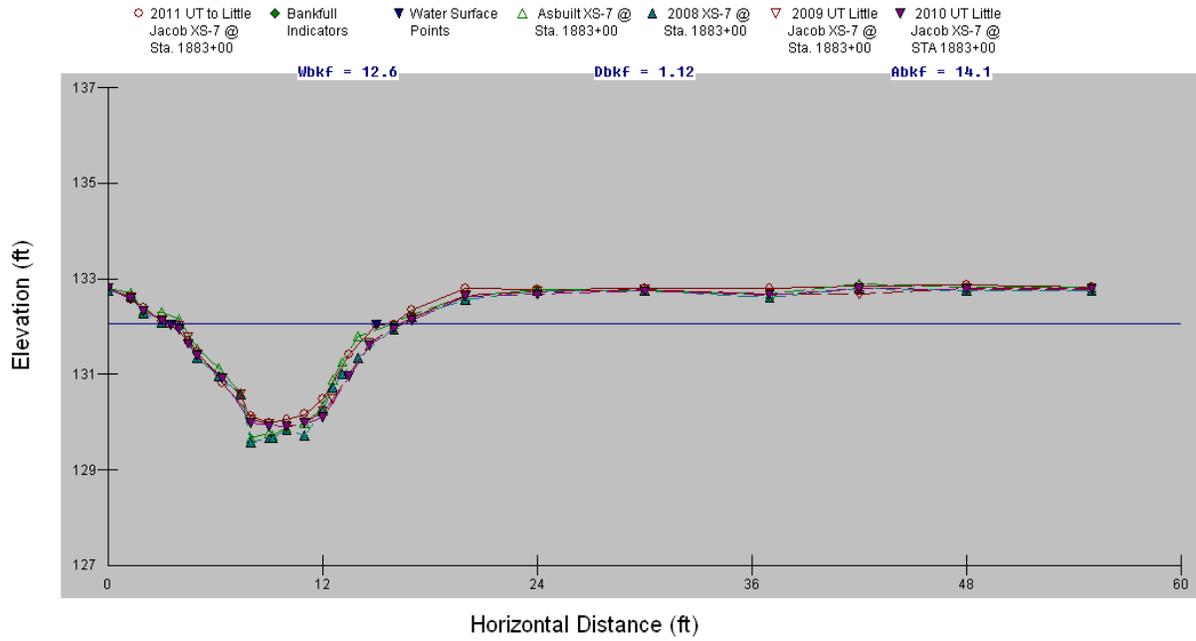
2011 UT to Little Jacob XS-7 @ Sta. 1883+00

Cross-Section #7 (Pool) Abbreviated Morphological Summary*					
	2008	2009	2010	2011	2012
Bankfull Cross Sectional Area (ft ²)	15.14	14.80	14.91	14.05	
Maximum Bankfull Depth (ft)	2.37	2.11	2.05	2.08	
Bankfull Mean Depth (ft)	0.80	1.23	1.24	1.12	
Bankfull Width (ft)	11.85	12.0	12.06	12.58

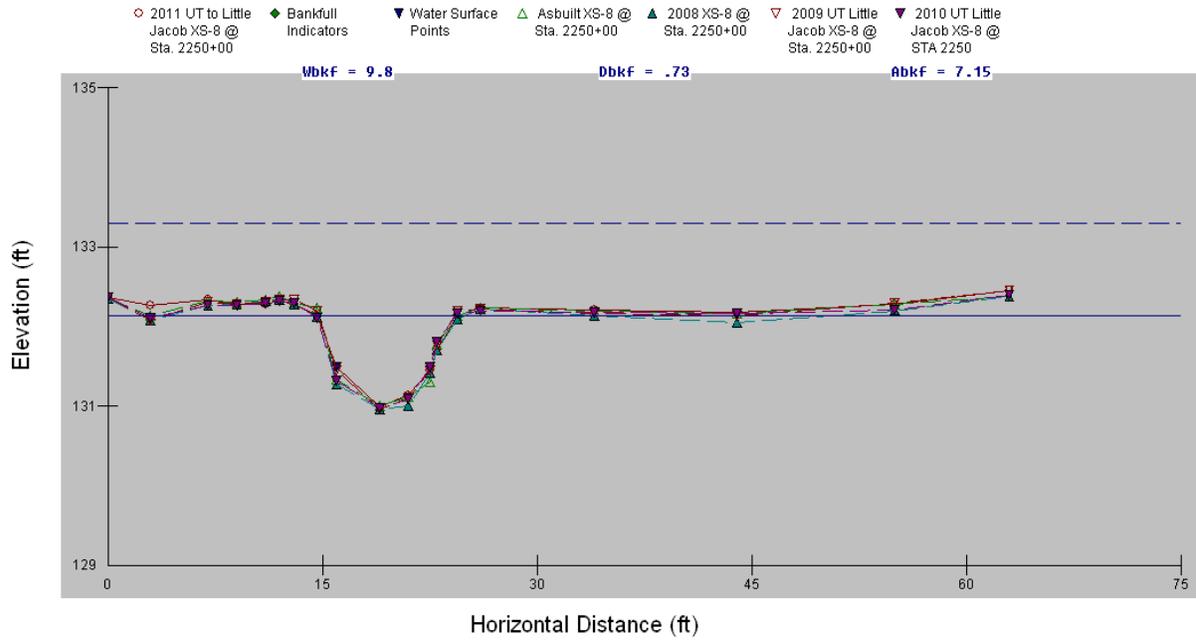
2011 UT to Little Jacob XS-8 @ Sta. 2250+00

Cross-Section #8 (Riffle) Abbreviated Morphological Summary					
	2008	2009	2010	2011	2012
Bankfull Width (ft)	9.77	9.8	9.8	9.8	
Bankfull Mean Depth (ft)	0.78	0.80	0.79	0.73	
Width/Depth Ratio	12.53	12.25	12.41	13.42	
Bankfull Cross Sectional Area (ft ²)	7.64	7.82	7.74	7.15	
Maximum Bankfull Depth (ft)	1.14	1.24	1.19	1.15	
Width of the Floodprone Area (ft)	63	63	63	63	
Entrenchment Ratio	6.45	6.43	6.43	6.43

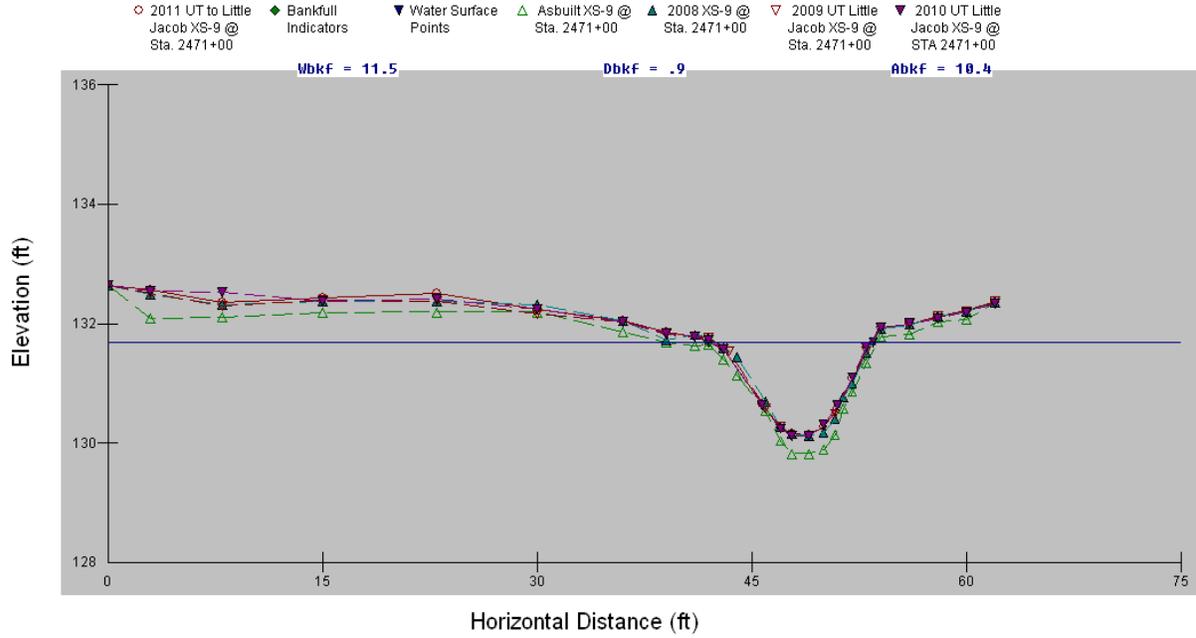
2011 UT to Little Jacob XS-9 @ Sta. 2471+00

Cross-Section #9 (Pool) Abbreviated Morphological Summary*					
	2008	2009	2010	2011	2012
Bankfull Cross Sectional Area (ft²)	10.8	10.84	10.54	10.36	
Maximum Bankfull Depth (ft)	1.64	1.65	1.61	1.55	
Bankfull Mean Depth (ft)	0.93	0.94	0.93	0.90	
Bankfull Width (ft)	11.56	11.55	11.33	11.50

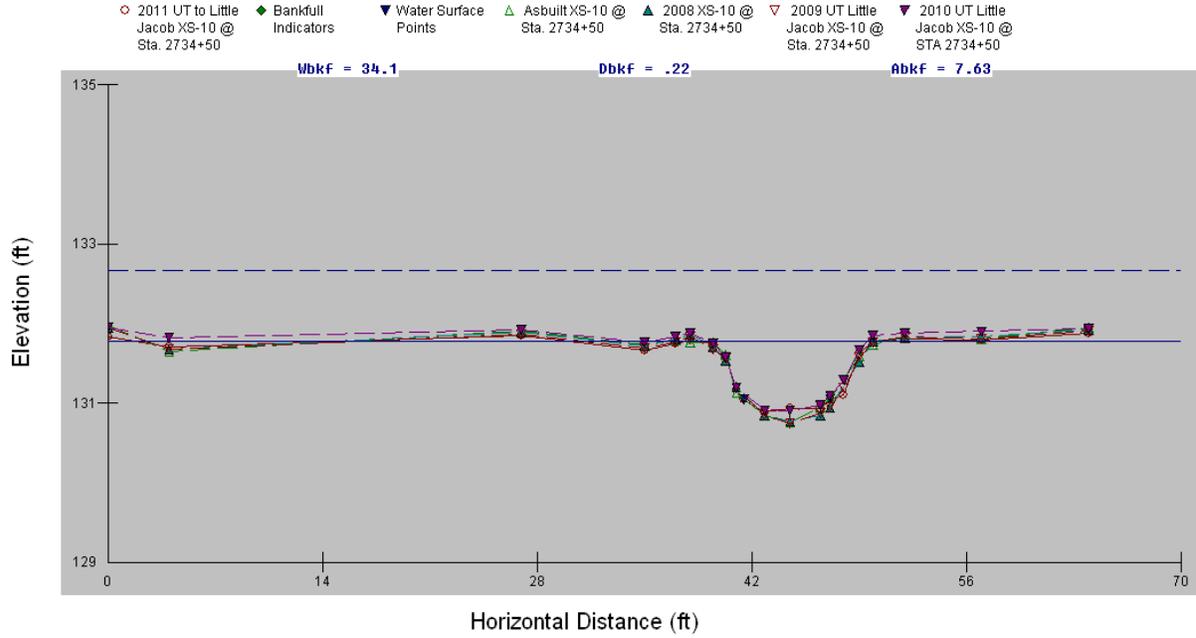
2011 UT to Little Jacob XS-10 @ Sta. 2734+50

Cross-Section #10 (Riffle) Abbreviated Morphological Summary					
	2008	2009	2010	2011	2012
Bankfull Width (ft)	11.1	11.1	11.55	11.53	
Bankfull Mean Depth (ft)	0.64	0.62	0.6	0.57	
Width/Depth Ratio	17.34	17.9	19.25	20.23	
Bankfull Cross Sectional Area (ft ²)	7.08	6.89	6.93	6.58	
Maximum Bankfull Depth (ft)	1.0	1.02	0.95	0.89	
Width of the Floodprone Area (ft)	64	64	64	64	
Entrenchment Ratio	5.77	5.77	5.54	5.55

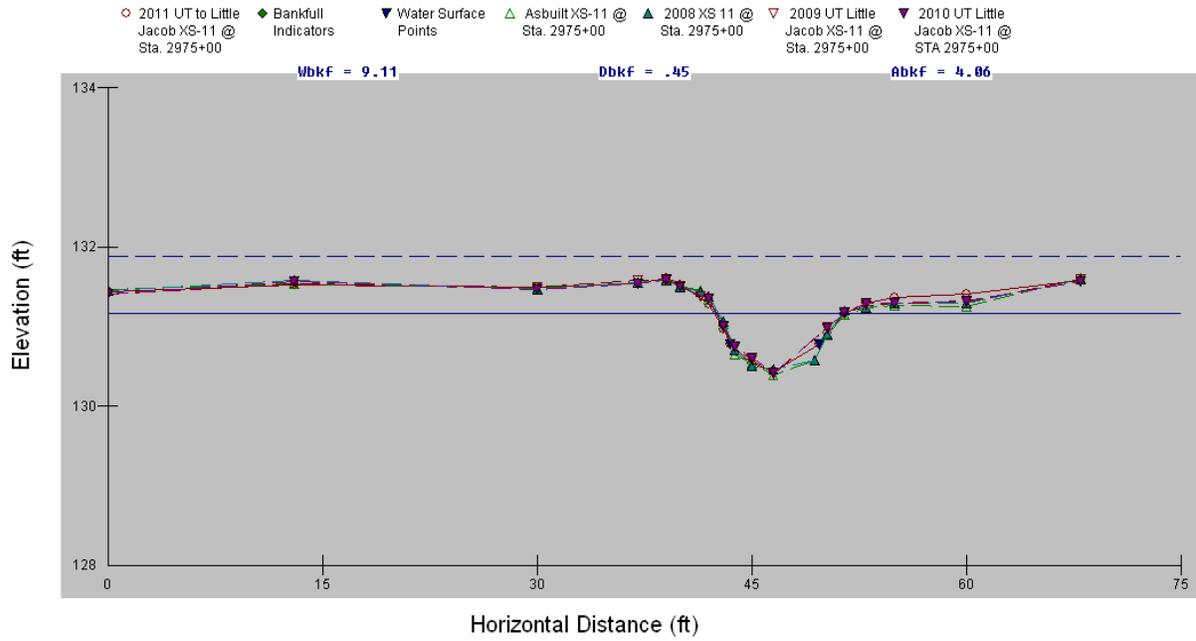
2011 UT to Little Jacob XS-11 @ Sta. 2975+00

Cross-Section #11 (Riffle) Abbreviated Morphological Summary					
	2008	2009	2010	2011	2012
Bankfull Width (ft)	8.94	9.0	9.01	9.11	
Bankfull Mean Depth (ft)	0.52	0.42	0.43	0.45	
Width/Depth Ratio	17.19	21.43	20.95	20.24	
Bankfull Cross Sectional Area (ft ²)	4.64	3.75	3.85	4.06	
Maximum Bankfull Depth (ft)	0.74	0.76	0.76	0.72	
Width of the Floodprone Area (ft)	68	68	68	68	
Entrenchment Ratio	7.61	7.56	7.54	7.46

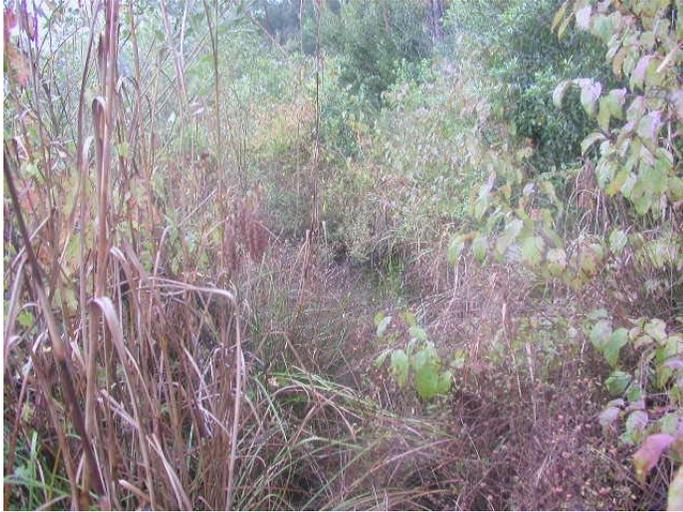
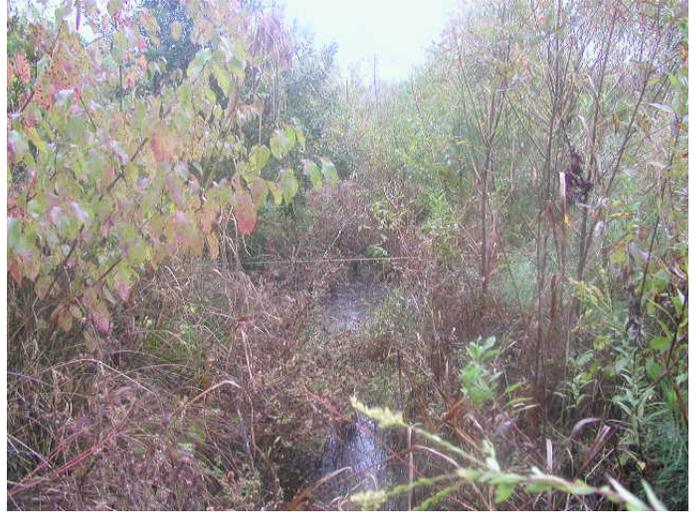
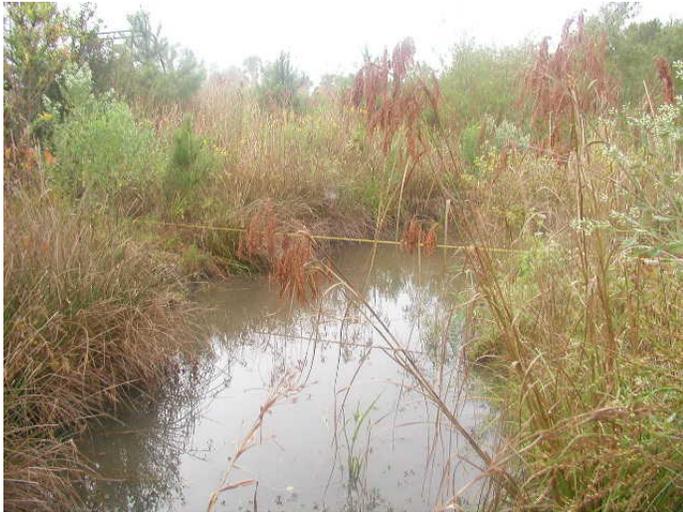
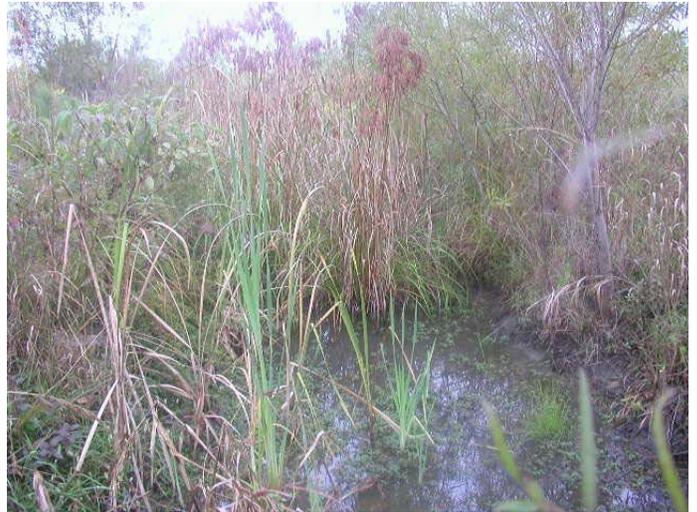
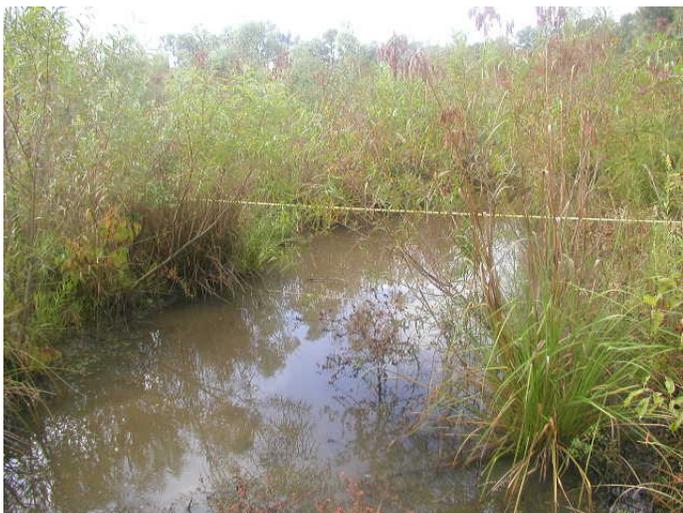
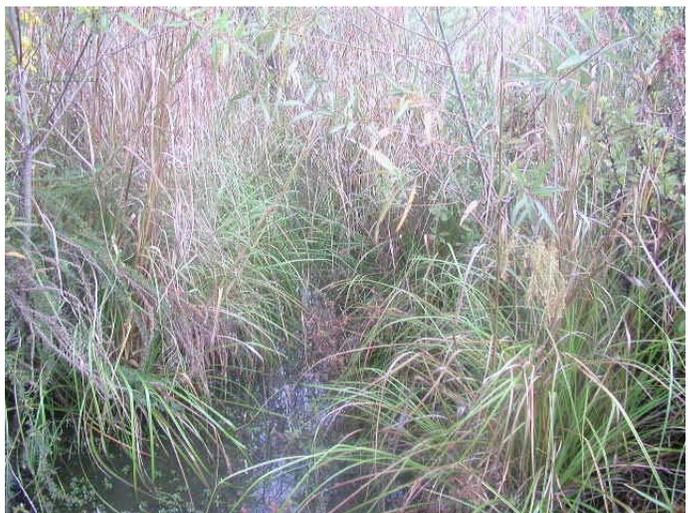
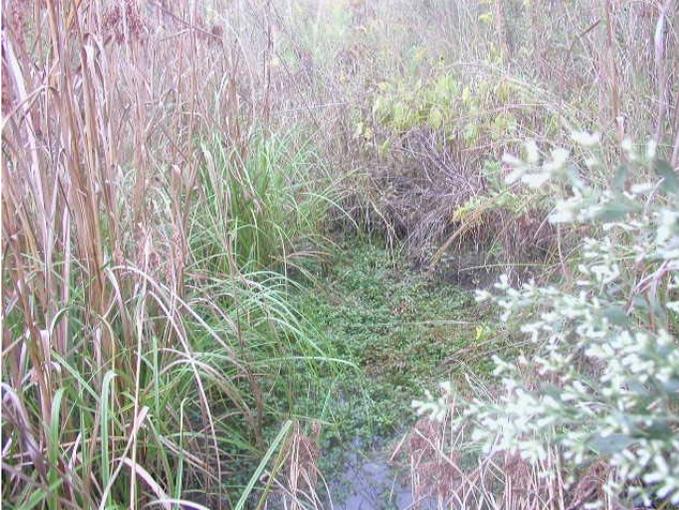
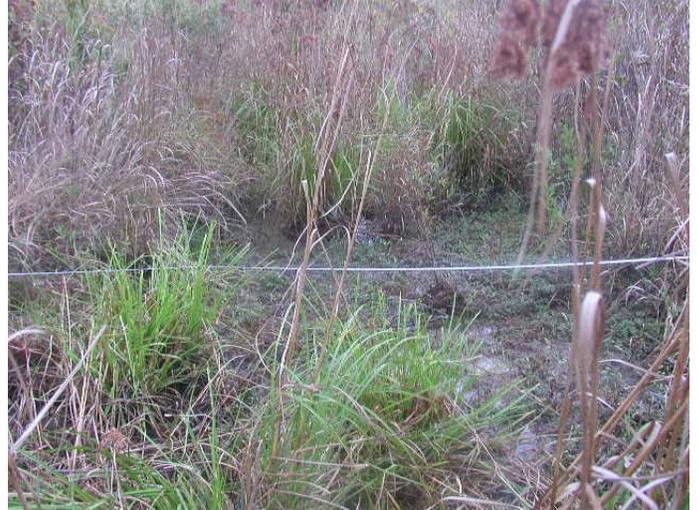
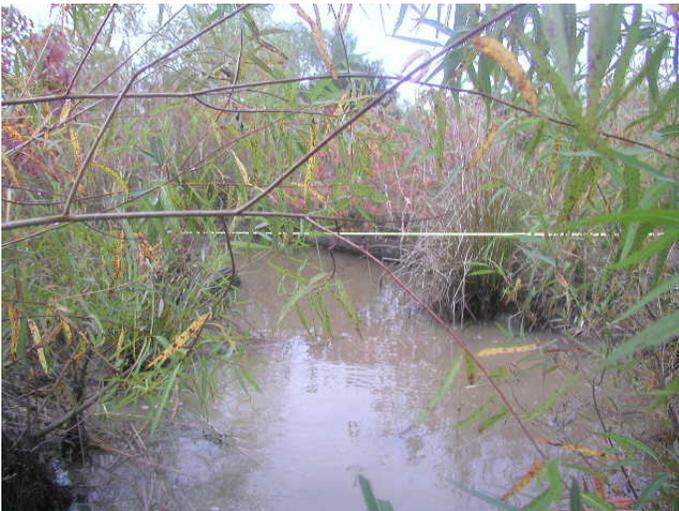
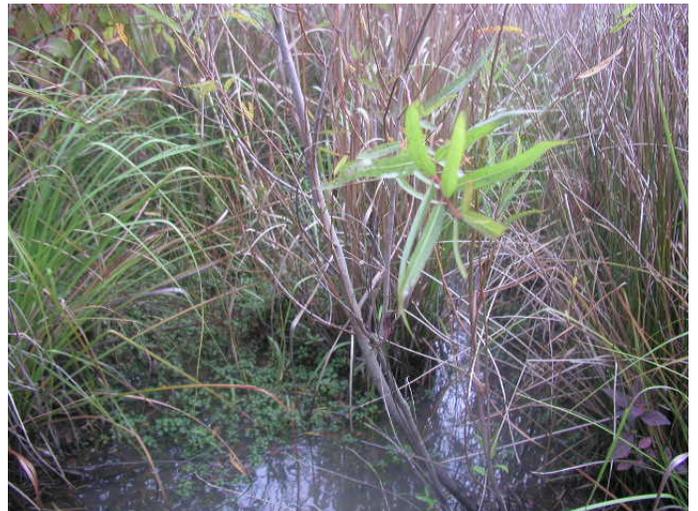
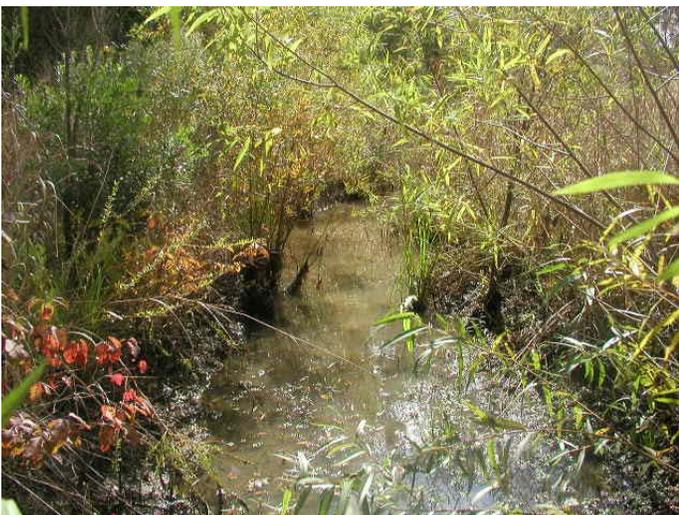
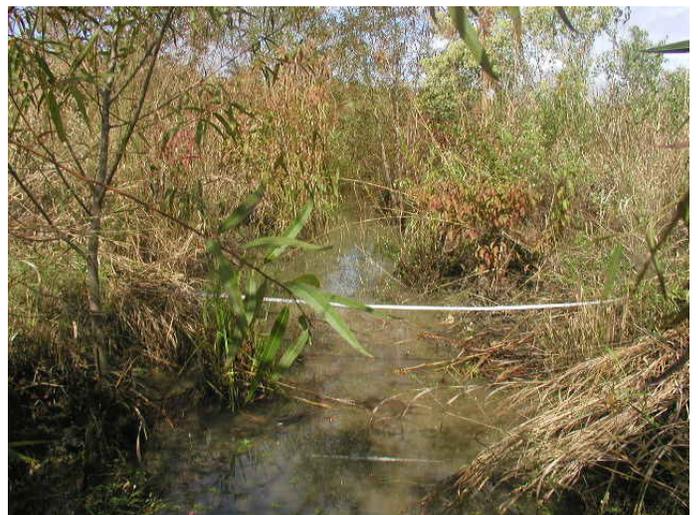
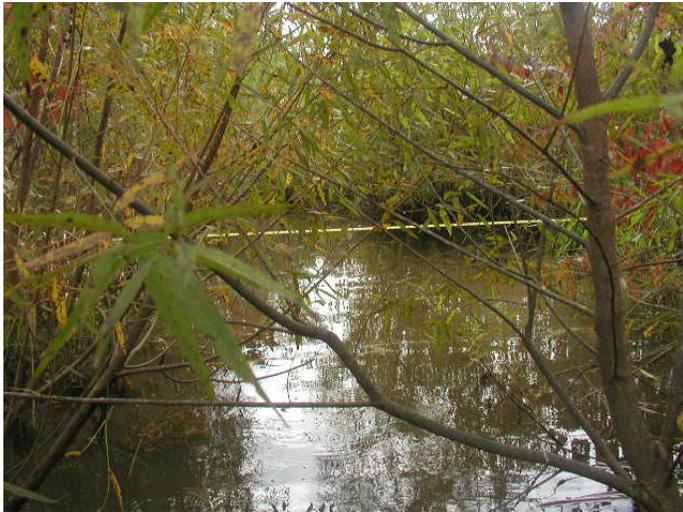
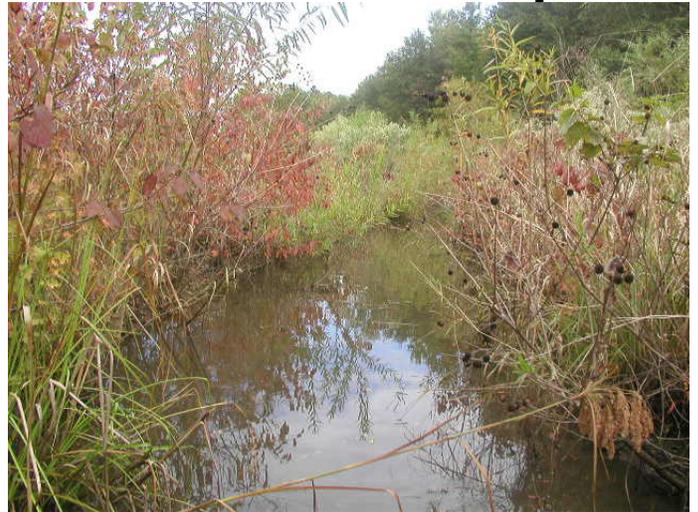
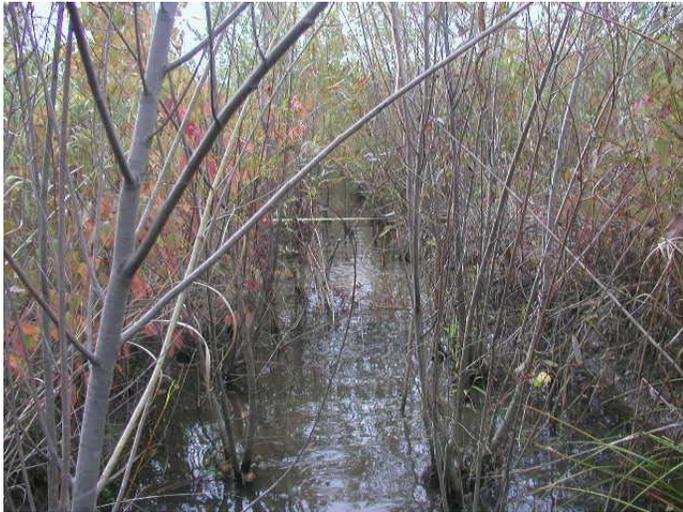
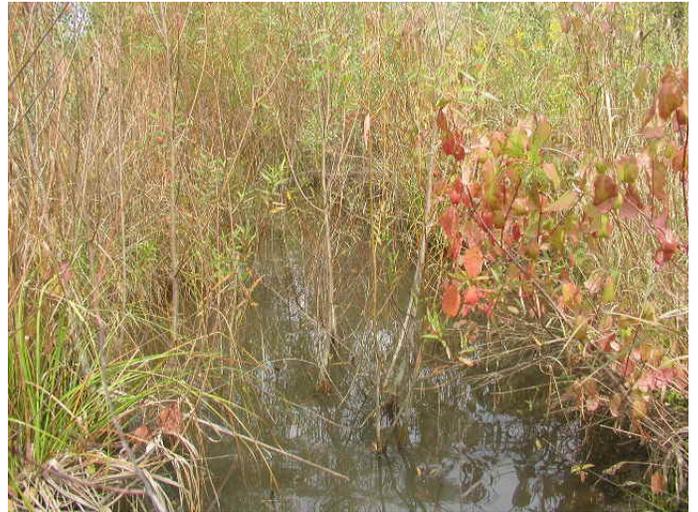
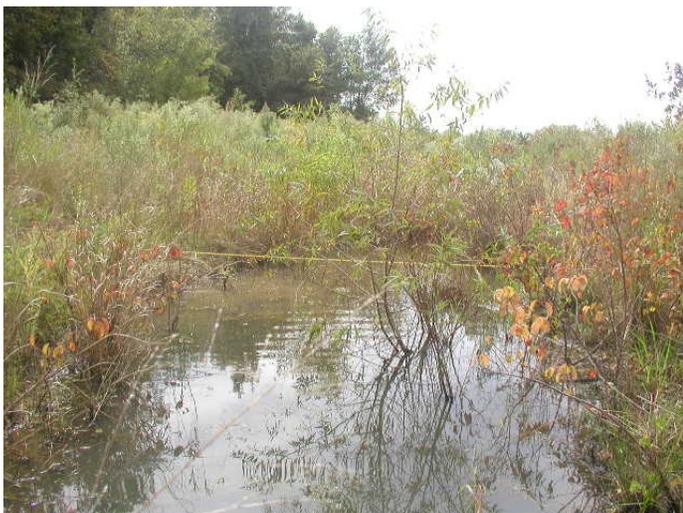
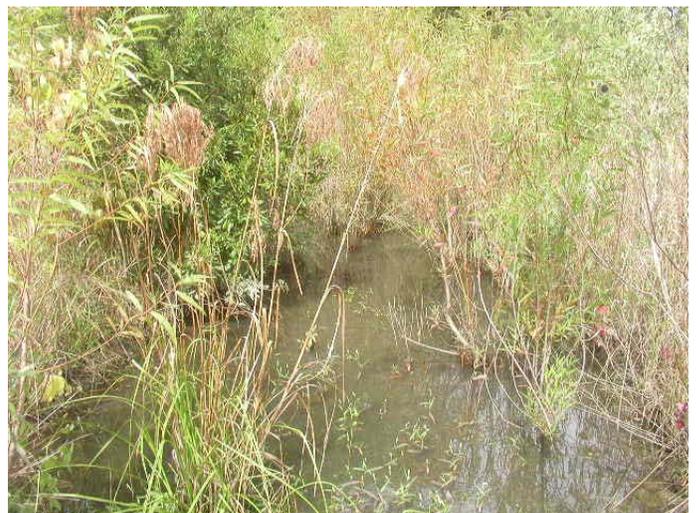
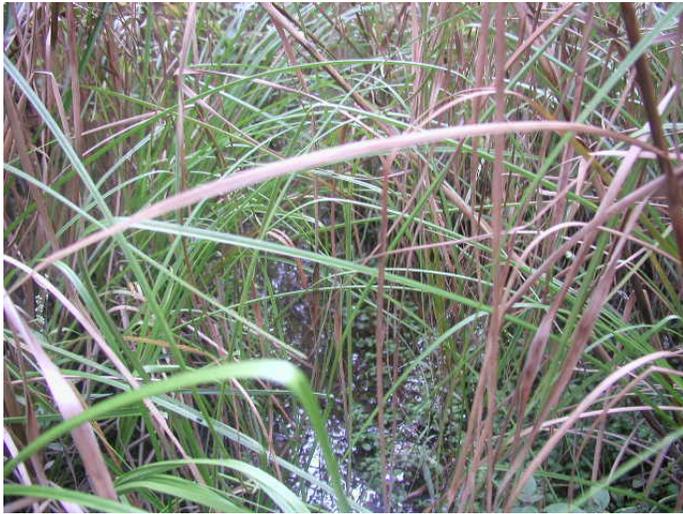
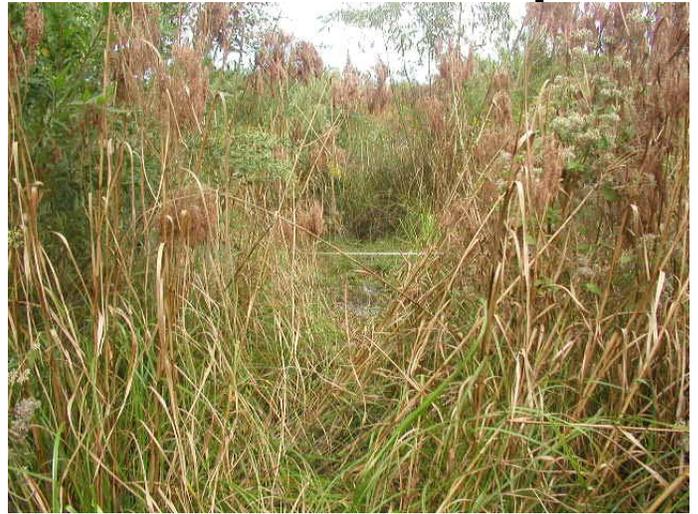
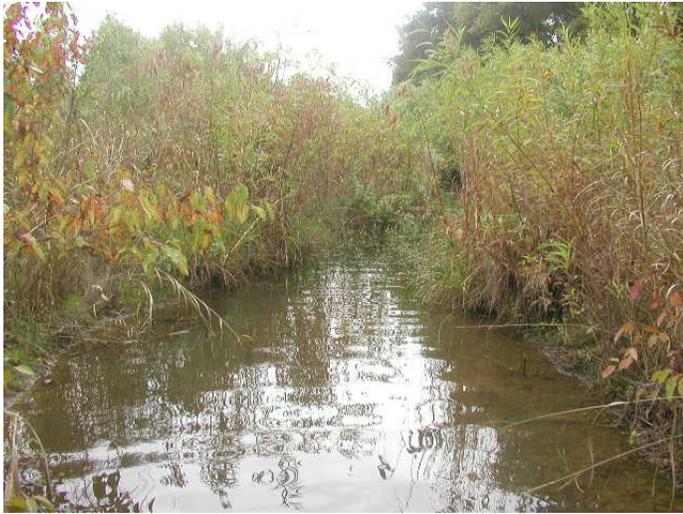
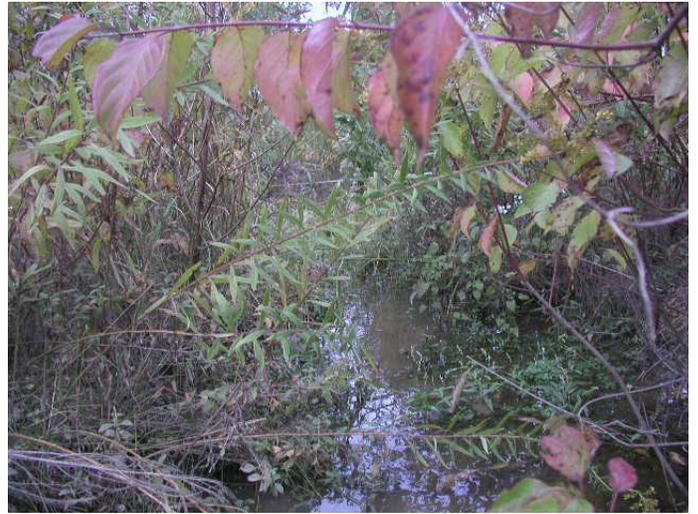
Photo points 1 through 11 showed an extensive growth of herbaceous and woody vegetation. The channel bed is stable throughout the stream restoration project at this time.
