ANNUAL REPORT FOR 2010

**Unnamed Tributary to Little Jacob
Swamp Mitigation Site
Robeson County
TIP No. R-0513WM**

Prepared By:
Natural Environment Unit & Roadside Environmental Unit
North Carolina Department of Transportation
December 2010

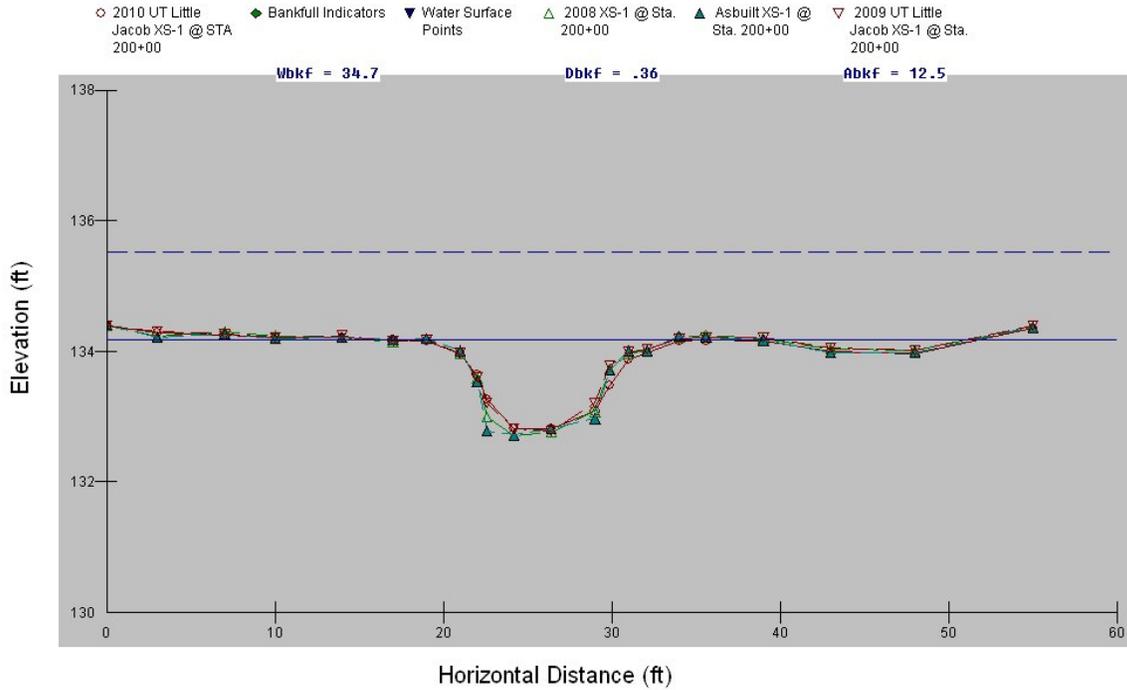
2010 UT Little Jacob XS-1 @ STA 200+00

Cross-Section #1 (Riffle) Abbreviated Morphological Summary					
	2008	2009	2010	2011	2012
Bankfull Width (ft)	10.0	10.04	10		
Bankfull Mean Depth (ft)	0.84	0.78	1.01		
Width/Depth Ratio	11.9	12.87	9.9		
Bankfull Cross Sectional Area (ft ²)	8.44	7.80	10.1		
Maximum Bankfull Depth (ft)	1.26	1.20	1.36		
Width of the Floodprone Area (ft)	55	55	55		
Entrenchment Ratio	5.5	5.48	5.5

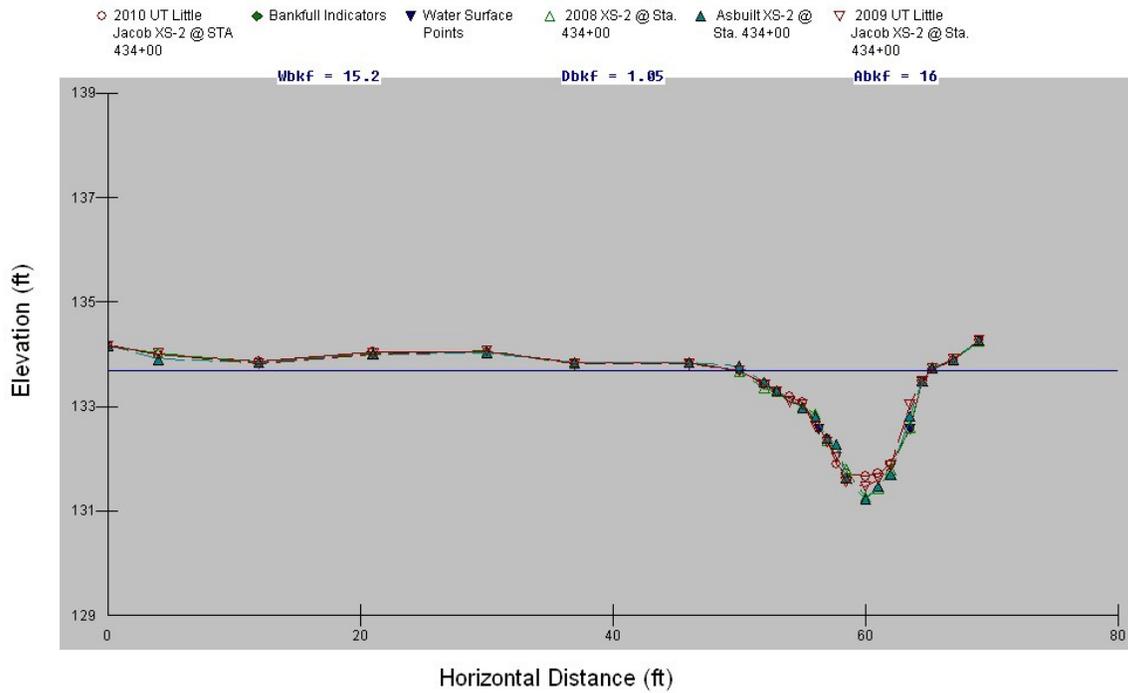
2010 UT Little Jacob XS-2 @ STA 434+00

Cross-Section #2 (Pool) Abbreviated Morphological Summary*					
	2008	2009	2010	2011	2012
Bankfull Cross Sectional Area (ft ²)	16.17	16.01	15.98		
Maximum Bankfull Depth (ft)	2.39	2.22	2.03		
Bankfull Mean Depth (ft)	1.08	1.06	1.05		
Bankfull Width (ft)	15.03	15.14	15.23

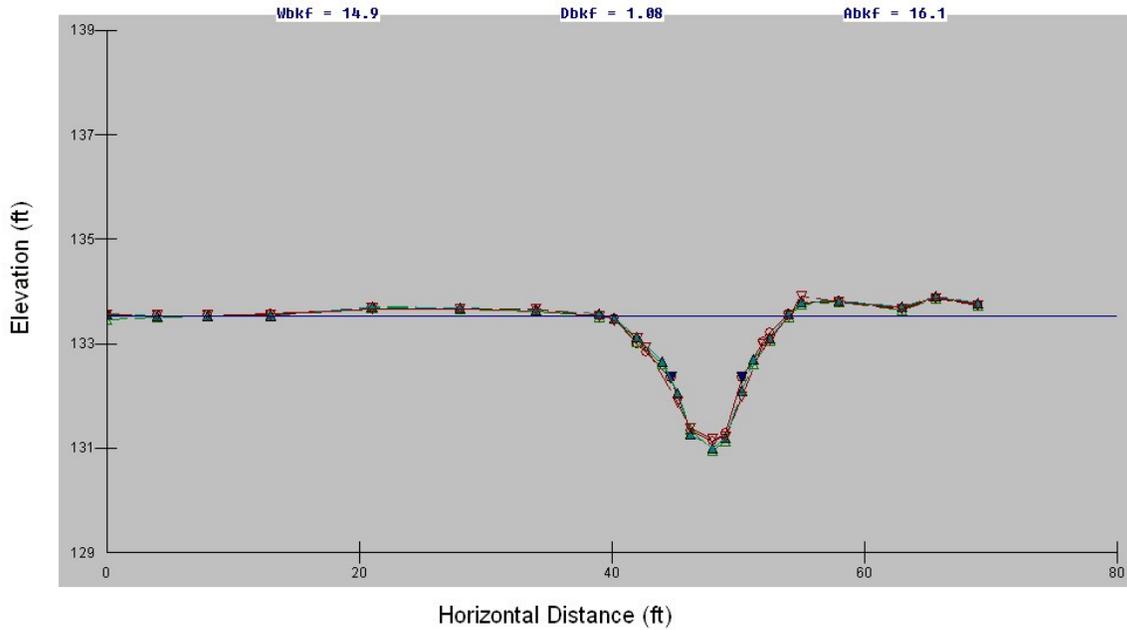
2010 UT Little Jacob XS-3 @ STA 622+00

Cross-Section #3 (Pool) Abbreviated Morphological Summary*					
	2008	2009	2010	2011	2012
Bankfull Cross Sectional Area (ft ²)	16.78	16.76	16.06		
Maximum Bankfull Depth (ft)	2.56	2.35	2.41		
Bankfull Mean Depth (ft)	0.8	1.12	1.08		
Bankfull Width (ft)	21.0	15	14.87

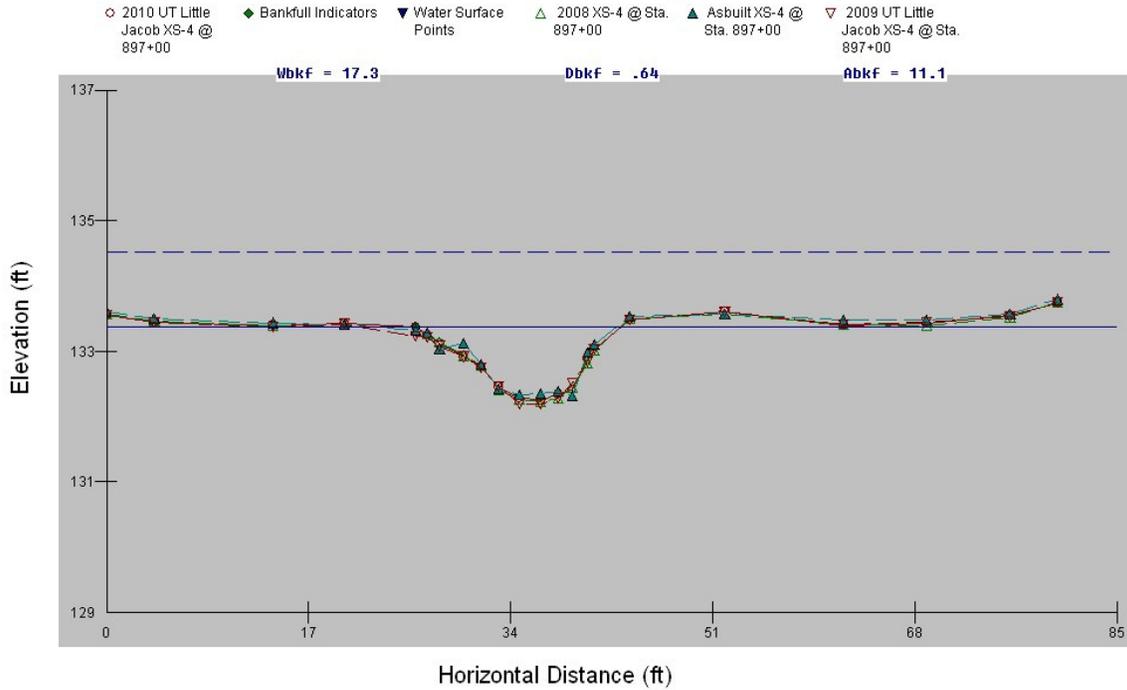
2010 UT Little Jacob XS-4 @ 897+00

Cross-Section #4 (Riffle) Abbreviated Morphological Summary					
	2008	2009	2010	2011	2012
Bankfull Width (ft)	16.84	16.27	17.28		
Bankfull Mean Depth (ft)	0.60	0.55	0.64		
Width/Depth Ratio	28.07	29.58	27		
Bankfull Cross Sectional Area (ft²)	10.16	8.94	11.06		
Maximum Bankfull Depth (ft)	1.09	1.04	1.14		
Width of the Floodprone Area (ft)	80	80	80		
Entrenchment Ratio	4.75	4.92	4.63

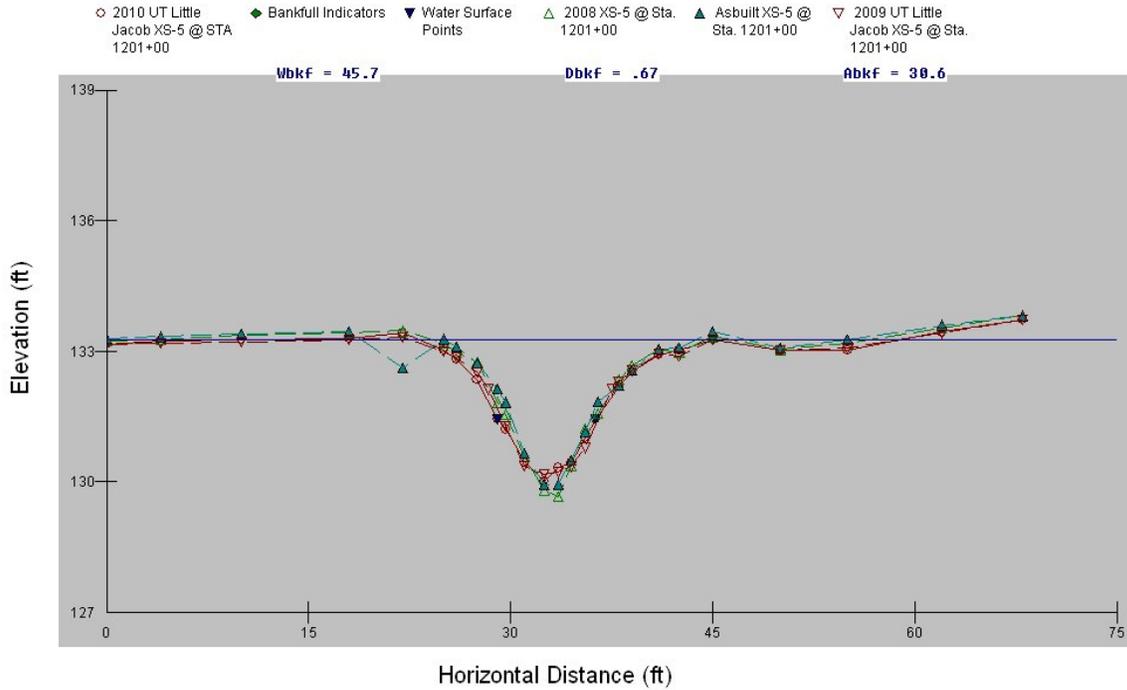
2010 UT Little Jacob XS-5 @ STA 1201+00

Cross-Section #5 (Pool) Abbreviated Morphological Summary*					
	2008	2009	2010	2011	2012
Bankfull Cross Sectional Area (ft ²)	22.13	20.88	27.68		
Maximum Bankfull Depth (ft)	3.39	2.73	3.24		
Bankfull Mean Depth (ft)	1.24	1.42	1.38		
Bankfull Width (ft)	8.91	14.74	20

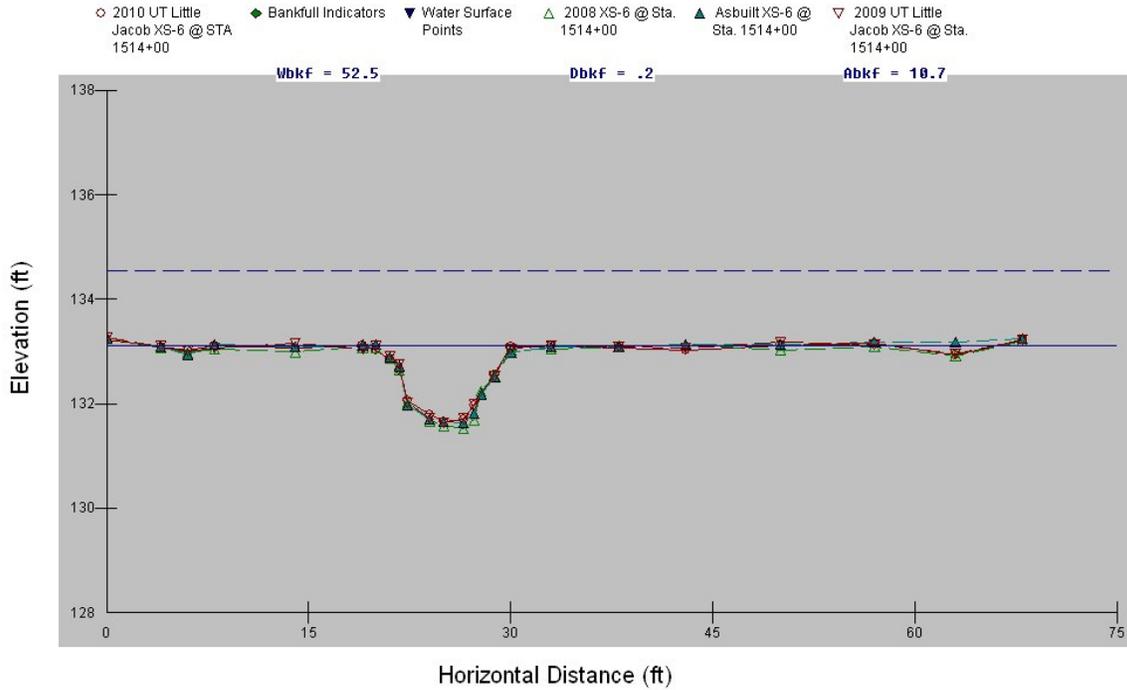
2010 UT Little Jacob XS-6 @ STA 1514+00

Cross-Section #6 (Riffle) Abbreviated Morphological Summary					
	2008	2009	2010	2011	2012
Bankfull Width (ft)	9.8	9.75	11		
Bankfull Mean Depth (ft)	0.91	0.88	0.82		
Width/Depth Ratio	10.77	11.08	13.41		
Bankfull Cross Sectional Area (ft ²)	8.94	8.56	9.05		
Maximum Bankfull Depth (ft)	1.51	1.42	1.44		
Width of the Floodprone Area (ft)	68	68	68		
Entrenchment Ratio	6.94	6.97	6.18

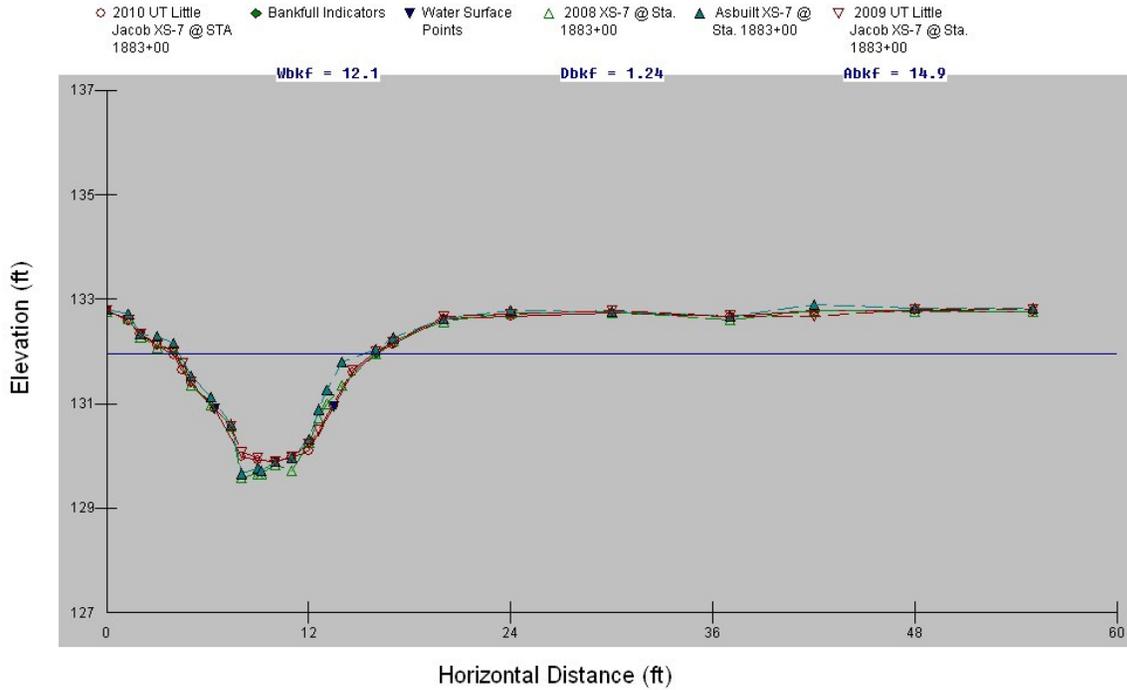
2010 UT Little Jacob XS-7 @ STA 1883+00

Cross-Section #7 (Pool) Abbreviated Morphological Summary*					
	2008	2009	2010	2011	2012
Bankfull Cross Sectional Area (ft ²)	15.14	14.80	14.91		
Maximum Bankfull Depth (ft)	2.37	2.11	2.05		
Bankfull Mean Depth (ft)	0.80	1.23	1.24		
Bankfull Width (ft)	11.85	12.0	12.06

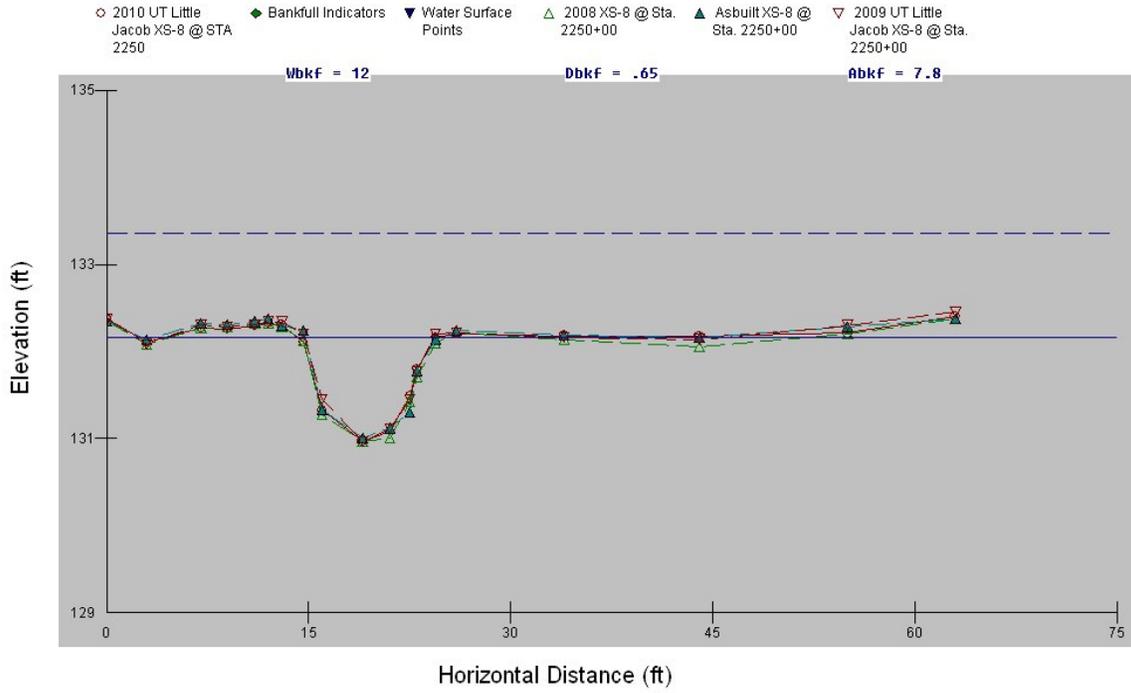
2010 UT Little Jacob XS-8 @ STA 2250+00

Cross-Section #8 (Riffle) Abbreviated Morphological Summary					
	2008	2009	2010	2011	2012
Bankfull Width (ft)	9.77	9.8	9.8		
Bankfull Mean Depth (ft)	0.78	0.80	0.79		
Width/Depth Ratio	12.53	12.25	12.41		
Bankfull Cross Sectional Area (ft ²)	7.64	7.82	7.74		
Maximum Bankfull Depth (ft)	1.14	1.24	1.19		
Width of the Floodprone Area (ft)	63	63	63		
Entrenchment Ratio	6.45	6.43	6.43

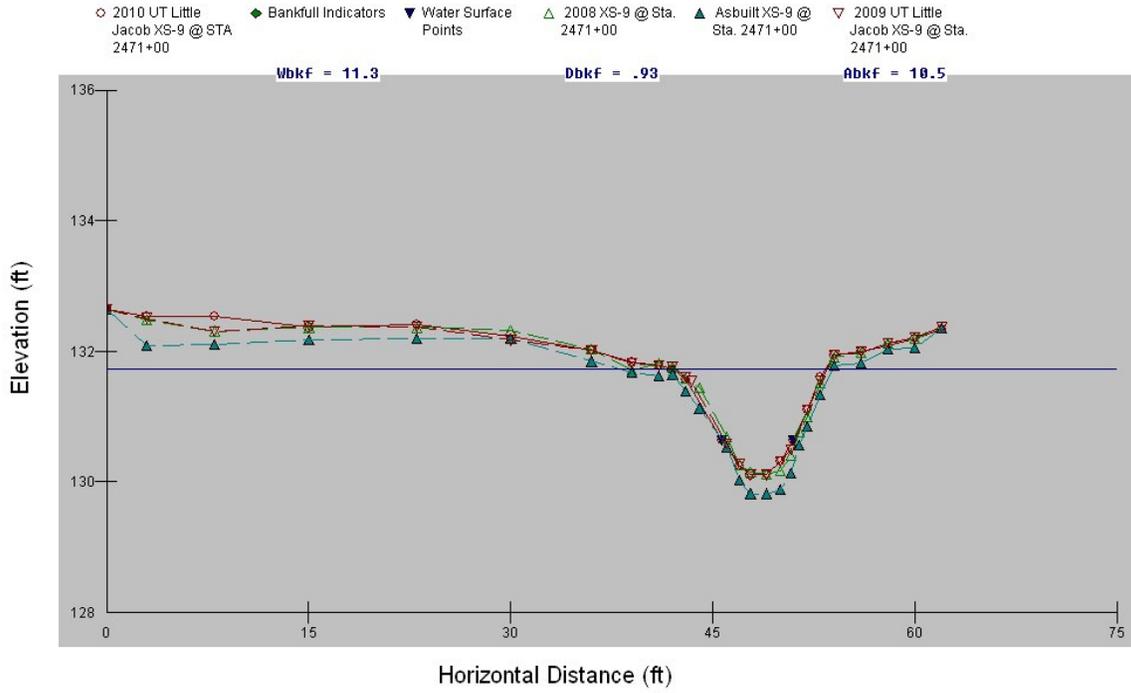
2010 UT Little Jacob XS-9 @ STA 2471+00

Cross-Section #9 (Pool) Abbreviated Morphological Summary*					
	2008	2009	2010	2011	2012
Bankfull Cross Sectional Area (ft ²)	10.8	10.84	10.54		
Maximum Bankfull Depth (ft)	1.64	1.65	1.61		
Bankfull Mean Depth (ft)	0.93	0.94	0.93		
Bankfull Width (ft)	11.56	11.55	11.33

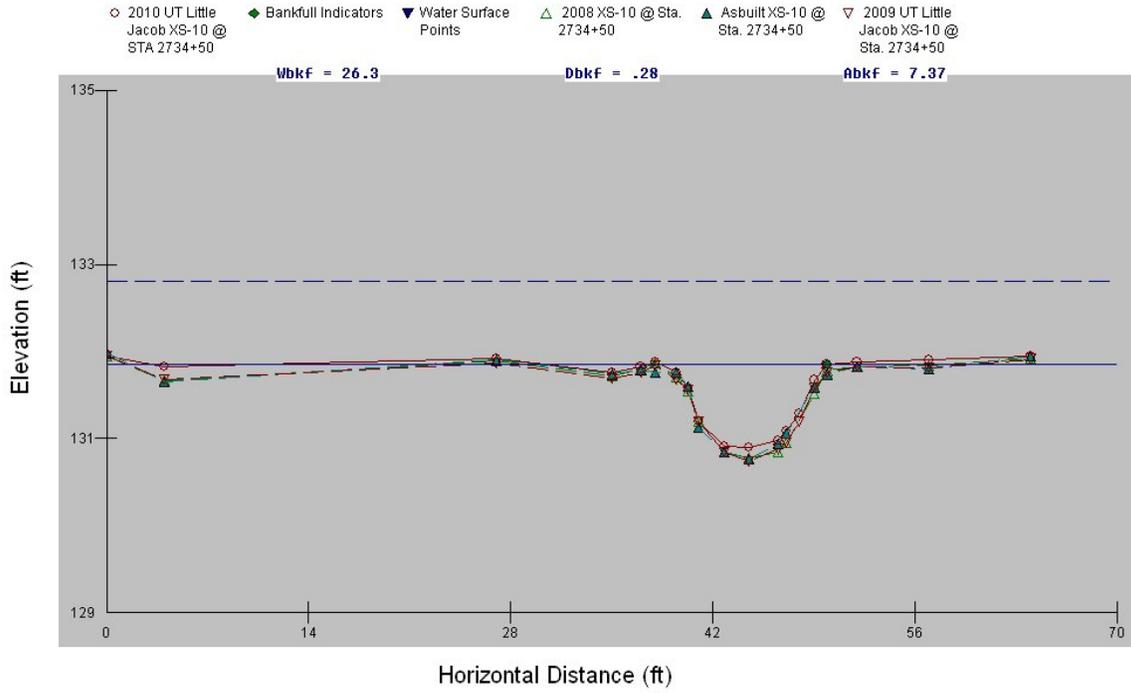
2010 UT Little Jacob XS-10 @ STA 2734+50

Cross-Section #10 (Riffle) Abbreviated Morphological Summary					
	2008	2009	2010	2011	2012
Bankfull Width (ft)	11.1	11.1	11.55		
Bankfull Mean Depth (ft)	0.64	0.62	0.6		
Width/Depth Ratio	17.34	17.9	19.25		
Bankfull Cross Sectional Area (ft ²)	7.08	6.89	6.93		
Maximum Bankfull Depth (ft)	1.0	1.02	0.95		
Width of the Floodprone Area (ft)	64	64	64		
Entrenchment Ratio	5.77	5.77	5.54

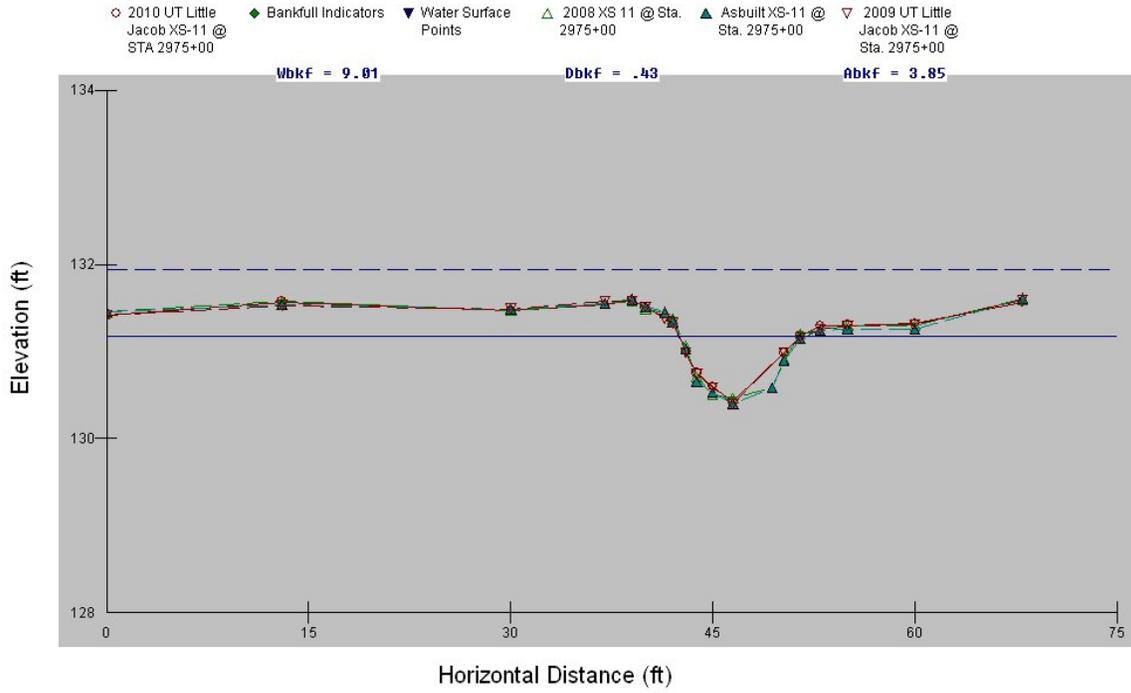
2010 UT Little Jacob XS-11 @ STA 2975+00

Cross-Section #11 (Riffle) Abbreviated Morphological Summary					
	2008	2009	2010	2011	2012
Bankfull Width (ft)	8.94	9.0	9.01		
Bankfull Mean Depth (ft)	0.52	0.42	0.43		
Width/Depth Ratio	17.19	21.43	20.95		
Bankfull Cross Sectional Area (ft ²)	4.64	3.75	3.85		
Maximum Bankfull Depth (ft)	0.74	0.76	0.76		
Width of the Floodprone Area (ft)	68	68	68		
Entrenchment Ratio	7.61	7.56	7.54
