# ANNUAL REPORT FOR 2014

**Mile Branch  
Guilford County  
TIP No. R-0609IA  
COE Action ID: 2004-00340  
DWR #: 2006-0331**

Prepared By:  
Natural Environment Section & Roadside Environmental Unit  
North Carolina Department of Transportation  
October 2014

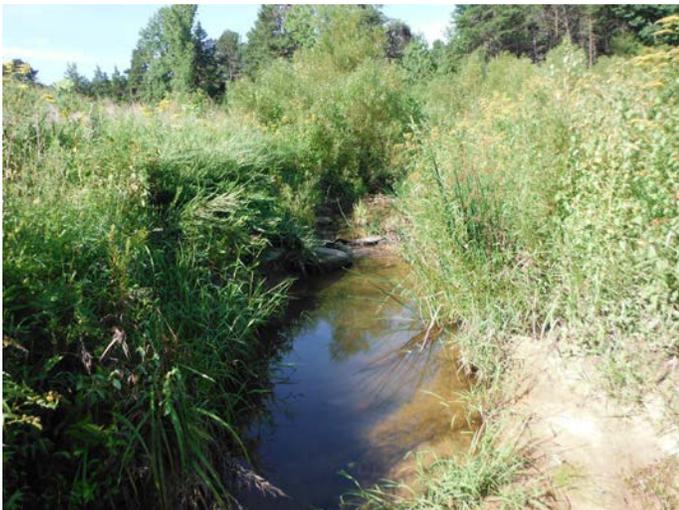
Photo Point #3 (Upstream)  
August 2014

During the 2012 monitoring evaluation, there were two beaver dams noted onsite at Photo Point #3 (large dam) and at Cross Section #3 (small dam) that have been breached and beavers have been trapped by USDA. DOT Maintenance removed the debris from the large dam so water could access the floodplain. On February 13, 2013, NCDOT replanted bare root seedlings and live stakes along the area where beaver activity had occurred.

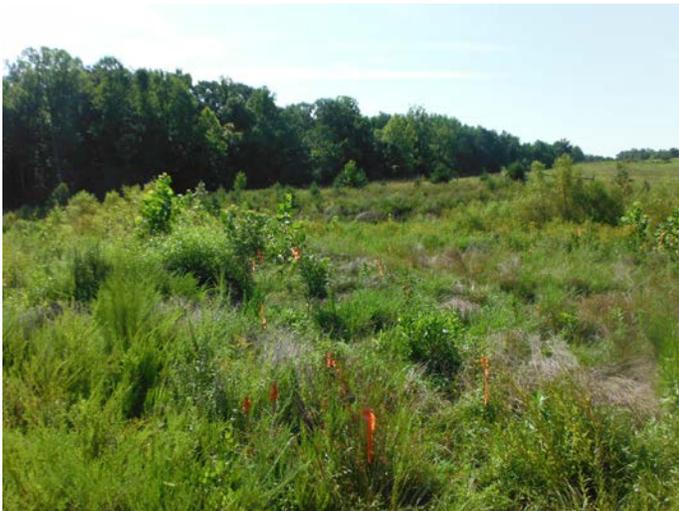
Vegetation Plot #1

Plot #	Tulip Poplar	American Sycamore	Green Ash	Willow Oak	Overcup Oak	River Birch	Blackgum	Total (Year 6)	Total (at planting)	Density (Trees/Acre)
1	6	7	19	1				33	40	561
2	6	9	8	2	8	4	1	38	55	470
<b>Year 6 Average Density (Trees/Acre)</b>										<b>515</b>
Year 5 Average Density										628
Year 4 Average Density										486
Year 3 Average Density										527
Year 2 Average Density										327
Year 1 Average Density										485

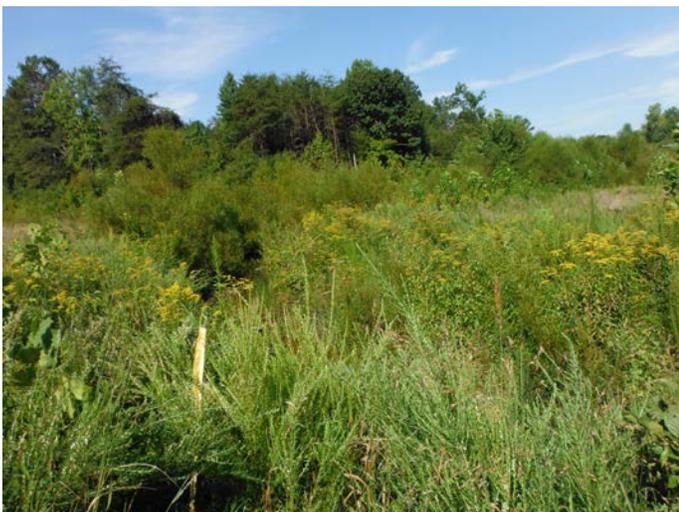
A site visit was conducted on March 2, 2014 with the regulatory agencies and NCDOT personnel present. The regulatory agencies requested that more trees were needed along the northern buffer and along the streambank where the beaver dams were removed. The streambanks where the beaver dams were removed have started to re-vegetate with alder, silky dogwood, black willow, and sycamore so additional planting should not be needed along the streambanks where the beaver dams were removed.

Large beaver dam area re-vegetating  
August 2014

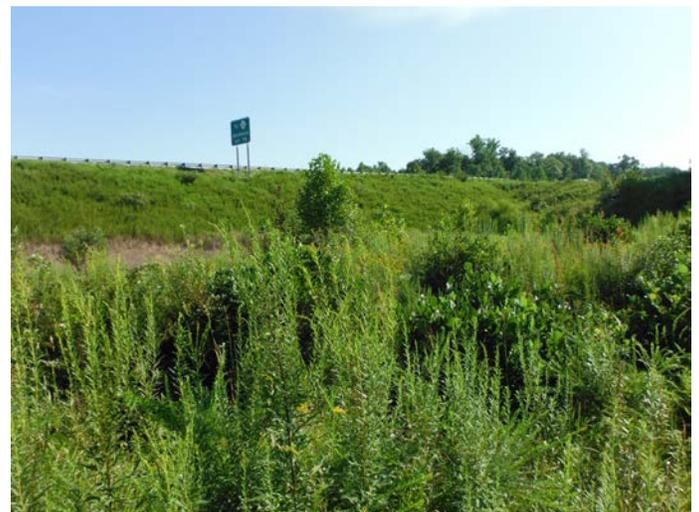
Small beaver dam area re-vegetating

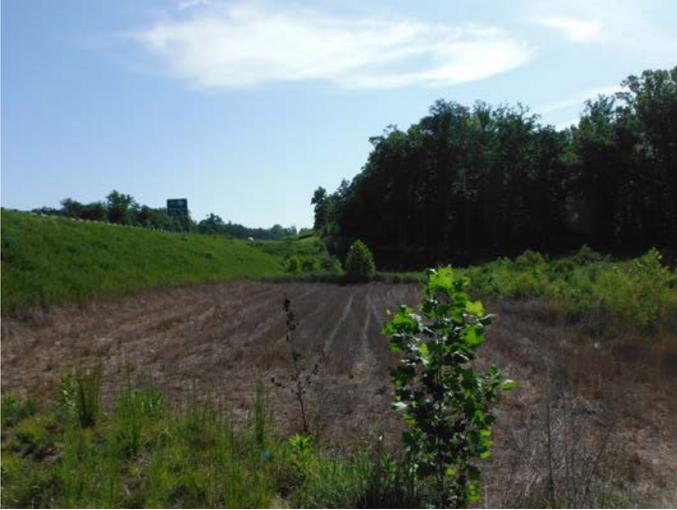
On May 21-22, 2014, NCDOT mowed approximately 0.3 acres of the north buffer where there was a dense area of lespedeza with little planted vegetation surviving and spot sprayed other areas of the site that has lesser amounts of lespedeza. On July 7, 2014, NCDOT mowed the 0.3 acres of the north buffer again and completed an herbicide application on this area.

Herbicide application of northern buffer

On May 21-22, 2014, NCDOT mowed approximately 0.3 acres of the north buffer where there was a dense area of lespedeza with little planted vegetation surviving and spot sprayed other areas of the site that has lesser amounts of lespedeza. On July 7, 2014, NCDOT mowed the 0.3 acres of the north buffer again and completed an herbicide application on this area. NCDOT plans to replant the 0.3 acres of the north buffer in the fall of 2014 and to continue spot spraying the lespedeza within the site.
