Monitoring Data Record

Project Title: R-977A US 64 COE Action ID: 2005301150
Stream Name: UT to Hiwassee River (Site 11) DWQ Number: 3487
City, County and other Location Information: Murphy, Cherokee County, US 64, from
US 19-74-129 in Murphy to East of NC 141 in Peachtree (Sta. 12+20 to 15+50)
Date Construction Completed: March 2007 Monitoring Year: (4) of 5
Ecoregion: _____ 8 digit HUC unit 06020002
USGS Quad Name and Coordinates: _____

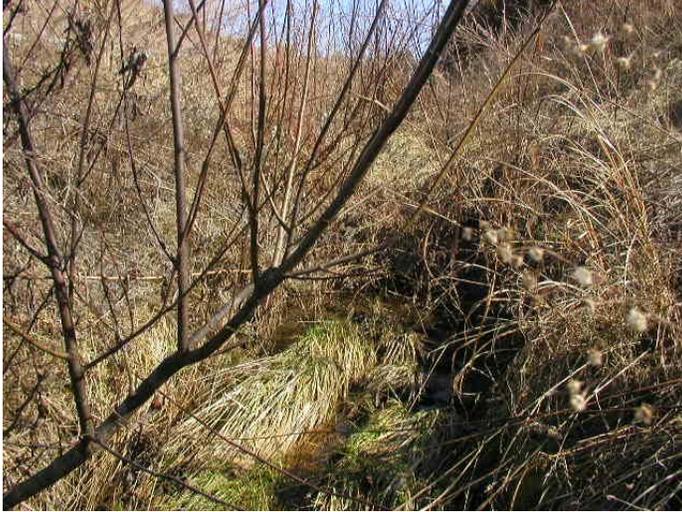
Photo Point #7 (Upstream)

This is the Year 4 Winter evaluation for the UT Hiwassee River stream relocation. The crossvanes @ Sta. 13+20 in Photo Point # 7 (Upstream and Downstream) had water piping under these structures or underground where the blasting occurred to relocate the channel. A permit modification was completed to relocate an additional 135 feet of stream at Site 11. Photo Point numbers 10 and 11 up and downstream, respectively, show this additional 135 feet. This section of stream relocation is mainly bedrock. NCDOT will continue to monitor this stream relocation.

Date Inspected 2/8/11	Station 13+20 PP#7 Upstream and Downstream Photo	Station Number	Station Number	Station Number	Station Number
Structure Type	Crossvane				
Is water piping through or around structure?	Water piping under crossvanes due to blasting that took place to relocate stream				
Head cut or down cut present?					
Bank or scour erosion present?					
Other problems noted?
