Monitoring Data Record

Project Title: R-977A US 64 COE Action ID: 2005301150
Stream Name: UT to Hiwassee River (Site 11) DWQ Number: 3487
City, County and other Location Information: Murphy, Cherokee County, US 64, from
US 19-74-129 in Murphy to East of NC 141 in Peachtree (Sta. 12+20 to 15+50)
Date Construction Completed: March 2007 Monitoring Year: (5) of 5
Ecoregion: _____ 8 digit HUC unit 06020002
USGS Quad Name and Coordinates: _____

Year 5 Winter – February 2012

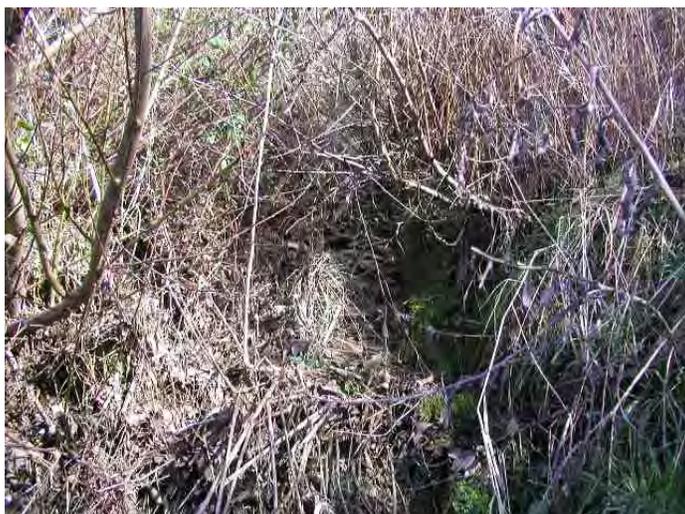
Photo Point #6 (Upstream)

This is the Year 5 Winter evaluation for the UT Hiwassee River stream relocation. The channel is stable at this time but water continues to piping underground around Photo Point #6 due to blasting to relocate the channel. Water was flowing under two crossvanes downstream of Photo Point #7. A permit modification was completed to relocate an additional 135 feet of stream at Site 11. Photo Point numbers 10 and 11 up and downstream, respectively shows this additional 135 feet. This section of stream relocation is mainly bedrock. NCDOT will continue to monitor this stream relocation.

Date Inspected 2/20/12	Up and Downstream of PP#6	Downstream of PP#7	Station Number	Station Number	Station Number
Structure Type		Crossvanes			
Is water piping through or around structure?	No flow in channel. Water is piping underground due to blasting to relocate the channel.	Water piping under two crossvanes			
Head cut or down cut present?					
Bank or scour erosion present?					
Other problems noted?
