Monitoring Data Record

Project Title: R-977A US 64 COE Action ID: 2005301150  
Stream Name: UT to Hiwassee River (Site 11) DWQ Number: 3487  
City, County and other Location Information: Murphy, Cherokee County, US 64, from  
US 19-74-129 in Murphy to East of NC 141 in Peachtree (Sta. 12+20 to 15+50)  
Date Construction Completed: March 2007 Monitoring Year: ( 1 ) of 5  
Ecoregion: \_\_\_\_\_ 8 digit HUC unit 06020002  
USGS Quad Name and Coordinates: \_\_\_\_\_

Year 1 Summer – August 2008

UT Hiwassee River  
R-977A  
Cherokee County

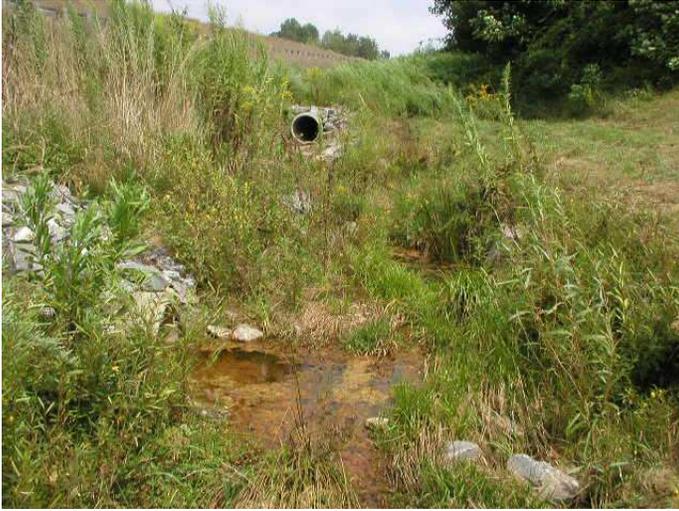
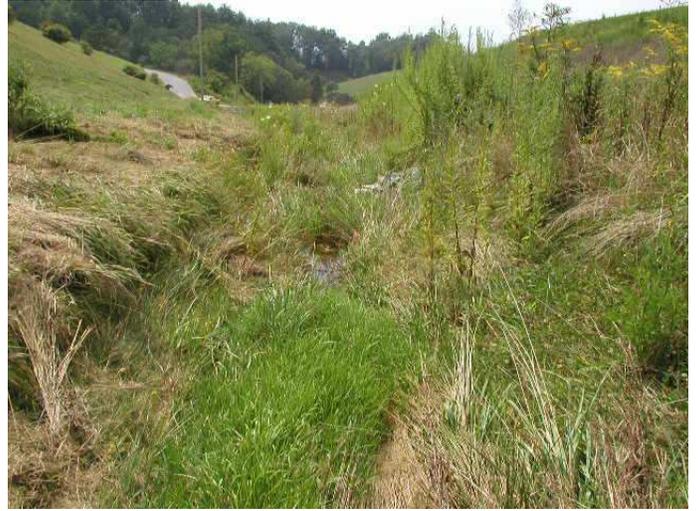
Photo Point #1 (Upstream)

The buffer area upstream of the church driveway culvert (Photo Points 1 through 4) has continued to be mowed. The Residence Office plans to notify the church again about not mowing this area. Planted vegetation is minimal along this section of the stream relocation.

Estimated causes, and proposed/required remedial action: Some additional planting of pussy willow and redtip dogwood was completed downstream of the church driveway culvert. The entire site should be completely planted by December 2008.

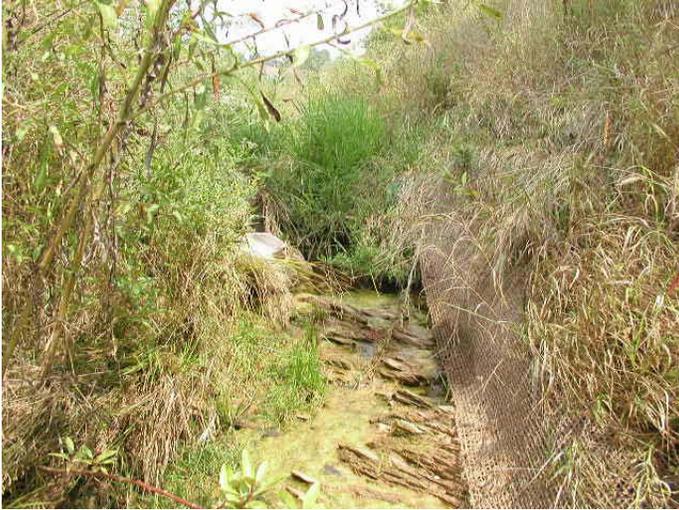
Photo Point #7 (Upstream)

Date Inspected 8/13/08	Station 13+20 PP#7 Downstream Photo	Station 13+00 PP#8 Upstream Photo	Station 13+40 to 13+80 Between PP#5 and PP#6	Station Number	Station Number
Structure Type	Crossvane	Crossvane			
Is water piping through or around structure?	Water piping under crossvane	Water piping under crossvane	Water piping bypassing stream bed underground where blasting took place		
Head cut or down cut present?					
Bank or scour erosion present?					
Other problems noted?
