# ANNUAL REPORT FOR 2009

**Jeffreys Warehouse Stream Mitigation Site  
Wayne County  
TIP No. R-1030AA**

Prepared By:  
Natural Environment Unit & Roadside Environmental Unit  
North Carolina Department of Transportation  
October 2009

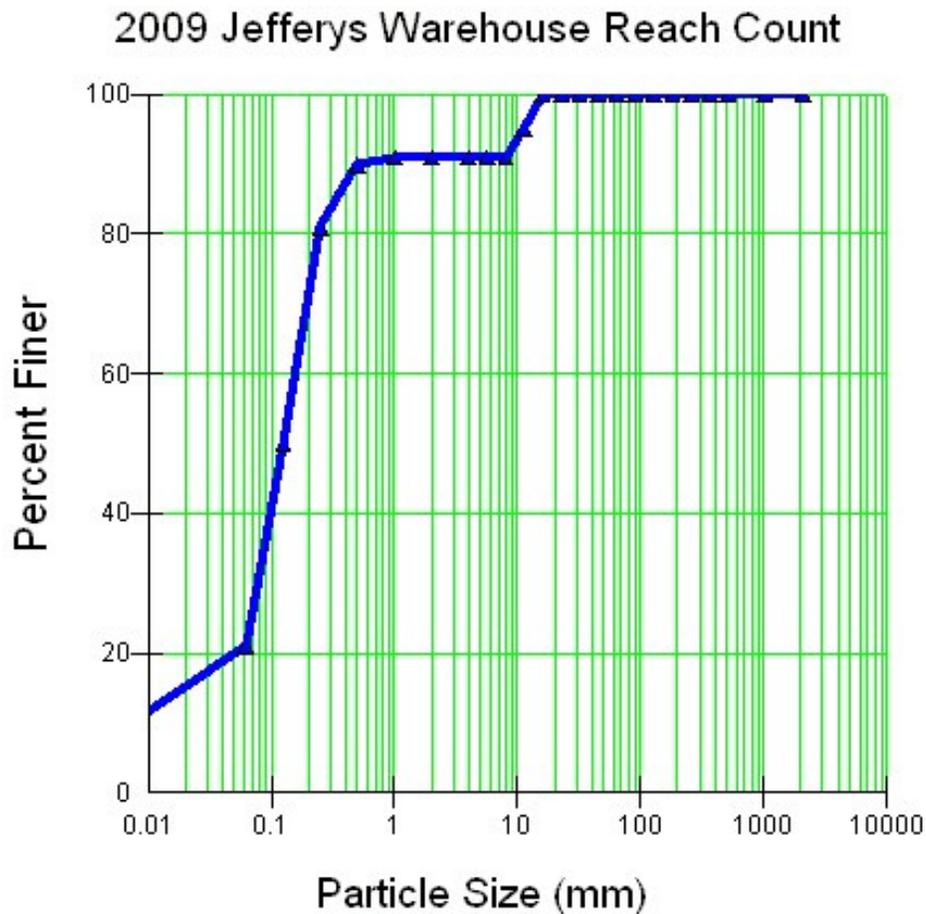
**Chart 1.** Particle Size Distribution for Entire Reach

A representative pebble count was taken throughout the surveyed reach. This information is used to determine the stream type. Jeffreys Warehouse Mitigation Site was designed as a sand bed system with the  $D_{50}$  being less than one. The pebble counts taken during the Year 2009 monitoring period noted that the  $D_{50}$  (50 percent of the sampled population is equal to or finer than the representative particle diameter) for the entire reach of Jeffreys Warehouse Mitigation Site was approximately 0.13 mm, which is indicative of a sand-bed stream.
