Monitoring Data Record

Project Title: I-540 Northern Wake Expressway (R-2000AB) COE Action ID: 200021863
Stream Name: UT to Kit Creek DWQ Number: 030918
City, County and other Location Information: Wake County, Site 6 (Sta.10+41 to 12+76 YRPA-)
Date Construction Completed: March 2005 Monitoring Year: (4) of 5
Ecoregion: _____ 8 digit HUC unit 03030002
USGS Quad Name and Coordinates: _____

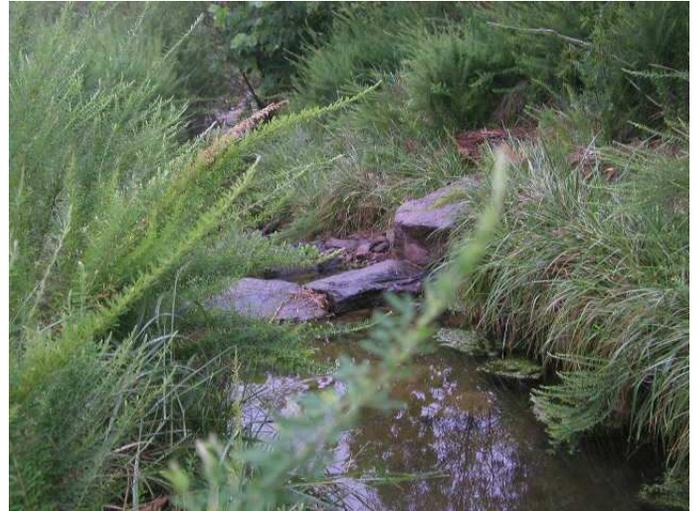
Photo Point #4 (Downstream)

The stream is stabilized for the Year 4 Summer evaluation except for a crossvane at Sta. 2+00 –Stream 1-. Water was flowing under this crossvane at the time of monitoring. The stream bed consists of mainly Triassic rock which is probably a contributing factor to the water flowing under this crossvane. There is evidence that a bankfull event has occurred since the last monitoring evaluation. NCDOT will continue to monitor this stream relocation.

Date 7/6/09	Station Number 2+00 -Stream 1- PP#4 Downstream	Station Number	Station Number	Station Number	Station Number
Structure Type	Crossvane				
Is water piping through or around structure?	Water is piping under crossvane				
Head cut or down cut present?					
Bank or scour erosion present?					
Other problems noted?
