Monitoring Data Record

Project Title: I-540 Northern Wake Expressway (R-2000AB) COE Action ID: 200021863

Stream Name: UT to Kit Creek DWQ Number: 030918

City, County and other Location Information: Wake County, Site 6 (Sta.10+41 to 12+76\_YRPA-)

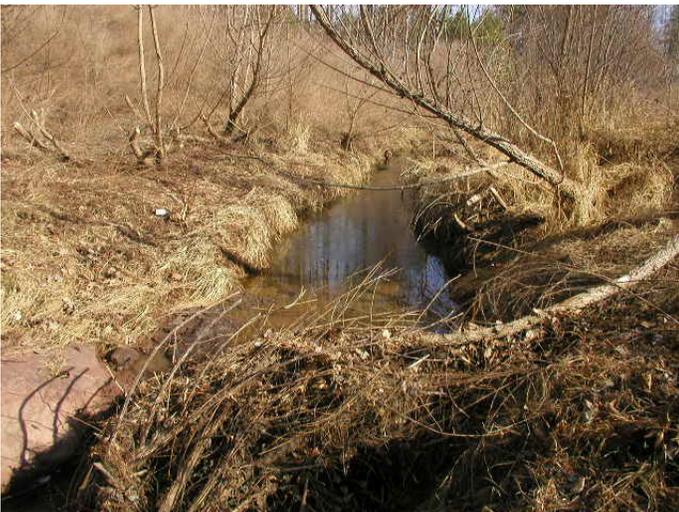
Beaver activity noted onsite. Some of the black willows have been cut back due to the beaver activity.

Photo Point #3 (Upstream) Larger Beaver Dam

Estimated causes, and proposed/required remedial action: NCDOT plans to trap the beavers and breach the dams located on site.

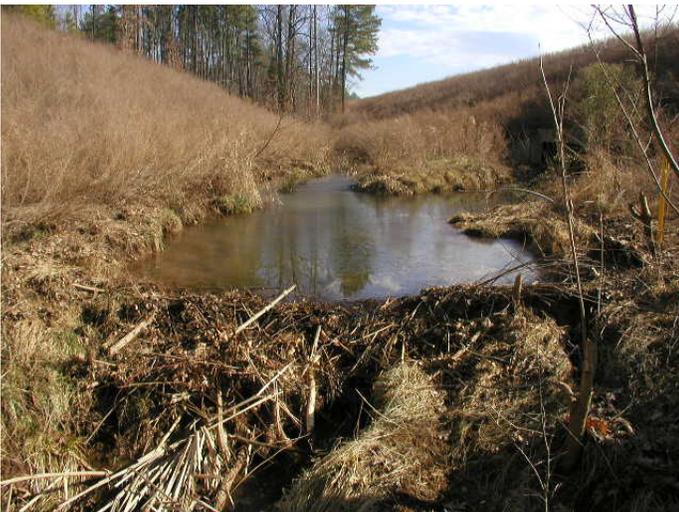
Photo of Beaver Dam at Sta. 0+90 –Stream 1-
