Monitoring Data Record

Project Title: R-2000G (I-540) COE Action ID: 199920387

Stream Name: UT Neuse River (Site 10) DWQ Number: 030114

City, County and other Location Information: I-540, Wake County (Sta.460+53 -L- to 459+80 -L- RT.)

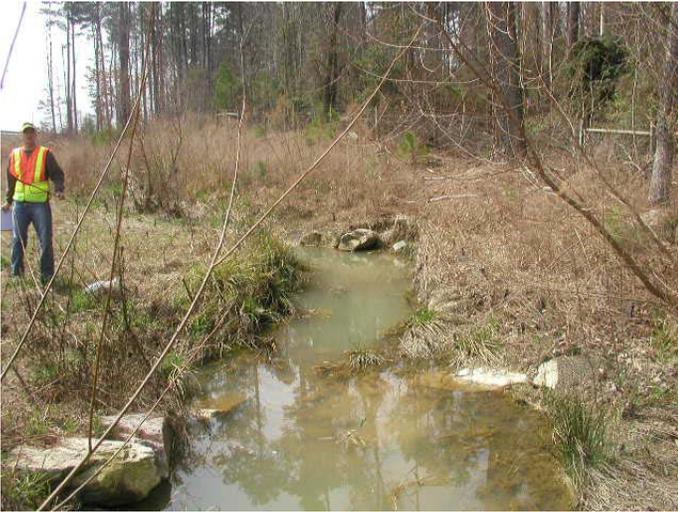
Photo Point #4 (Upstream)

An automobile accident occurred in June 2007 on I-540, which is adjacent to this stream relocation. The accident site carried over the guardrail and into the stream relocation area. Since, the accident has occurred steps have been taking to seed and mulch the area that was disturbed. Photo Point #4 upstream shows the stream relocation area where the accident occurred.

Estimated causes, and proposed/required remedial action: This area was replanted with bareroot seedlings and some additional live staking also took place.

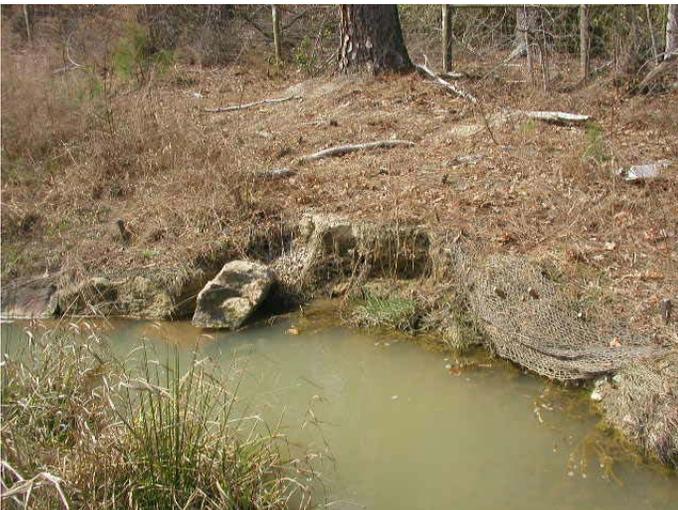
The stream is stable for the Year 2 Winter Evaluation. There is some minor bank erosion on the left bank at the end of a cross vane arm @ Sta. 460+00. Some additional live staking took place in this area to help stabilize the left streambank. There is evidence that a bankfull event has recently occurred. NCDOT will continue to monitor this stream relocation.

7/16/07	Sta. 460+00	Station Number	Station Number	Station Number	Station Number
Structure Type	Cross vane				
Is water piping through or around structure?					
Head cut or down cut present?					
Bank or scour erosion present?	Minor bank erosion at the end of cross vane arm				
Other problems noted?

Bank erosion on left bank at the end of a cross vane arm @ Sta. 460+00  
Year 2 Winter – March 2008
