Monitoring Data Record

Project Title: R-2000G (I-540) COE Action ID: 199920387

Stream Name: UT Neuse River (Site 10) DWQ Number: 030114

City, County and other Location Information: I-540, Wake County (Sta.460+53 -L- to 459+80 -L- RT.)

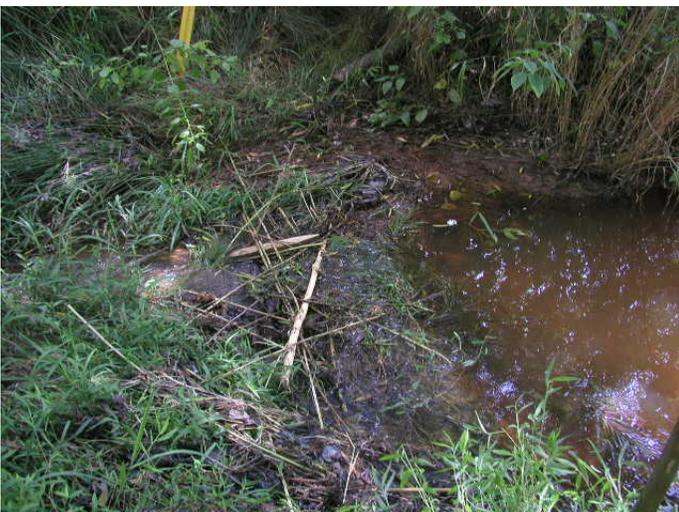
The stream is stable for the Year 4 Summer Evaluation. Beaver activity was noted onsite during the monitoring evaluation. NCDOT will contact USDA to trap the beavers and breach the dams. NCDOT will continue to monitor this stream relocation.

Date	Sta. 0+85	Sta. 1+10	Station	Station	Station
7/28/10	-RPC- @ PP#4	-RPC- @ PP#3	Number	Number	Number
Structure Type					
Is water piping through or around structure?					
Head cut or down cut present?					
Bank or scour erosion present?					
Other problems noted?	Beaver Dam	Beaver Dam

Beaver dam at Sta. 0+85 -RPC- next to Photo Point #4
