# ANNUAL REPORT FOR 2004

**Cedar Point Mitigation Site  
Carteret County  
Project No. 6.16901T  
TIP No. R-2105 AB**

Prepared By:  
Office of Natural Environment & Roadside Environmental Unit  
North Carolina Department of Transportation  
December 2004

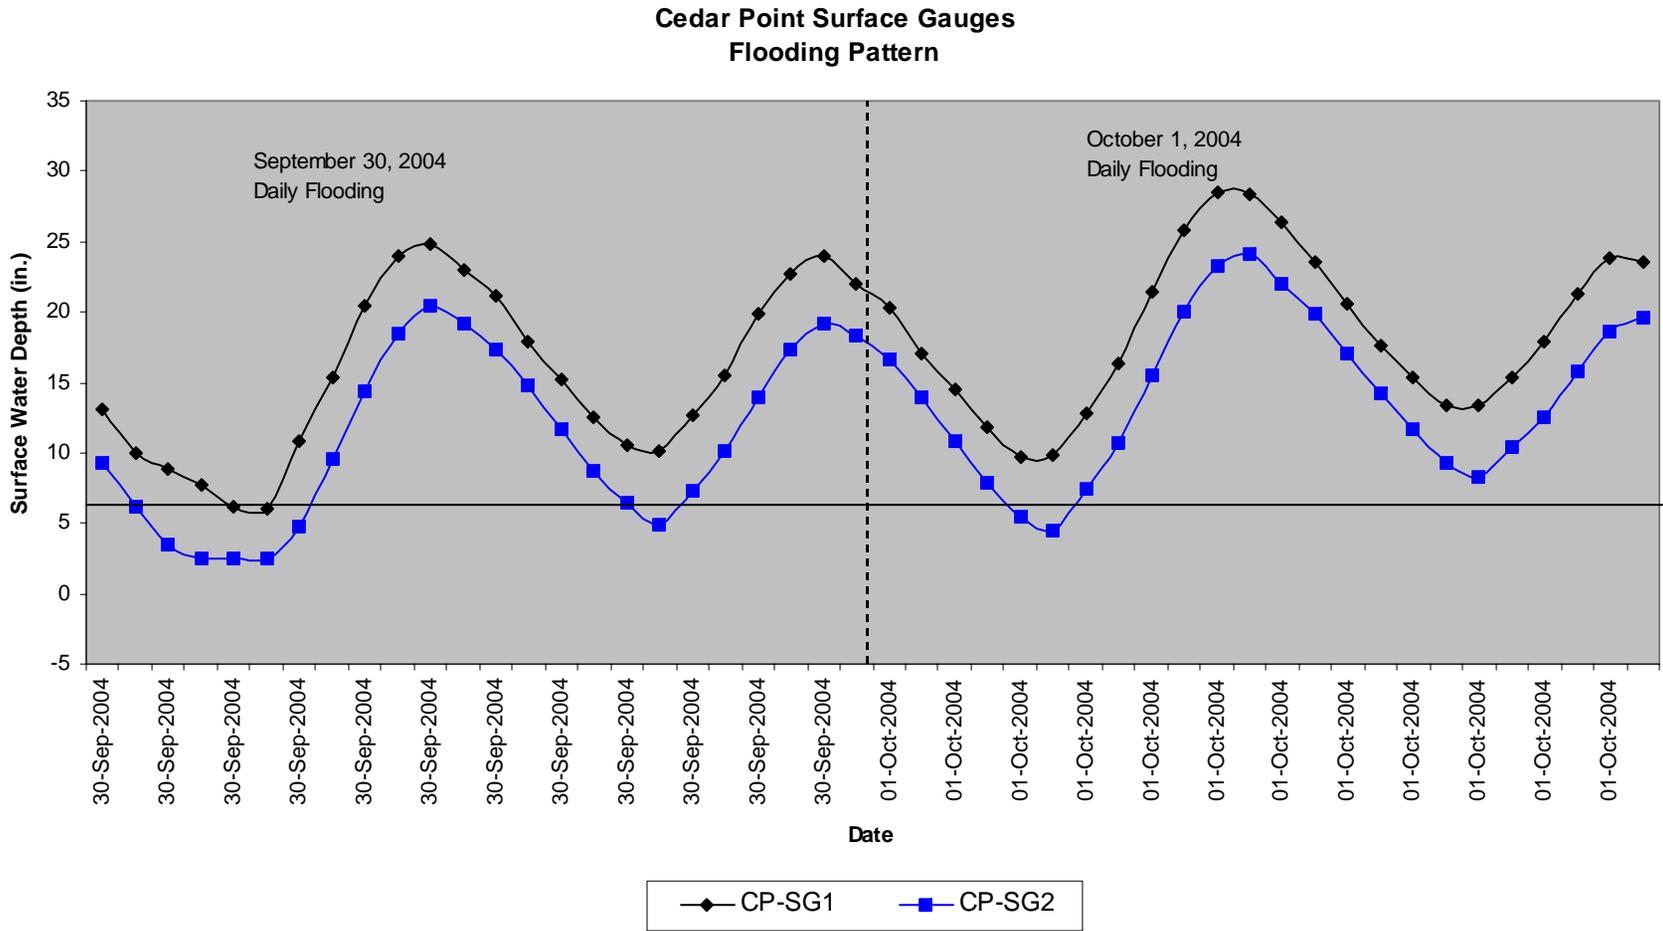
Figure 3. Plot of Daily Flooding Pattern (2-day period shown)

Figure 3 is a surface water plot of the data recorded at both gauges over a two-day period. This figure illustrates that flooding occurs twice daily as required in the permit conditions. The two days in the plot were chosen at random and are representative of conditions throughout the growing season.

The surface gauges indicate that the site is being flooded twice daily during the growing season. An examination of the water levels over a two-day period (Figure 3) illustrates that the site floods twice daily under average climatic conditions. The two days in the plot were chosen at random and are representative of typical conditions during the growing season.

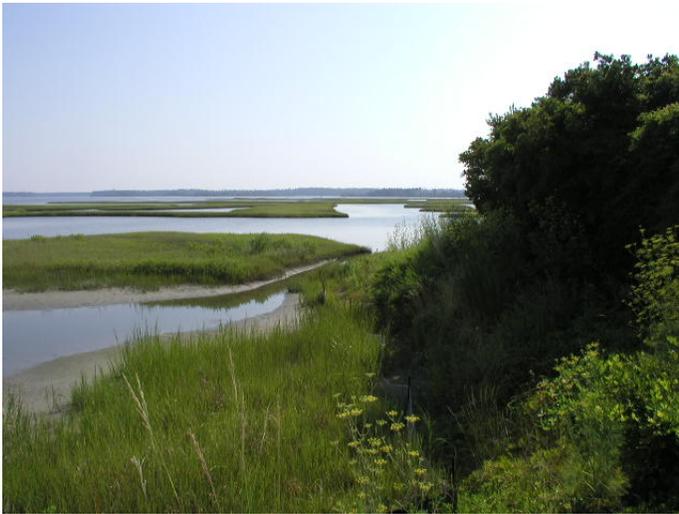
Photo 1

Vegetation on the Cedar Point Site has improved greatly since tilling, replanting, and fertilization in May 2003. This can be seen in photos 1, 2, and 5. Frequency and coverage are on track to meet the success criteria. *Spartina alterniflora* is coming in naturally in higher elevations, outside of the silt fence.
