ANNUAL REPORT FOR 2006

**Cedar Point Mitigation Site
Carteret County
TIP No. R-2105 AB**

Prepared By:
Natural Environment Unit & Roadside Environmental Unit
North Carolina Department of Transportation
January 2007

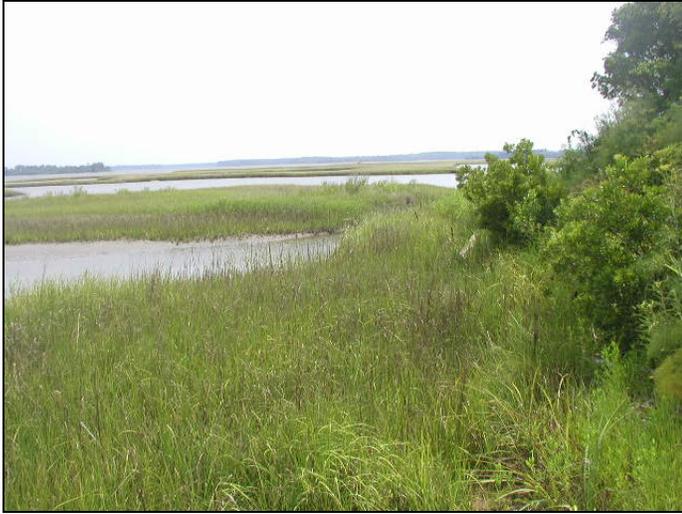
Photo 1

The site was tilled and replanted in May of 2003. Vegetation on site has improved greatly as seen in the photos. Frequency and coverage are on track for the fourth year of vegetation monitoring. *Spartina alterniflora* is coming in naturally throughout the site.
