Monitoring Data Record

Project Title: Cashiers (R-2224A) COE Action ID: 200230408

Stream Name: _____ DWQ Number: 000536
City, County and other Location Information: Sta. 136+00LT on NC 107 N of Cashiers, Jackson

Cashiers Stream

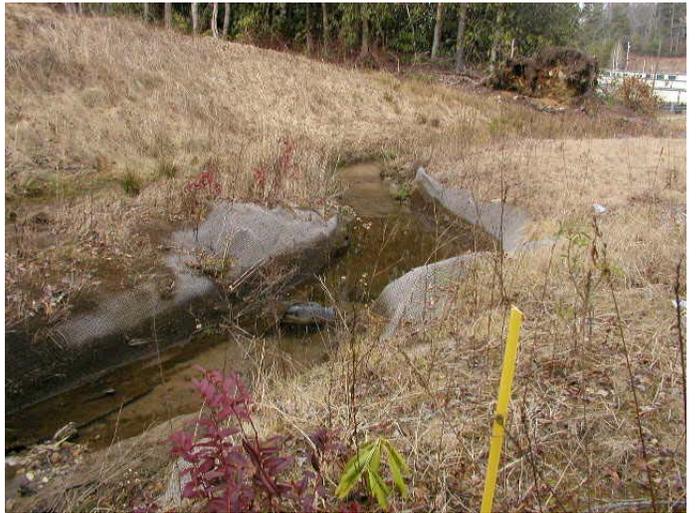
Photo 4

Large tree across stream just past (Photo 4) but is not affecting the flow of the stream at this time.

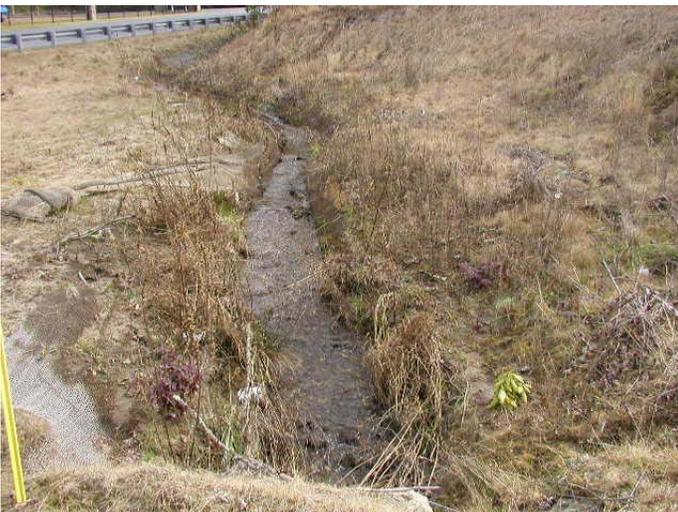
Photo 5

Coir fiber matting has become unstaked (Photo 5) but streambank is stable.

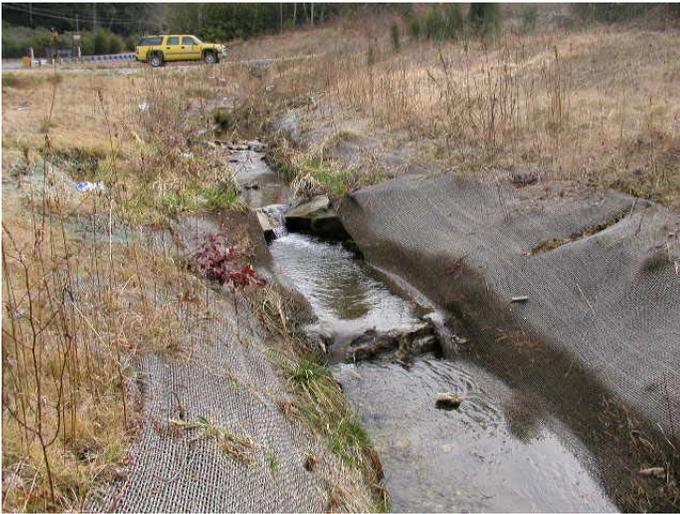
Photo 7

Minor bank erosion noted last monitoring period at (Photo 7) has stabilized itself but there is some major bank failure upstream from this point which is noted in (Photo 9) of the pictures. NCDOT will assess the situation to see what action needs to be taken.

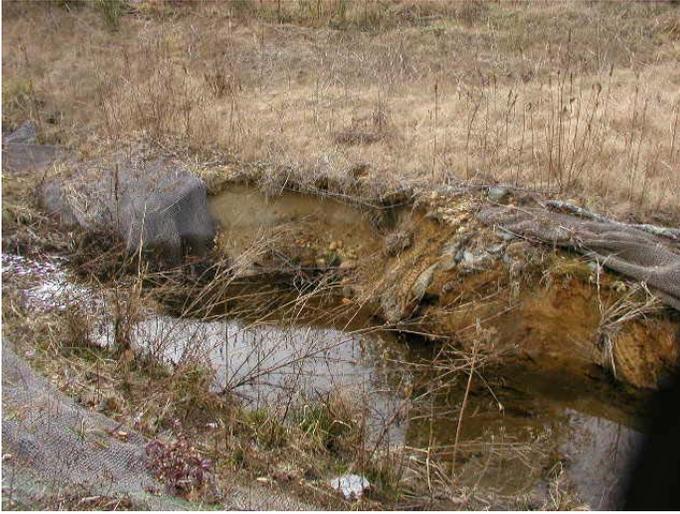
Photo 9 (bank failure)
