Monitoring Data Record

Project Title: R-2231B Myrick Pond COE Action ID: 199400590

City, County and other Location Information: Richmond County, Ellerbe Bypass (Station 141+40 LT.

Monitoring Year: (2) of 5

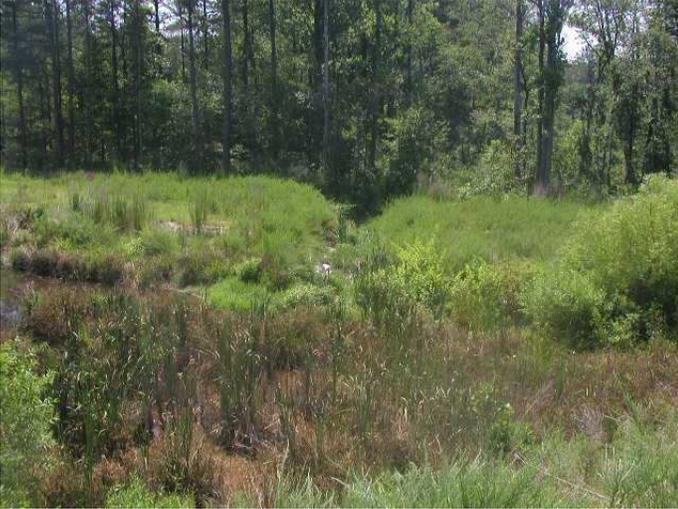
Photo Point #7 (Looking Downstream @ the Outlet End of the Culvert)

The Myrick Pond Stream Mitigation Site is stabilized for the Year 2 Summer evaluation. A bankfull event was noted during this time of monitoring. The stream was highly vegetated and stable at the time of monitoring. The cross vanes at the outlet end of the pipe are stable and functioning properly. NCDOT will continue to monitor this stream restoration site.
