Monitoring Data Record

Project Title: R-2248BB – Charlotte Outer Loop COE Action ID: 200131321
Stream Name: UT Thomas Pond (Site 9) DWQ Number: 011231
City, County and other Location Information: Mecklenburg County, Charlotte Outer Loop, NC 27 Exit (Mount Holly Road)
Date Construction Completed: April 2005 Monitoring Year: (4) of 5
Ecoregion: _____ 8 digit HUC unit 03050101
USGS Quad Name and Coordinates: _____

UT Thomas Pond

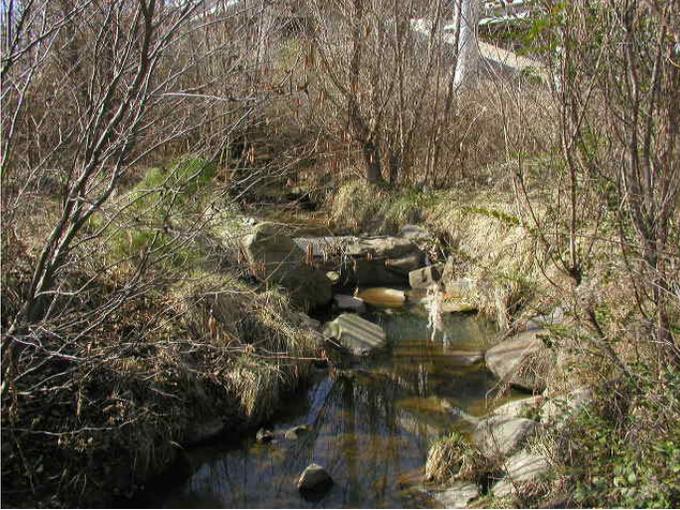
Photo Point #1 (Upstream)

| Date | Station Number | Station Number | Station Number | Station Number | Station Number | Station Number |
|--|---|--|--|--|--|---|
| 2/21/11 | 217+80 –L- (PP#1 Upstream) | 218+80 to 219+00 –L- (Additional Photo) | 219+00 –L- (Additional Photo) | 0+20 Loop E (Additional Photo) | 0+60 Loop E (Additional Photo) | 2+80 Loop E (Additional Photo) |
| Structure Type | Crossvane | | | | | |
| Is water piping through or around structure? | Water piping under crossvane | | | | | |

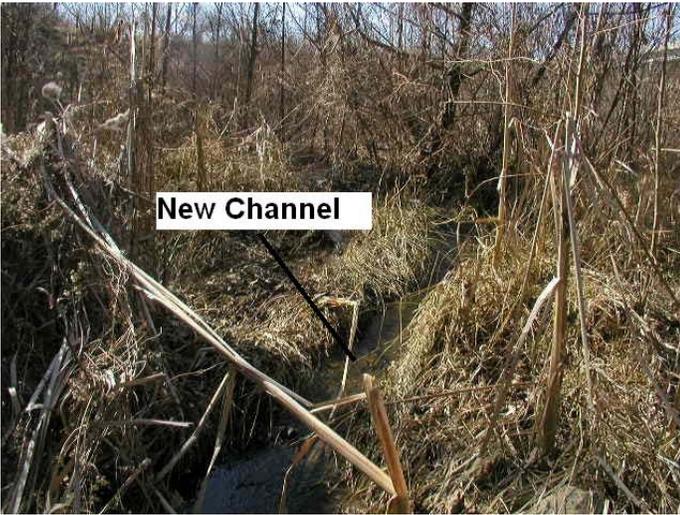
| Date | Station Number | Station Number | Station Number | Station Number | Station Number | Station Number |
|--|---|--|--|--|--|---|
| Other problems noted? | | New channel has formed b/t PP#2 and PP#3 | | | | |

Sta. 218+80 to 219+00 -L-
New channel has formed b/t PP#2 and PP#3

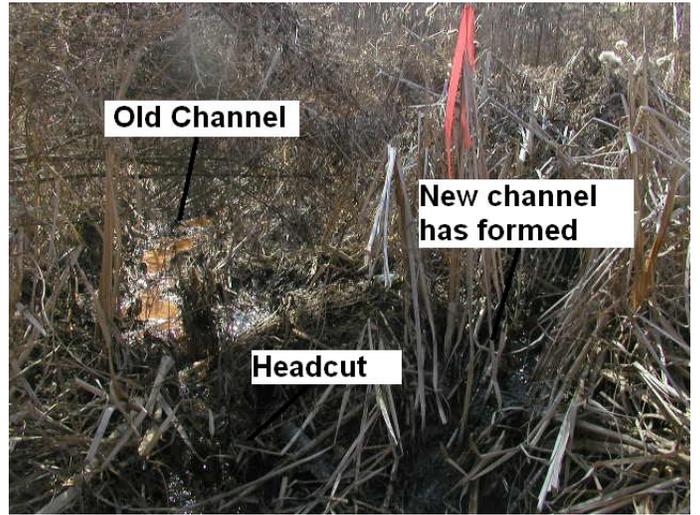
Sta. 219+00 -L-
A previous headcut has moved approx. 50 ft. upstream

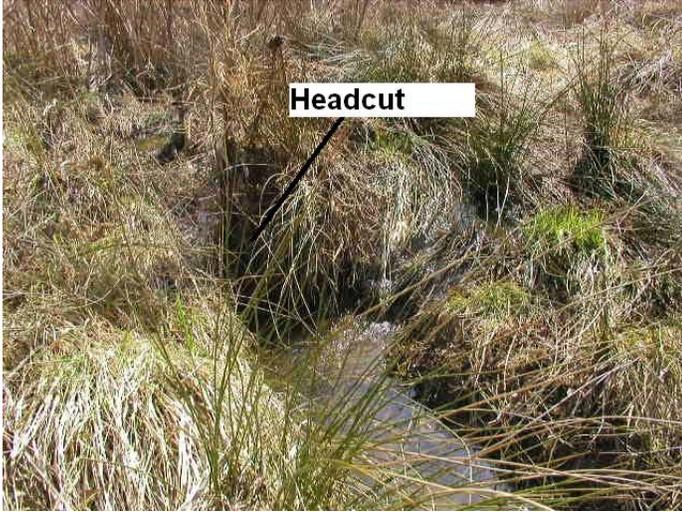
Sta. 0+20 –Loop E- (Headcut has formed approx. 20 ft. upstream of photo point #4)

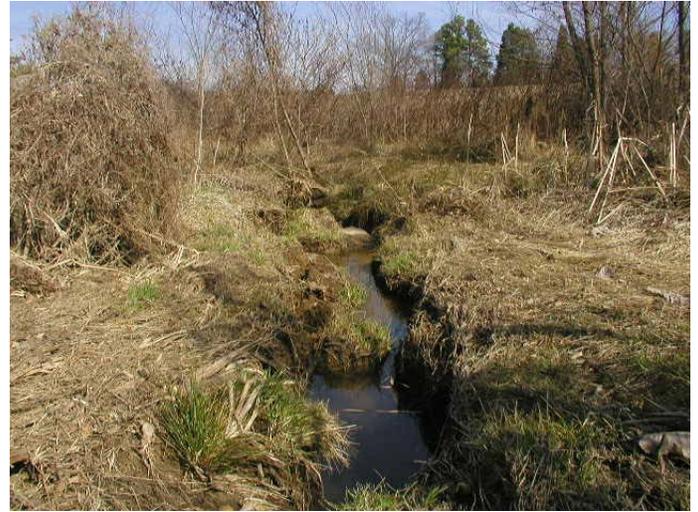
Sta. 0+20 –Loop E- (Banks of the channel are unstable downstream of photo point #4)

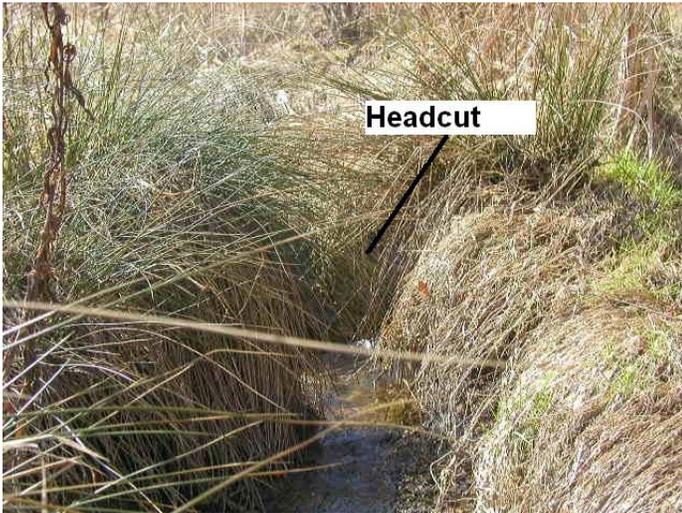
Sta. 0+60 –Loop E- (A previous headcut has moved approx. 30 ft. upstream)

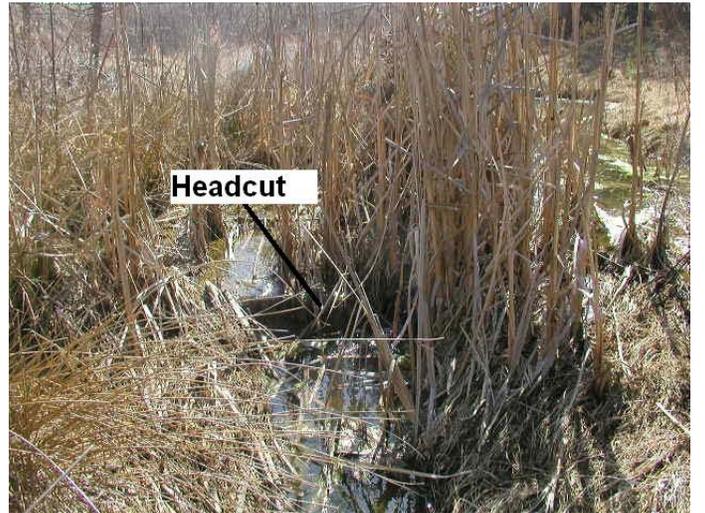
Sta. 2+80 –Loop E- (Headcut has formed approx. 30 ft. upstream of the box culvert at Loop E)
