Monitoring Data Record

Project Title: R-2248BB – Charlotte Outer Loop COE Action ID: 200131321
 Stream Name: UT Thomas Pond (Site 9) DWQ Number: 011231
 City, County and other Location Information: Mecklenburg County, Charlotte Outer Loop, NC 27 Exit (Mount Holly Road)
 Date Construction Completed: April 2005 Monitoring Year: (5) of 5
 Ecoregion: _____ 8 digit HUC unit 03050101
 USGS Quad Name and Coordinates: _____

This completes the Year 5 Winter evaluation for the UT Thomas Pond stream relocation. There are some areas of concern which are listed in the table below. There were no grade control structures installed within the sections of stream where these headcuts have formed.

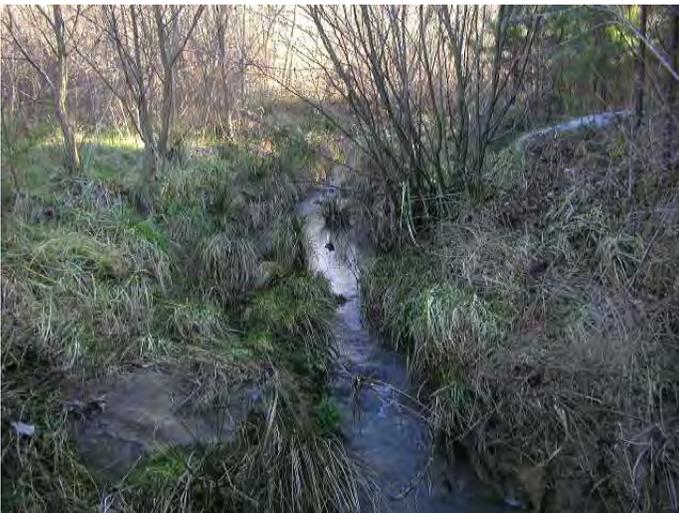
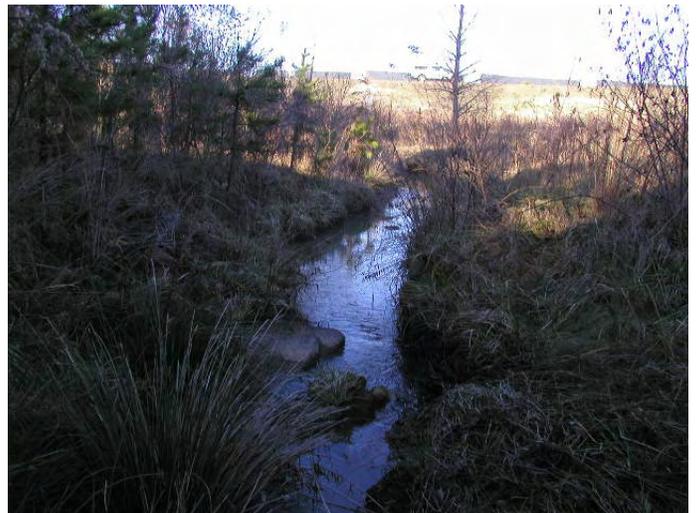
DWQ requested NCDOT to do a supplemental planting in the buffer around PP#5 and PP#6 (Loop E Area) that had previously been mowed.

Estimated causes, and proposed/required remedial action: NCDOT completed a supplemental planting in the buffer around PP#5 and PP#6 (Loop E Area) on January 24, 2012 with sycamore and river birch bareroot seedlings being planted. NCDOT installed signs to prevent further site disturbance.

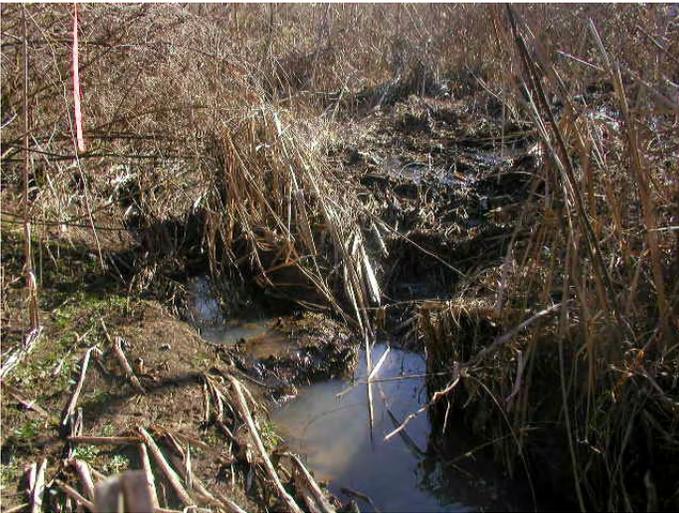
Sta. 219+00 -L-
Headcut has not moved upstream since Feb. 2011 evaluation

NCDOT will continue to monitor this stream relocation for channel stability.

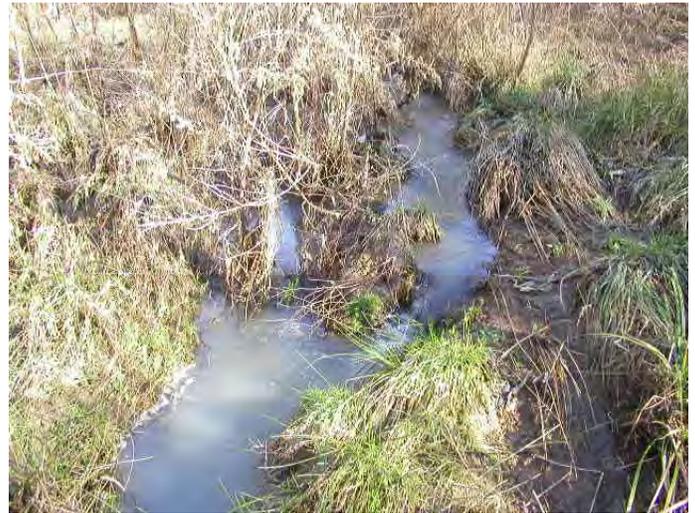
Sta. 0+20 -Loop E (Headcut has not moved upstream since Feb. 2011 evaluation)

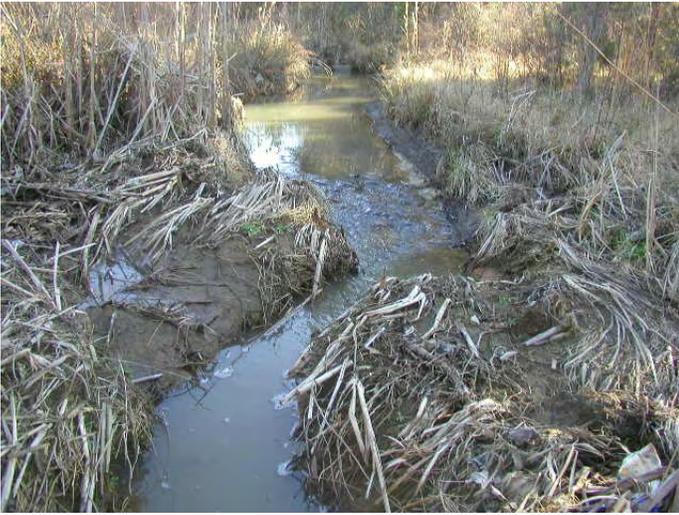
Sta. 2+80 –Loop E-
Breached debris in channel in Sept. 2011

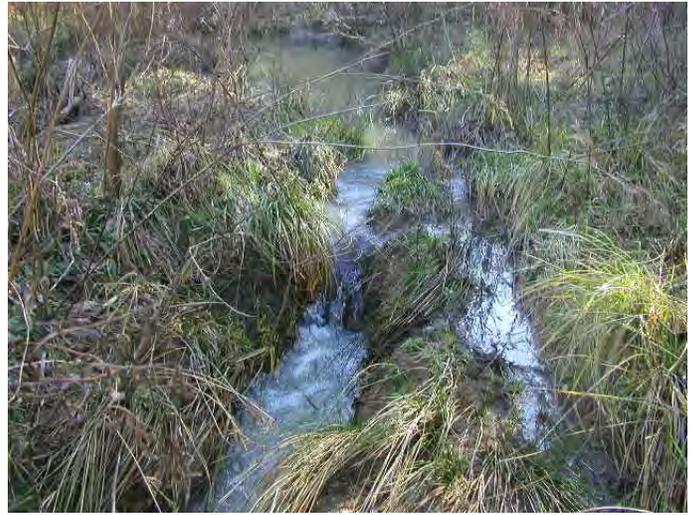
Sta. 0+60-Loop E-
Headcut b/t PP#4 and PP# 5 has not moved upstream since
Sept. 2011

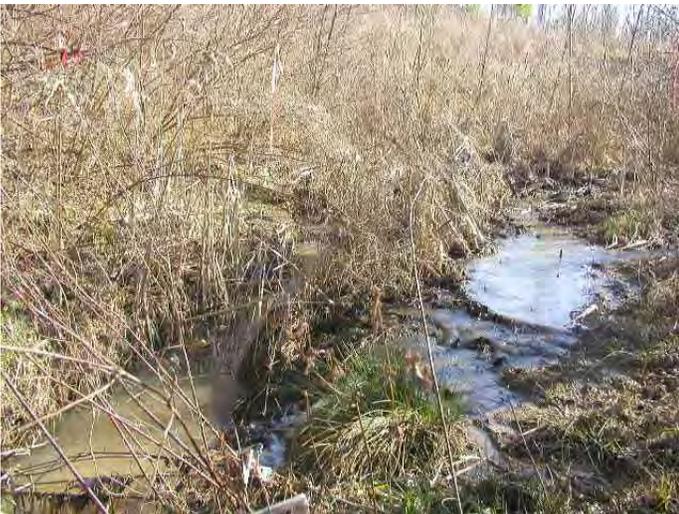
A site visit was conducted on July 21, 2011 with the regulatory agencies and NCDOT personnel present. There was some concern over the section of stream that had migrated from the original channel and formed a new channel and over the headcuts that have formed and but not practical at this time to put equipment on the site.

Sta. 219+00-L-
Newly formed channel to the right is stable at this time
Year 5 Winter – January 2012
