Monitoring Data Record

Project Title: R-2248D – Charlotte Outer Loop COE Action ID: 200131321  
 Stream Name: Trib. to Dixon Branch (Site 16) DWQ Number: 011231  
 City, County and other Location Information: Mecklenburg County, Charlotte Outer Loop, R-2248D Right of Project Station 13+50 Ramp 2D  
 Date Construction Completed: February 2005 Monitoring Year: ( 3 ) of 5  
 Ecoregion: \_\_\_\_\_ 8 digit HUC unit 03050103  
 USGS Quad Name and Coordinates: \_\_\_\_\_

# UT to Dixon Branch

## Site 16

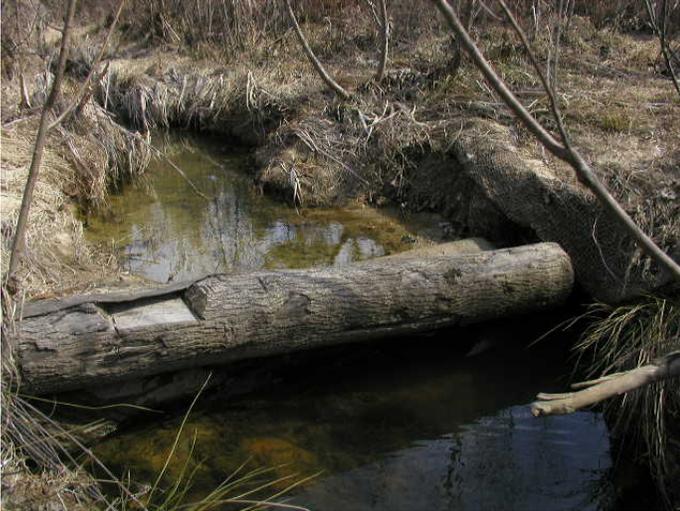
Log Sill #1

UT to Dixon Branch (Site 16) stream relocation was unstable for the Year 3 Winter evaluation. NCDOT installed log sills in May 2010 to stop the previously noted headcut and further stabilize the stream. Three of the four installed log sills have water piping under or around these structures. A headcut has moved further upstream since the log sills have failed. NCDOT plans to investigate the situation to see what remedial action is needed and will continue to monitor for channel stability at this stream relocation.

Date 3/2/11	Between PP#1 and PP#2	Station Number	Station Number	Station Number	Station Number
Structure Type	Log Sills				
Is water piping through or around structure?	Water is piping under or around three of the four installed log sills				
Head cut or down cut present?	Headcut				
Bank or scour erosion present?					
Other problems noted?

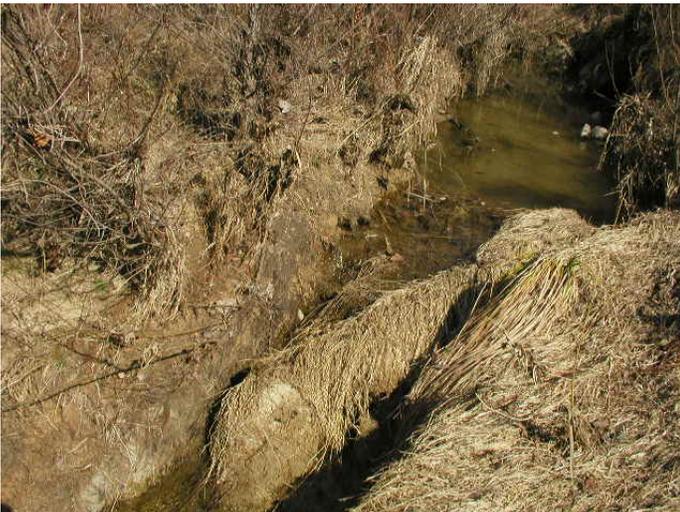
Headcut upstream of Log Sill #1  
Year 3 Winter – March 2011
