Monitoring Data Record

Project Title: R-2248D – Charlotte Outer Loop COE Action ID: 200131321
 Stream Name: Trib. to Dixon Branch (Site 19) DWQ Number: 011231
 City, County and other Location Information: Mecklenburg County, Charlotte Outer Loop, R-2248D Left of Project Station 10+00 Y-7
 Date Construction Completed: May 2008 Monitoring Year: (5) of 5
 Ecoregion: _____ 8 digit HUC unit 03050103
 USGS Quad Name and Coordinates: _____
Rosgen Classification: Proposed C4 stream type classification
 Length of Project: 400 ft. Urban or Rural: Urban Watershed Size: _____
 Monitoring DATA collected by: M. Green and J. Young Date: 1/23/13
 Applicant Information:
 Name: NCDOT – Roadside Environmental Unit
 Address: 1425 Rock Quarry Rd, Raleigh, NC 27610
 Telephone Number: (919) 861-3772 Email address: mlgreen@ncdot.gov
 Consultant Information:
 Name: _____
 Address: _____
 Telephone Number: _____ Email address: _____
Project Status: _____

UT to Dixon Branch

Site 19

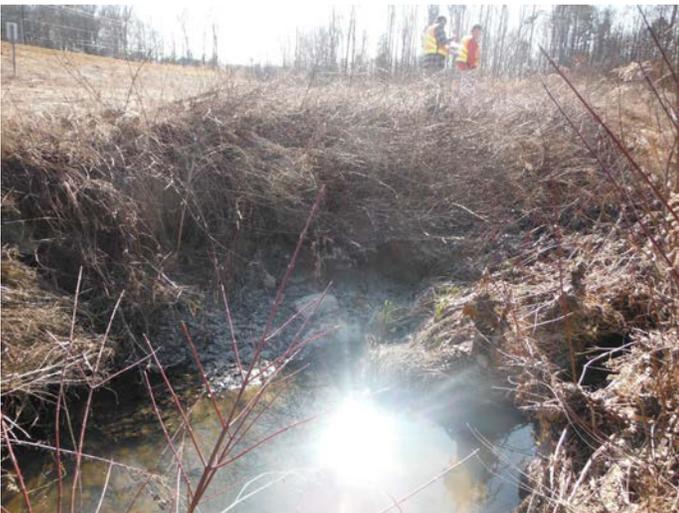
UT to Dixon Branch (Site 19) stream relocation is stable for the Year 5 Winter evaluation. Some areas of bank scouring still exist upstream of the pipe crossing at Sta. 10+80 Y-7 and Sta. 10+40 Y-7. NCDOT has installed live stakes along the streambank to help stabilize these areas of scouring behind the J-hooks. The areas of bank scouring show little or no change since the last evaluation and remain stable at this time. The area downstream of the pipe that had extensive erosion was repaired during May 2010 and is highly stable. NCDOT will continue to monitor channel stability at this stream relocation.

Date 1/23/13	Station 10+80 Y-7 (additional photo)	Station 10+40 Y-7	Station	Station Number	Station Number
Structure Type					
Is water piping through or around structure?					
Head cut or down cut present?					
Bank or scour erosion present?	Bank scouring on left bank behind J-hook	Bank scouring on left bank behind J-hook			
Other problems noted?

Left bank scouring at end of J-Hook @ Sta. 10+80 Y-7

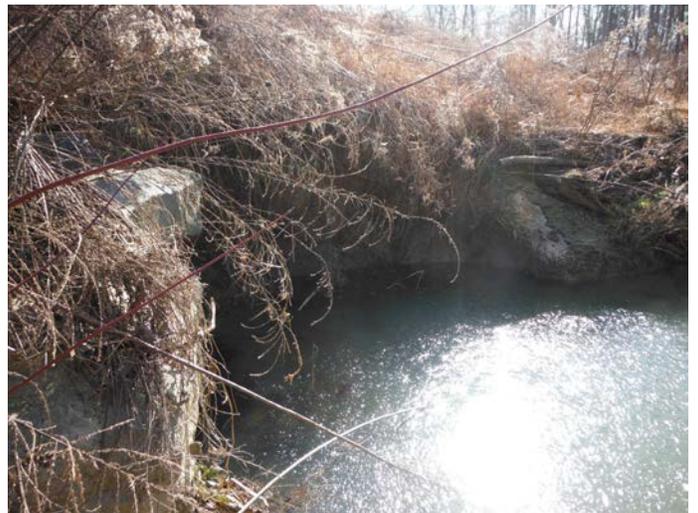
Left bank scouring at end of J-Hook @ Sta. 10+40 Y-7
