UT to Dixon Branch Site 19

UT to Dixon Branch Mitigation Site 19
 Site Map (Photo Point Locations)
 Mecklenburg County, North Carolina

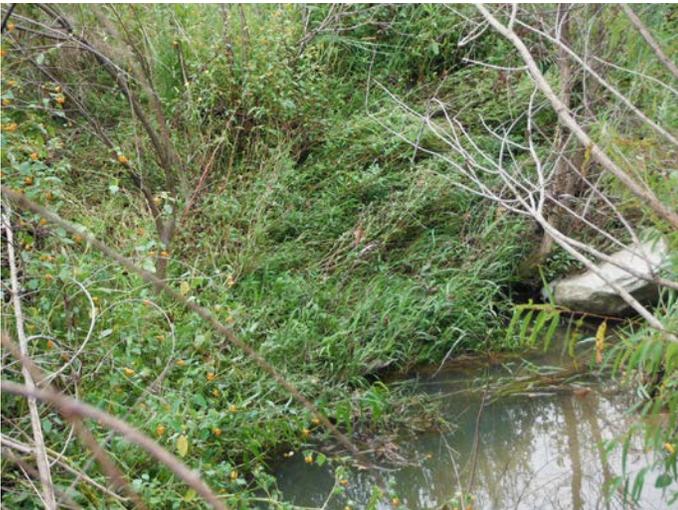
UT to Dixon Branch (Site 19) stream relocation is stable for the Year 6 Summer evaluation, except for, the areas of bank scouring that still exist upstream of the pipe crossing at Sta. 10+80 Y-7 and Sta. 10+40 Y-7. The areas of bank scouring were noted behind two j-hooks. The area downstream of the pipe that had extensive erosion was repaired during May 2010 and is highly stable.

Left bank scouring at end of J-Hook @ Sta. 10+80 Y-7

On April 21, 2014, an onsite meeting was held between regulatory agencies and NCDOT to review the site. The regulatory agencies requested that the bank scouring areas needed to be repaired. NCDOT has scoped a consultant to design remediation plans to repair the stream.

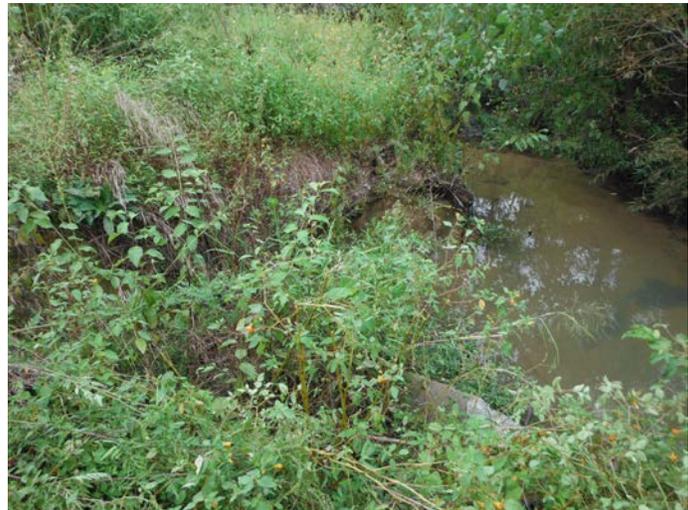
Left bank scouring at end of J-Hook @ Sta. 10+40 Y-7
