Monitoring Data Record

Project Title: R-2248D – Charlotte Outer Loop COE Action ID: 200131321  
 Stream Name: Trib. to Dixon Branch (Site 19) DWQ Number: 011231  
 City, County and other Location Information: Mecklenburg County, Charlotte Outer Loop, R-2248D Left of Project Station 10+00 Y-7  
 Date Construction Completed: May 2008 Monitoring Year: ( 6 ) of 5  
 Ecoregion: \_\_\_\_\_ 8 digit HUC unit 03050103  
 USGS Quad Name and Coordinates: \_\_\_\_\_

# UT to Dixon Branch

## Site 19

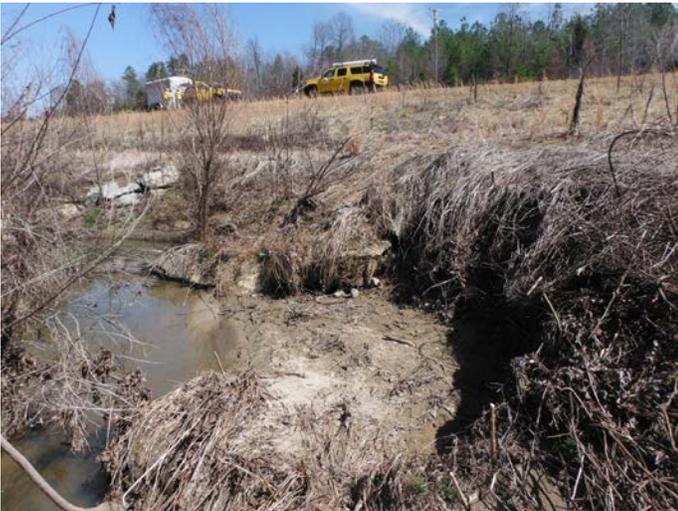
UT to Dixon Branch (Site 19) stream relocation is stable for the Year 6 Winter evaluation. Some areas of bank scouring still exist upstream of the pipe crossing at Sta. 10+80 Y-7 and Sta. 10+40 Y-7. The areas of bank scouring behind the two j-hooks have filled in with sediment deposition due to bankfull events since the last monitoring visit. NCDOT live staked these areas on 3/11/14 to help promote woody plant growth. The area downstream of the pipe that had extensive erosion was repaired during May 2010 and is highly stable. A bankfull event had occurred since the last monitoring evaluation. NCDOT will continue to monitor channel stability at Site 19.

Left bank scouring at end of J-Hook @ Sta. 10+80 Y-7

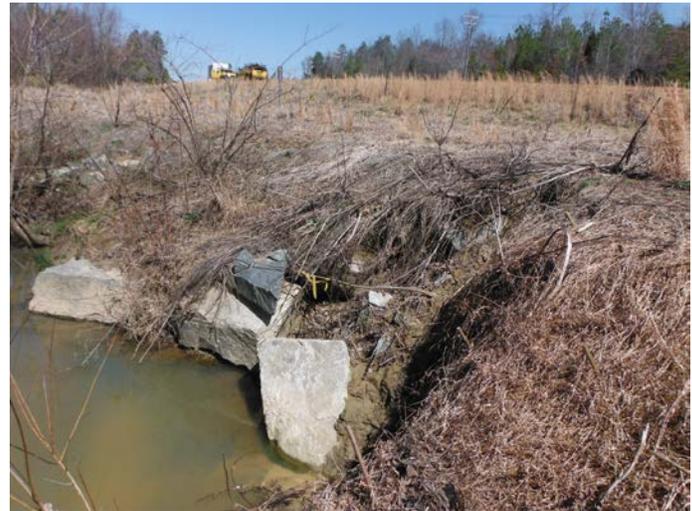
Left bank scouring at end of J-Hook @ Sta. 10+40 Y-7

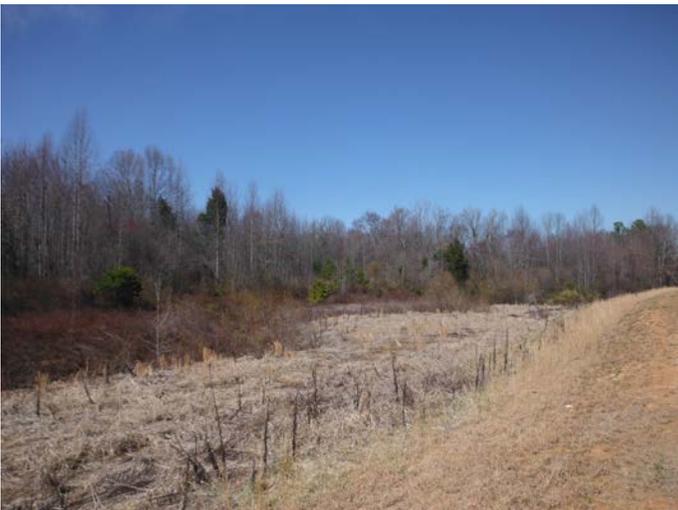
Overview Photo of Site 19  
Year 6 Winter – March 2014
