Monitoring Data Record

Project Title: R-2248D – Charlotte Outer Loop COE Action ID: 200131321
 Stream Name: Trib. to Dixon Branch (Site 24) DWQ Number: 011231
 City, County and other Location Information: Mecklenburg County, Charlotte Outer Loop, R-2248D Sta. 378+15 to 379+40 –L- Left and Sta.380+16 to 381+23 –L- Left
 Date Construction Completed: February 2005 Monitoring Year: (4) of 5
 Ecoregion: 8 digit HUC unit 03050103
 USGS Quad Name and Coordinates: _____

Length of Project: 1020 ft. Urban or Rural: Urban Watershed Size: _____
 Monitoring DATA collected by: M. Green and J. Young Date: 9/20/12

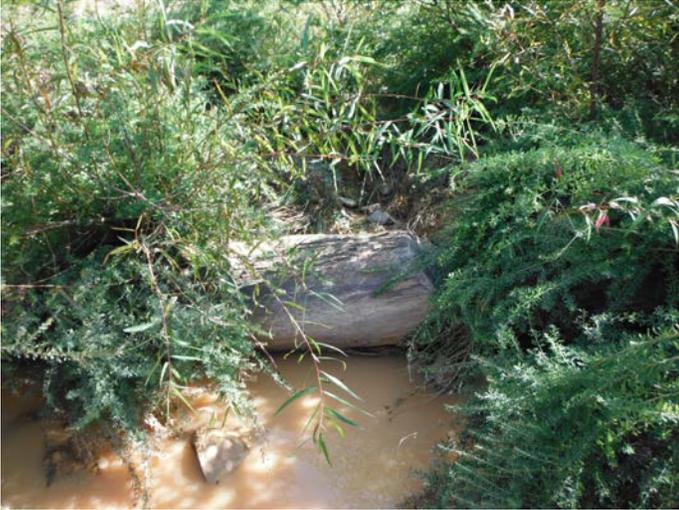
UT to Dixon Branch (Site 24) stream relocation is stable for the Year 4 Summer evaluation, except for, a log sill at Sta. 380+40 that has water piping under this structure. The right bank at this log sill has eroded. Repairs to this log sill are scheduled for Fall 2012. A bankfull event has occurred since the last monitoring evaluation. NCDOT will continue to monitor the channel stability.

Date 9/20/12	Station 380+40-L- (additional photo)	Station Number	Station Number	Station Number	Station Number
Structure Type	Log Sill #1				
Is water piping through or around structure?	Water was piping under log sill				
Head cut or down cut present?					
Bank or scour erosion present?	Bank erosion on right bank				
Other problems noted?

Water piping under Log Sill #1 and right bank is eroded at Sta. 380+40-L-
