Monitoring Data Record

Project Title: R-2248D – Charlotte Outer Loop COE Action ID: 200131321
 Stream Name: Trib. to Dixon Branch (Site 24) DWQ Number: 011231
 City, County and other Location Information: Mecklenburg County, Charlotte Outer Loop, R-2248D Sta. 378+15 to 379+40 –L- Left and Sta.380+16 to 381+23 –L- Left
 Date Construction Completed: February 2005 Monitoring Year: (5) of 5
 Ecoregion: 8 digit HUC unit 03050103
 USGS Quad Name and Coordinates: _____

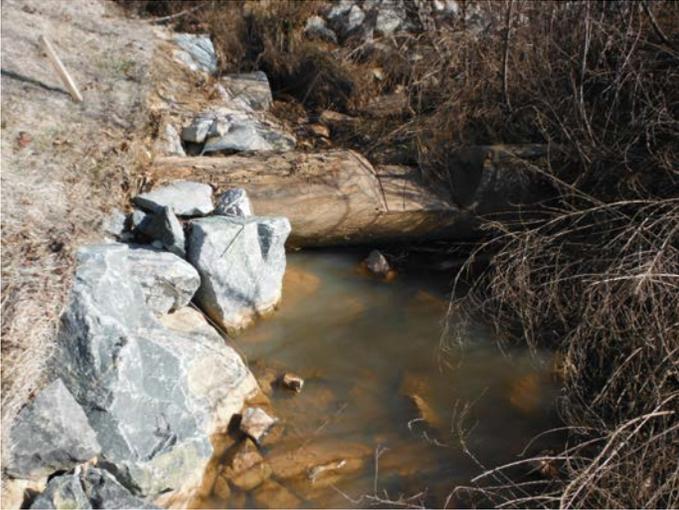
UT to Dixon Branch (Site 24) stream relocation is stable for the Year 5 Winter evaluation. The eroded right bank at the log sill at Sta. 380+40-L- that was previously noted was repaired on 10/9/12. This log sill continues to have water piping under it but remains stable at this time. NCDOT will continue to monitor the channel stability.

Date 1/23/13	Station 380+40-L- (additional photo)	Station Number	Station Number	Station Number	Station Number
Structure Type	Log Sill #1				
Is water piping through or around structure?	Water was piping under log sill				
Head cut or down cut present?					
Bank or scour erosion present?					
Other problems noted?

Water piping under Log Sill #1 @ Sta. 380+40-L-
Year 5 Winter – January 2013

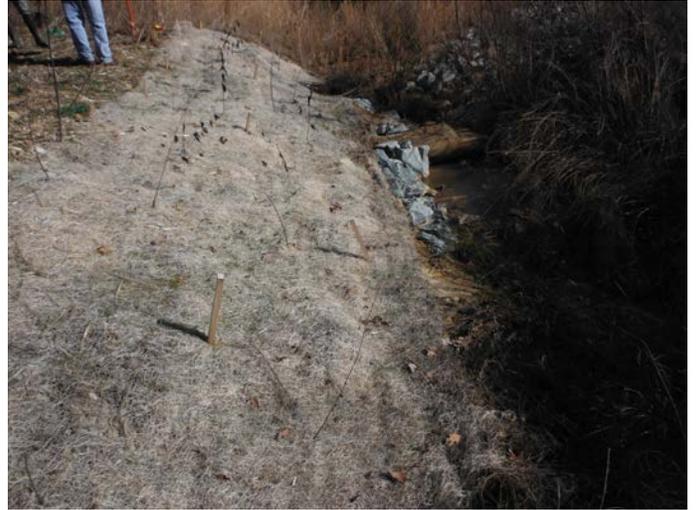
Repaired right bank at Sta. 380+40-L-

ADDITIONAL COMMENTS: Vegetation was dormant at the time of monitoring. NCDOT replanted Type II plantings (sycamore, river birch, yellow poplar, and willow oak bareroot seedlings) throughout Site 24 and installed live stakes (black willow and silky dogwood) where missing or dead live stakes were found on March 2, 2011. A supplemental planting of the right buffer at PP#3 took place on 1/23/13 due to the repair of the right bank at the log sill at Sta. 380+40-L- on 10/9/12. NCDOT will continue to monitor plant survival in the summer of 2013.
