Monitoring Data Record

Project Title: R-2248D – Charlotte Outer Loop COE Action ID: 200131321
 Stream Name: Trib. to Dixon Branch (Site 19) DWQ Number: 011231
 City, County and other Location Information: Mecklenburg County, Charlotte Outer Loop, R-2248D Left of Project Station 10+00 Y-7
 Date Construction Completed: May 2008 Monitoring Year: (1) of 5
 Ecoregion: _____ 8 digit HUC unit 03050103
 USGS Quad Name and Coordinates: _____
Rosgen Classification: Proposed C4 stream type classification
 Length of Project: 400 ft. Urban or Rural: Urban Watershed Size: _____
 Monitoring DATA collected by: M. Green and J. Young Date: 9/1/09
 Applicant Information:
 Name: NCDOT – Roadside Environmental Unit
 Address: 1425 Rock Quarry Rd, Raleigh, NC 27610
 Telephone Number: (919) 861-3772 Email address: mlgreen@ncdot.gov
 Consultant Information:
 Name: _____
 Address: _____
 Telephone Number: _____ Email address: _____
Project Status: _____

UT to Dixon Branch

Site 19

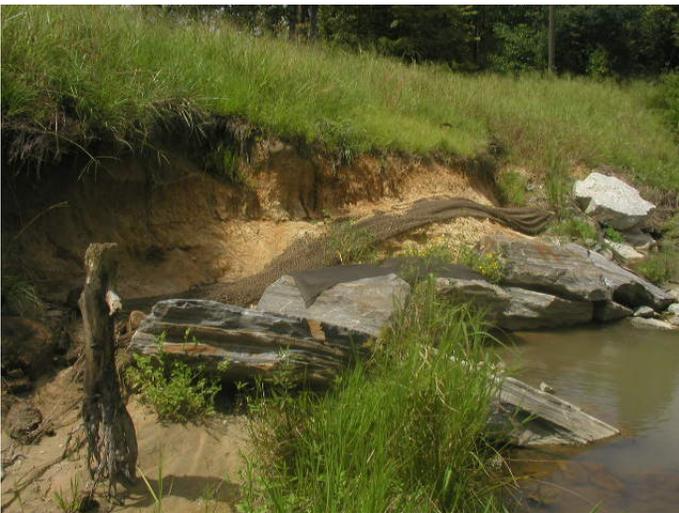
UT to Dixon Branch (Site 19) stream relocation has experienced some bank erosion prior to the Year 1 Summer evaluation. The right arm of the first crossvane at the outlet of the pipe (Sta 9+90 Y-7) has been displaced into the center of the channel. Also, downstream of the pipe the right bank has experienced some bank erosion at Sta. 9+80 Y-7. NCDOT will continue to monitor this stream relocation to see if any remedial action is warranted.

Date 9/1/09	Station 9+90 Y-7	Station 9+80 Y-7	Station Number	Station Number	Station Number
Structure Type	Crossvane				
Is water piping through or around structure?					
Head cut or down cut present?					
Bank or scour erosion present?		Bank erosion on right bank			
Other problems noted?	Right arm of crossvane has been displaced into channel.

Photo of right bank downstream of pipe
