Monitoring Data Record

Project Title: R-2408B COE Action ID: SAW-2009-00860

Stream Name: UT to Rocky Branch DWQ Number: 20090451

Year 3 – July 2014

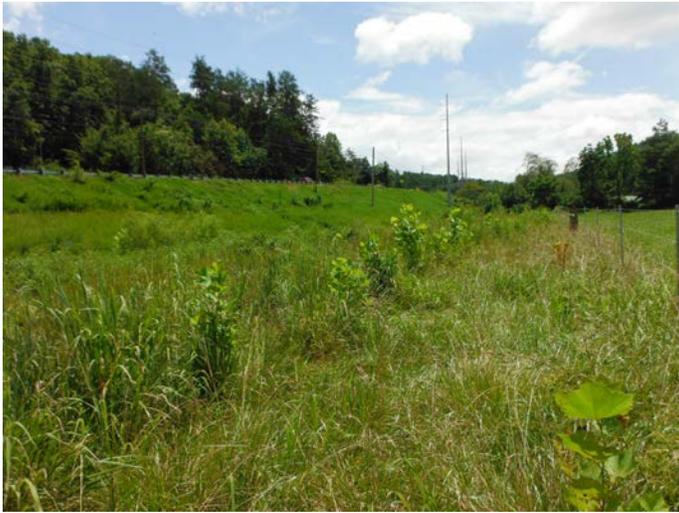
Buffer Vegetation

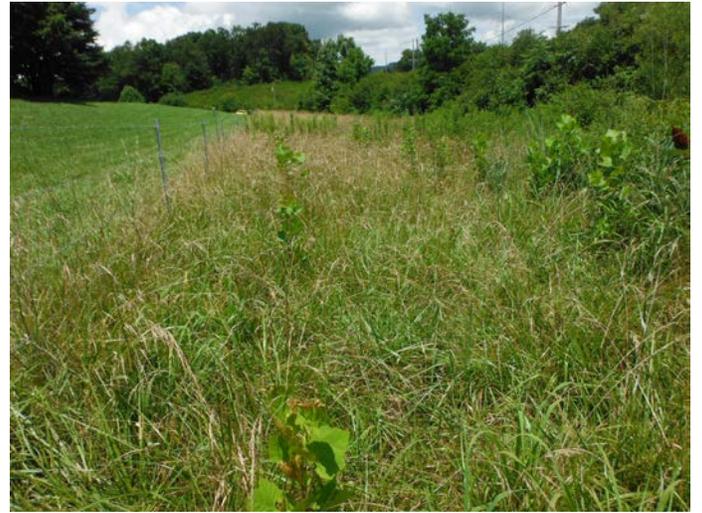
Buffer Vegetation

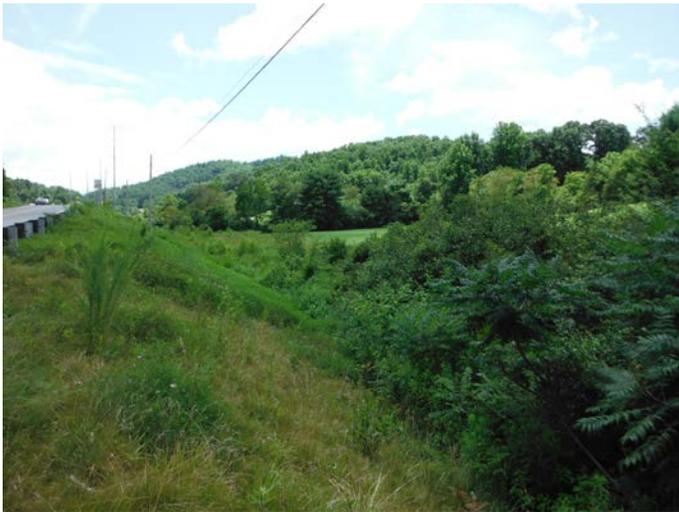
Site Overview Photo taken from NC 28
