ANNUAL REPORT FOR 2014

Bailey Branch Site D Mitigation Site
Madison County
TIP No. R-2518A
COE Action ID: SAW-2007-2197-357/300
DWR #: 20071134

Prepared By:
Natural Environment Section & Roadside Environmental Unit
North Carolina Department of Transportation
November 2014

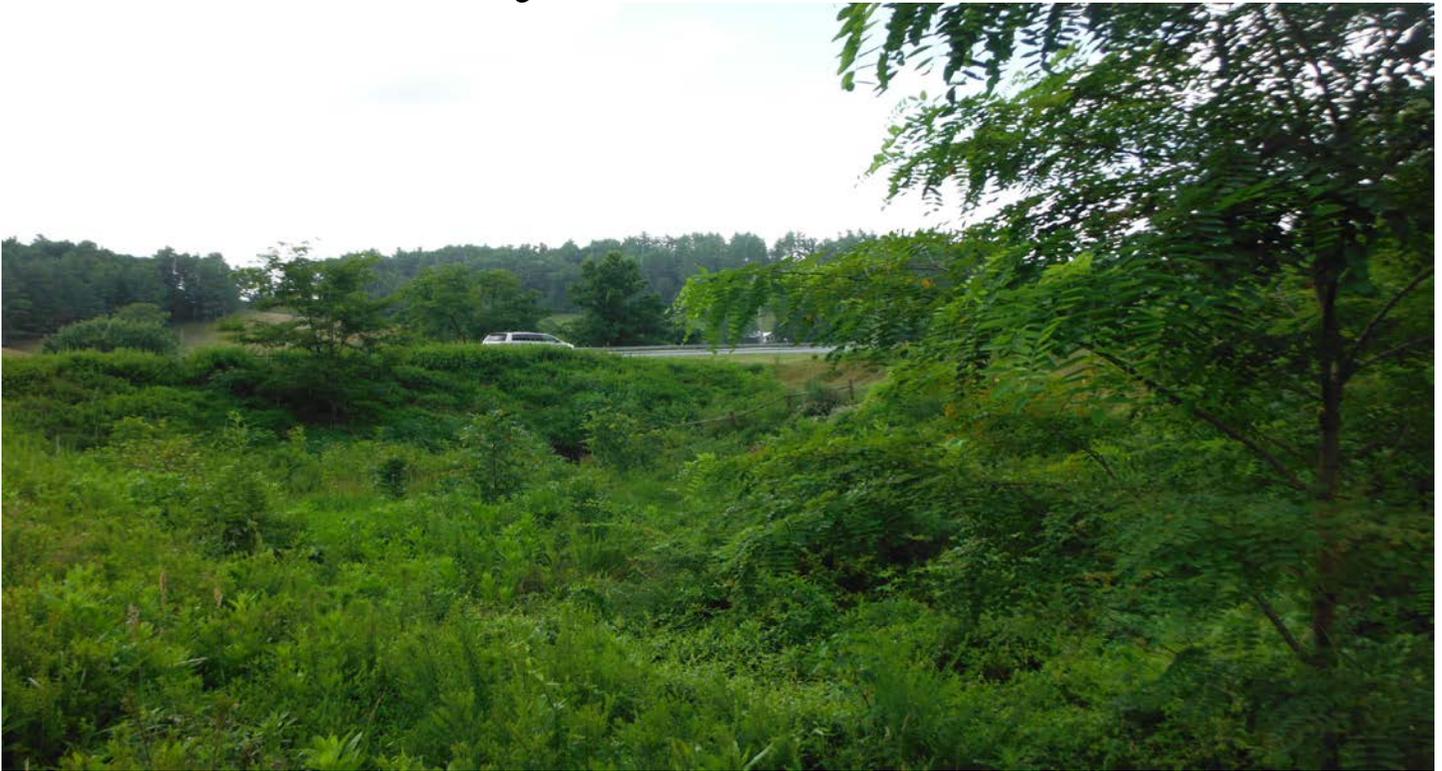
Vegetation Overview Photo

Streambank & Buffer Vegetation: The streambank reforestation was completed in March 2012. The Year 3 vegetation monitoring evaluation noted: Type I: Black Willow and Type II: Sycamore, Green Ash, Tulip Poplar, and White Oak were surviving at the time of the monitoring evaluation.
