ANNUAL REPORT FOR 2011

**Holland Creek Site M Mitigation Site
Madison County
TIP No. R-2518A**

Prepared By:
Natural Environment Unit & Roadside Environmental Unit
North Carolina Department of Transportation
December 2011

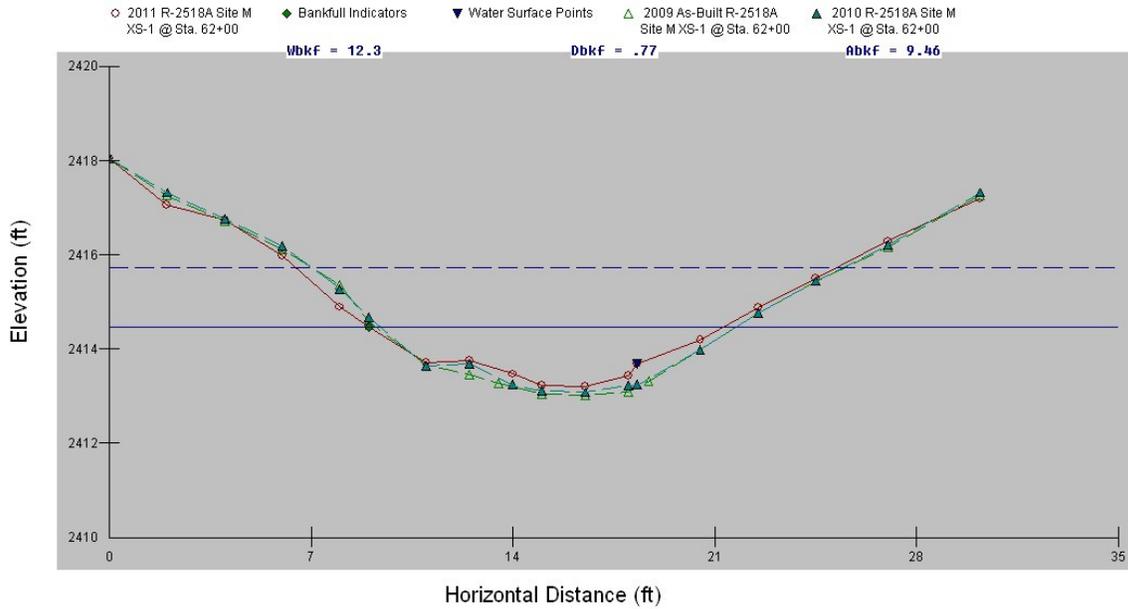
R-2518A Site M XS-1 @ Sta. 62+00

Based on comparisons of the As-Built to the monitoring data, all of the cross sections appear stable with little or no active bank erosion. Graphs of the cross sections are presented in Appendix A. Future survey data will vary depending on actual location of rod placement and alignment; however, this information should remain similar in appearance. The longitudinal profile showed that the channel was stable for the 2011 monitoring evaluation. Pebble counts were not required per the permit conditions and therefore were not completed.

Site M: Cross-Section #1 (Riffle) Abbreviated Morphological Summary					
	2010	2011	2012	2013	2014
Bankfull Cross Sectional Area (ft ²)	13.82	9.46			
Maximum Bankfull Depth (ft.)	1.59	1.27			
Width of the Floodprone Area (ft.)	21.42	18.84			
Bankfull Mean Depth (ft.)	1.04	0.77			
Width/Depth Ratio	12.73	16.03			
Entrenchment Ratio	1.62	1.53			
Bankfull Width (ft.)	13.24	12.34

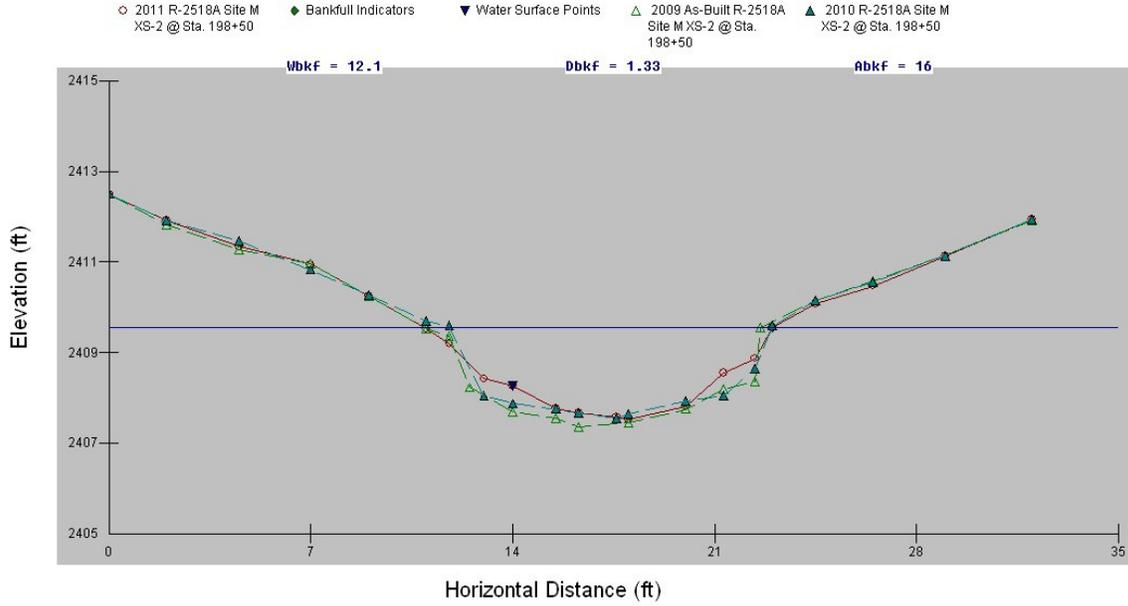
R-2518A Site M XS-2 @ Sta. 198+50

Site M: Cross-Section #2 (Pool) Abbreviated Morphological Summary					
	2010	2011	2012	2013	2014
Bankfull Cross Sectional Area (ft²)	17.46	15.98			
Maximum Bankfull Depth (ft.)	2.04	2.03			
Bankfull Mean Depth (ft.)	1.56	1.33			
Bankfull Width (ft.)	11.2	12.06
