# ANNUAL REPORT FOR 2014

**Holland Creek Site M Mitigation Site  
Madison County  
TIP No. R-2518A  
COE Action ID: SAW-2007-2197-357/300  
DWQ #: 20071134**

Prepared By:  
Natural Environment Section & Roadside Environmental Unit  
North Carolina Department of Transportation  
December 2014

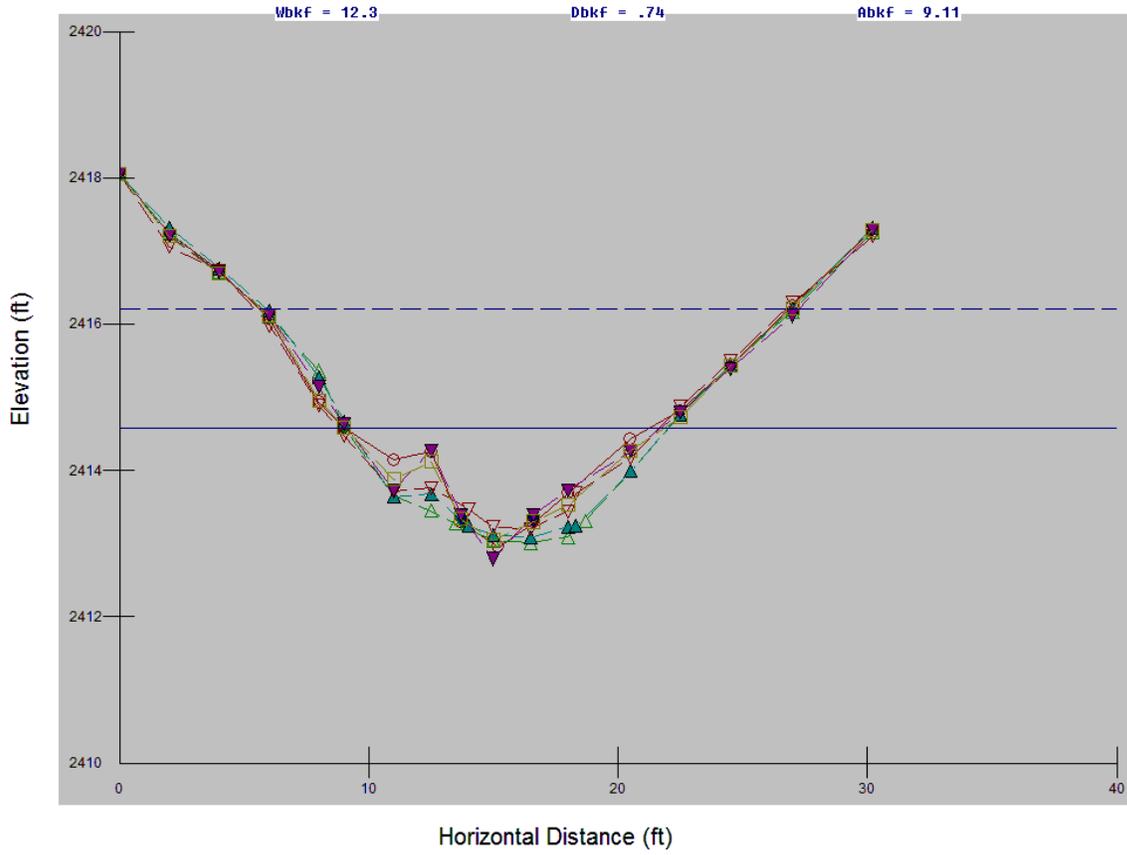
### R-2518A Site M XS#1 @ STA 62+00

<b>Site M: Cross-Section #1 (Riffle) Abbreviated Morphological Summary</b>					
	<b>2010</b>	<b>2011</b>	<b>2012</b>	<b>2013</b>	<b>2014</b>
<b>Bankfull Cross Sectional Area (ft<sup>2</sup>)</b>	13.82	9.46	10.61	10.3	9.11
<b>Maximum Bankfull Depth (ft.)</b>	1.59	1.27	1.84	1.54	1.63
<b>Width of the Floodprone Area (ft.)</b>	21.42	18.84	23.17	20.75	21.3
<b>Bankfull Mean Depth (ft.)</b>	1.04	0.77	0.82	0.80	0.74
<b>Width/Depth Ratio</b>	12.73	16.03	15.73	16.11	16.61
<b>Entrenchment Ratio</b>	1.62	1.53	1.8	1.61	1.73
<b>Bankfull Width (ft.)</b>	13.24	12.34	12.9	12.89	12.29

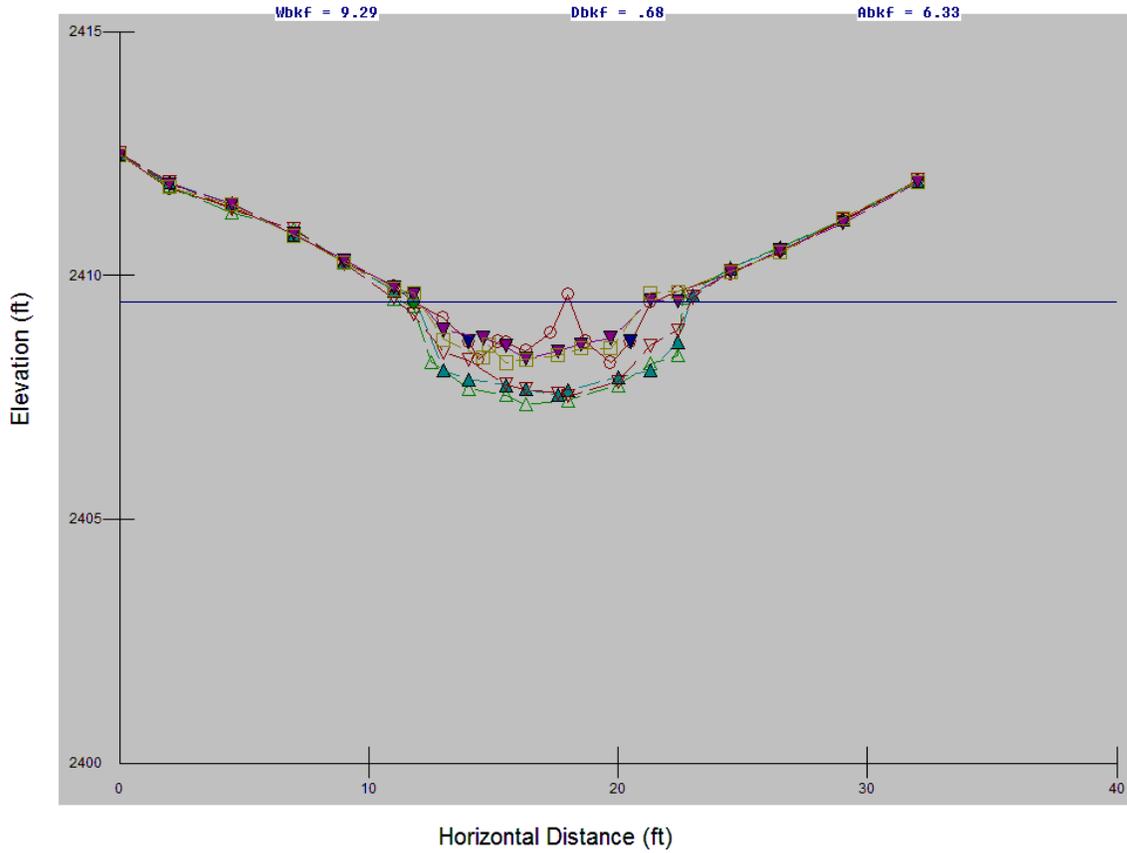
### R-2518A Site M XS#2 @ STA 198+50

Based on comparisons of the As-Built to the monitoring data, all of the cross sections appear stable with little or no active bank erosion. Graphs of the cross sections are presented in Appendix A. Future survey data will vary depending on actual location of rod placement and alignment; however, this information should remain similar in appearance. A mid-channel bar has developed at the surface water gauge as depicted in the Cross Section #2 graph. This area remains stable at this time.

Site M: Cross-Section #2 (Pool) Abbreviated Morphological Summary					
	2010	2011	2012	2013	2014
Bankfull Cross Sectional Area (ft <sup>2</sup> )	17.46	15.98	8.24	9.73	6.33
Maximum Bankfull Depth (ft.)	2.04	2.03	1.31	1.43	1.24
Bankfull Mean Depth (ft.)	1.56	1.33	0.74	1.02	0.68
Bankfull Width (ft.)	11.2	12.06	11.09	9.5	9.29

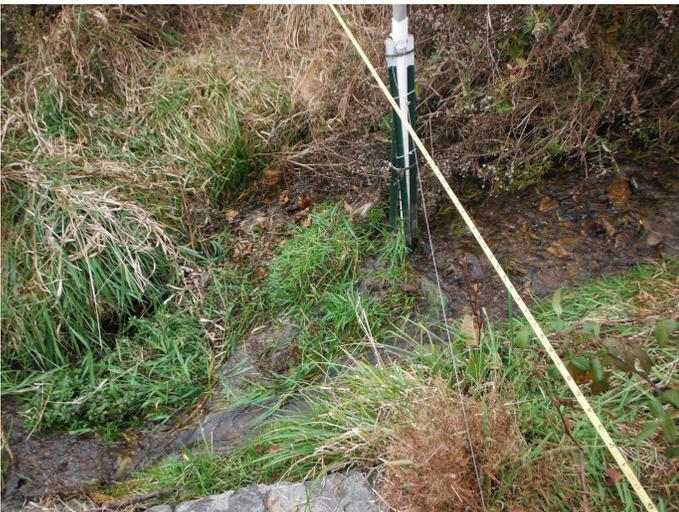
Mid channel bar has developed @ surface water gauge  
November 2014

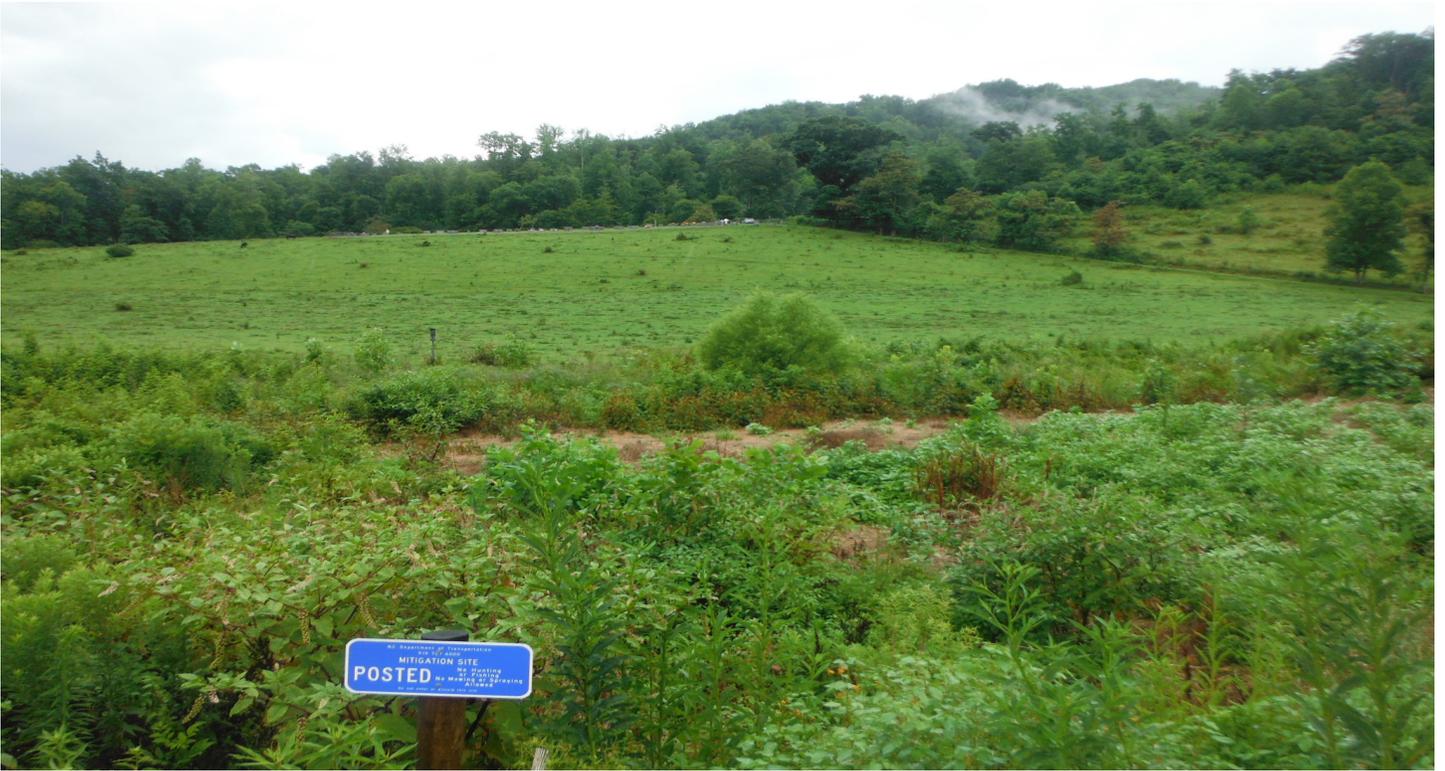
Vegetation Overview Photo

**Streambank & Buffer Vegetation:** The streambank reforestation was completed in March 2012. NCDOT completed a supplemental planting of the buffer on February 11, 2013 due to a limited number of trees noted surviving during the 2012 monitoring evaluation. The Year 3 vegetation monitoring evaluation noted: Type I: Black Willow, Silky Dogwood and Type II: Sycamore, Green Ash, and Tulip Poplar were surviving but still at a low threshold along the northeast buffer. NCDOT completed two herbicide applications to control the crown vetch that was out-competing the bare root seedlings.

NCDOT plans to replant the buffer in 2015. NCDOT will continue to monitor the planted vegetation in 2015.
