ANNUAL REPORT FOR 2013

**Ivy Gap Branch Site N Mitigation Site
Madison County
TIP No. R-2518A
COE Action ID: SAW-2007-2197-357/300
DWQ #: 20071134**

Prepared By:
Natural Environment Section & Roadside Environmental Unit
North Carolina Department of Transportation
November 2013

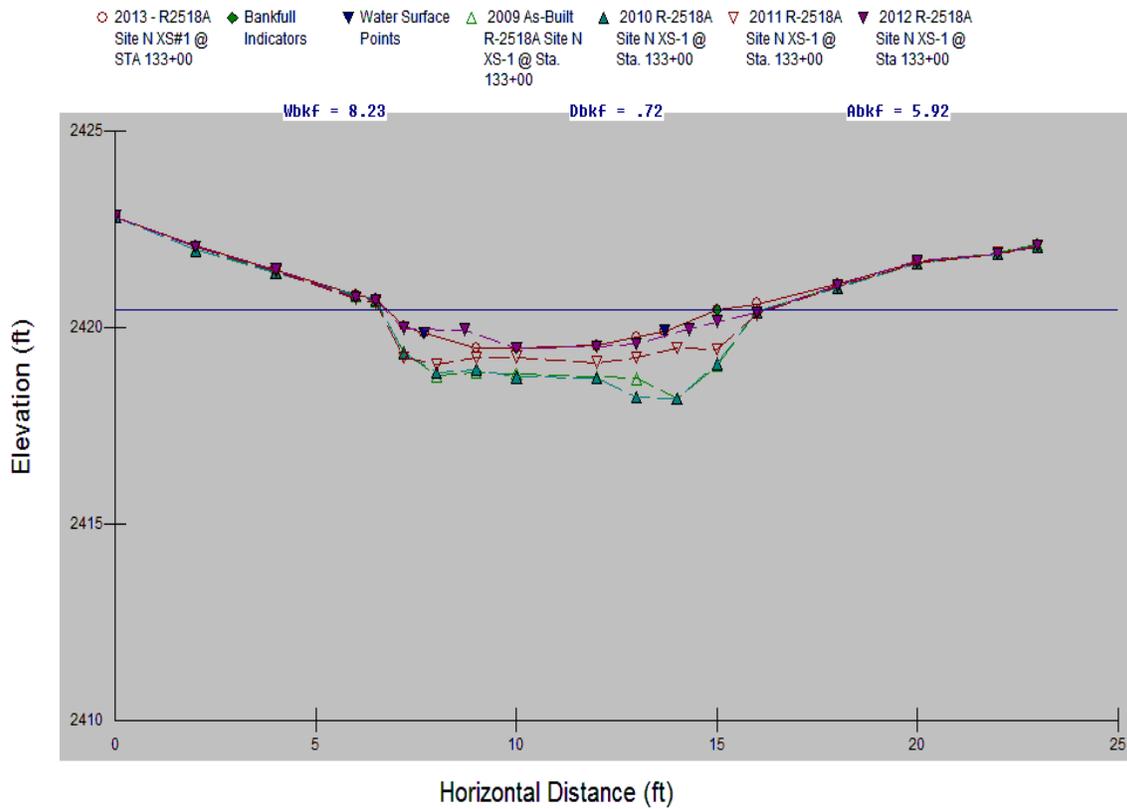
R2518A Site N XS#1 @ STA 133+00

Site N: Cross-Section #1 (Pool) Abbreviated Morphological Summary					
	2010	2011	2012	2013	2014
Bankfull Cross Sectional Area (ft ²)	14.26	12.34	5.23	5.92	
Maximum Bankfull Depth (ft.)	2.2	1.59	0.9	0.99	
Bankfull Mean Depth (ft.)	1.53	1.19	0.57	0.72	
Bankfull Width (ft.)	9.34	10.37	9.18	8.23

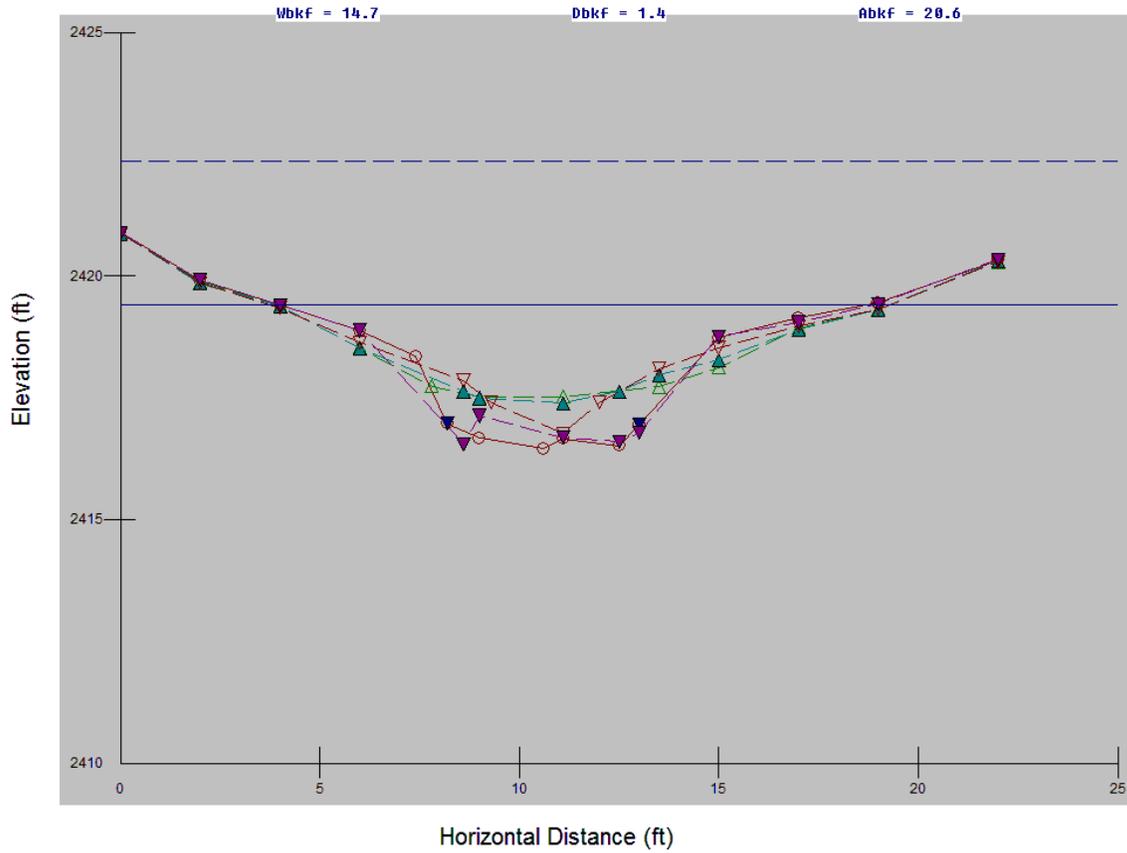
R-2518A Site N XS#2 @ STA 214+50

Site N: Cross-Section #2 (Riffle) Abbreviated Morphological Summary					
	2010	2011	2012	2013	2014
Bankfull Cross Sectional Area (ft ²)	17.17	11.37	20.96	20.59	
Maximum Bankfull Depth (ft.)	1.98	2.21	2.85	2.95	
Width of the Floodprone Area (ft.)	22	22	22	22	
Bankfull Mean Depth (ft.)	1.13	0.95	1.41	1.4	
Width/Depth Ratio	13.43	12.59	10.52	10.49	
Entrenchment Ratio	1.45	1.84	1.48	1.5	
Bankfull Width (ft.)	15.18	11.96	14.84	14.68

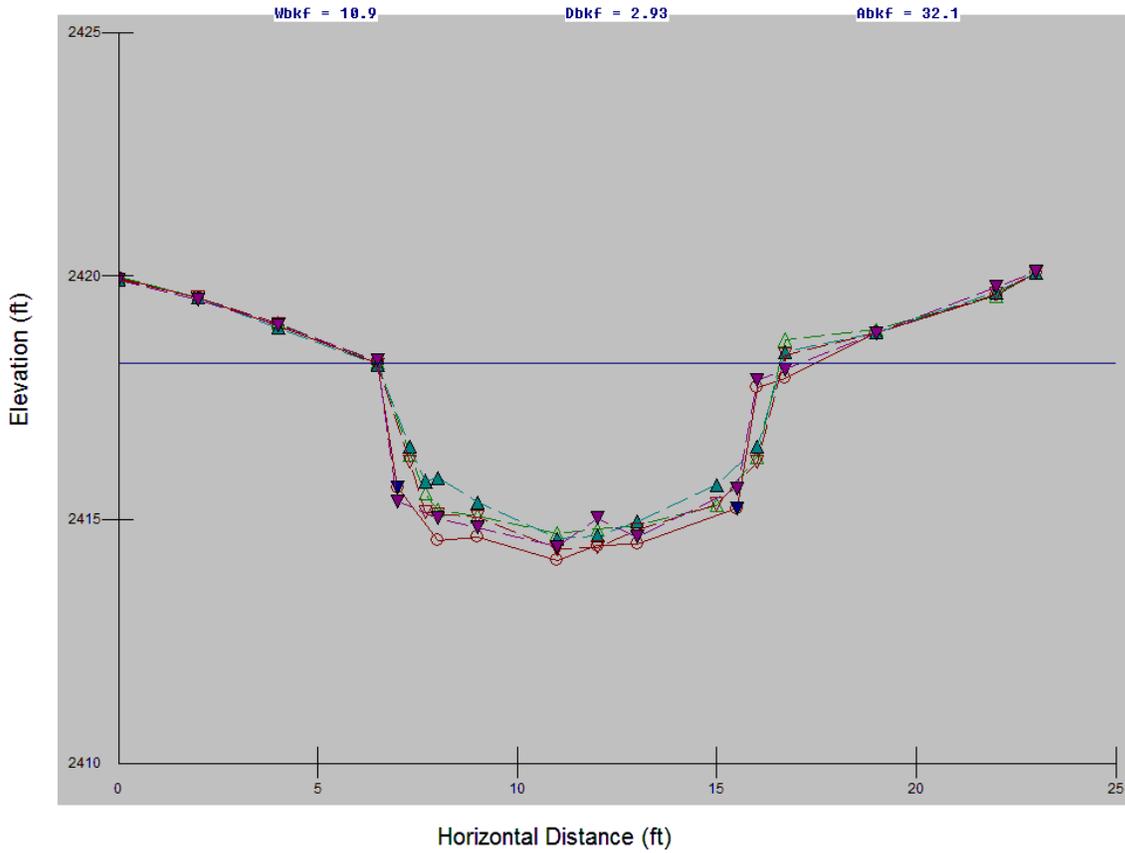
R-2518A Site N XS#3 @ STA 236+00

Site N: Cross-Section #3 (Pool) Abbreviated Morphological Summary					
	2010	2011	2012	2013	2014
Bankfull Cross Sectional Area (ft ²)	26.36	29.4	30.1	32.08	
Maximum Bankfull Depth (ft.)	3.57	3.78	3.82	4.03	
Bankfull Mean Depth (ft.)	2.61	2.9	2.8	2.93	
Bankfull Width (ft.)	10.11	10.14	10.75	10.93

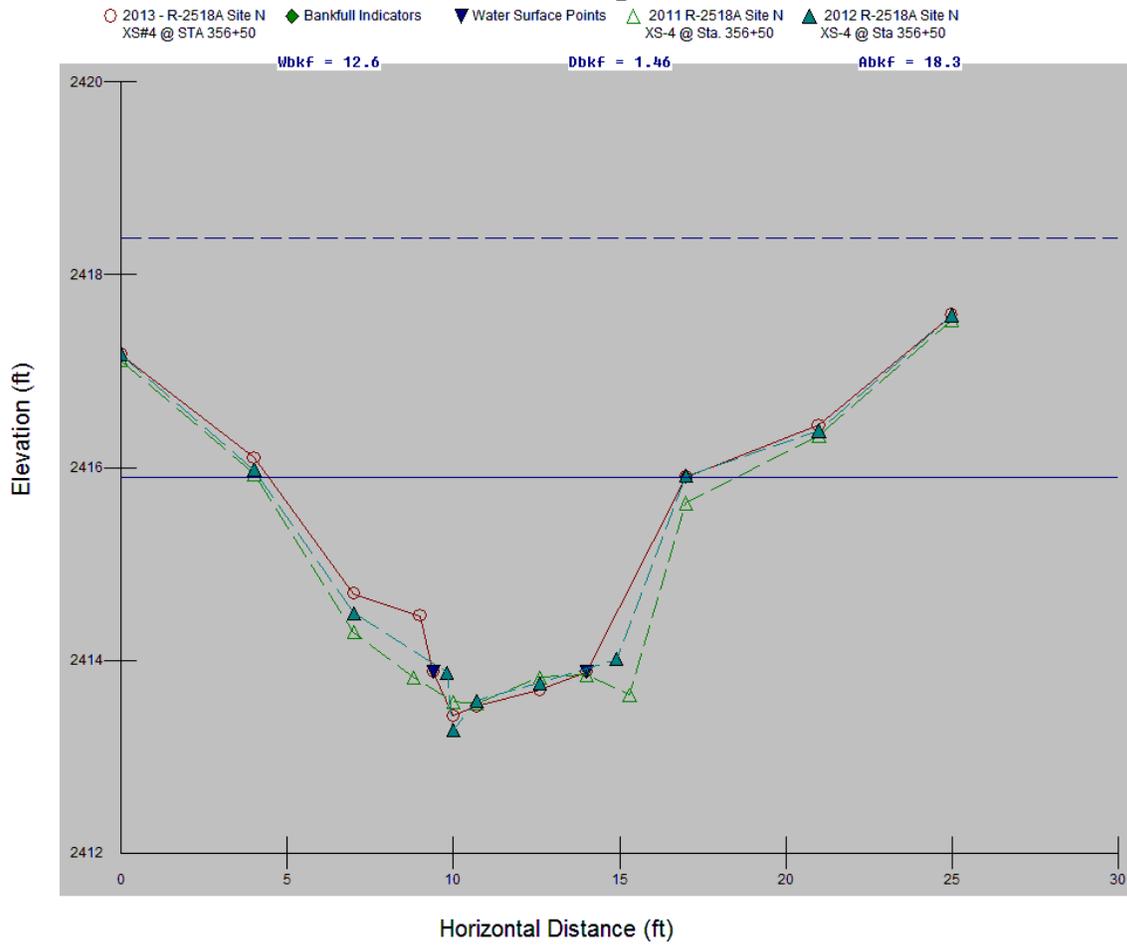
R-2518A Site N XS#4 @ STA 356+50

Site N: Cross-Section #4 (Riffle) Abbreviated Morphological Summary				
	2011	2012	2013	2014
Bankfull Cross Sectional Area (ft ²)	18.6	20	18.3	
Maximum Bankfull Depth (ft.)	2.08	2.64	2.48	
Width of the Floodprone Area (ft.)	25	25	25	
Bankfull Mean Depth (ft.)	1.49	1.55	1.46	
Width/Depth Ratio	8.36	8.31	8.61	
Entrenchment Ratio	2.01	1.94	1.99	
Bankfull Width (ft.)	12.45	12.88	12.57

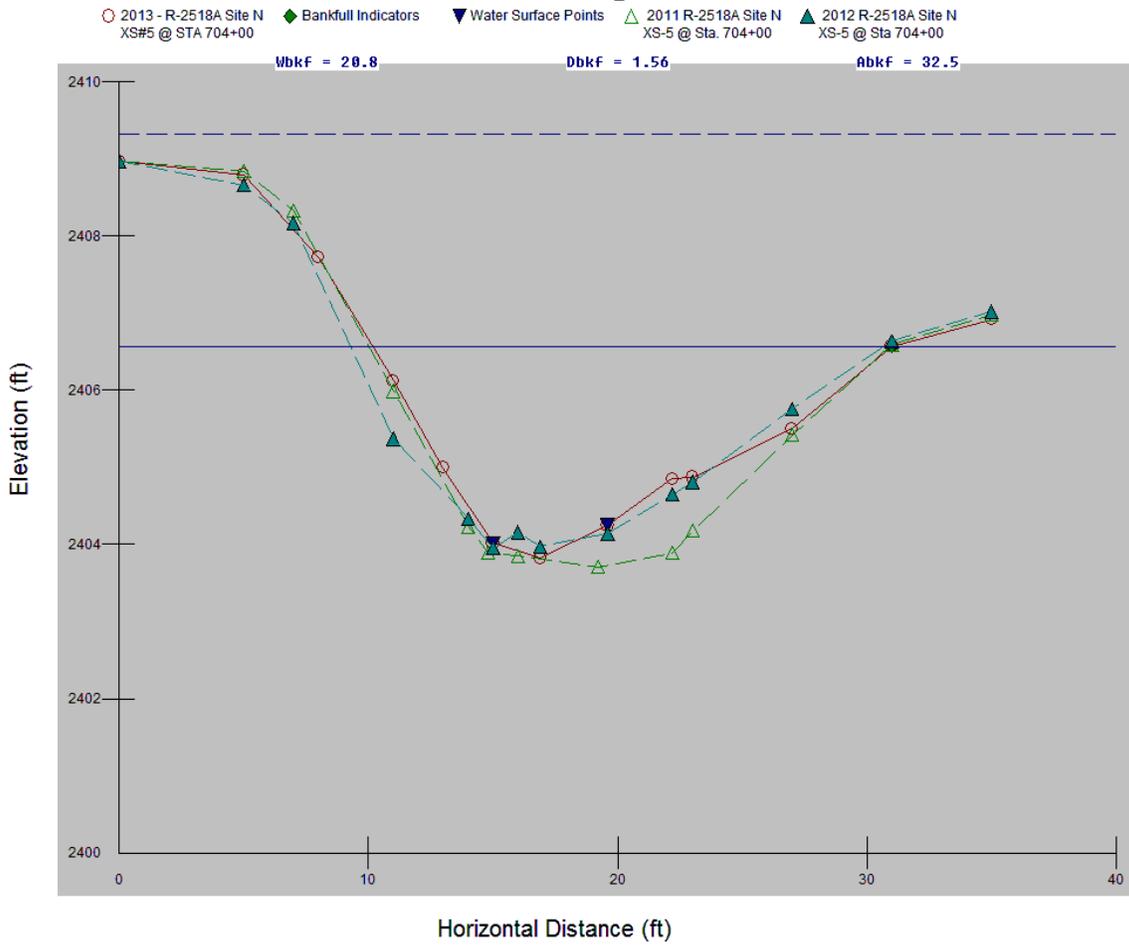
R-2518A Site N XS#5 @ STA 704+00

Site N: Cross-Section #5 (Riffle) Abbreviated Morphological Summary				
	2011	2012	2013	2014
Bankfull Cross Sectional Area (ft ²)	38.94	35.43	32.51	
Maximum Bankfull Depth (ft.)	2.88	2.69	2.75	
Width of the Floodprone Area (ft.)	35	35	35	
Bankfull Mean Depth (ft.)	1.85	1.62	1.56	
Width/Depth Ratio	11.37	13.46	13.36	
Entrenchment Ratio	1.66	1.6	1.68	
Bankfull Width (ft.)	21.03	21.81	20.84

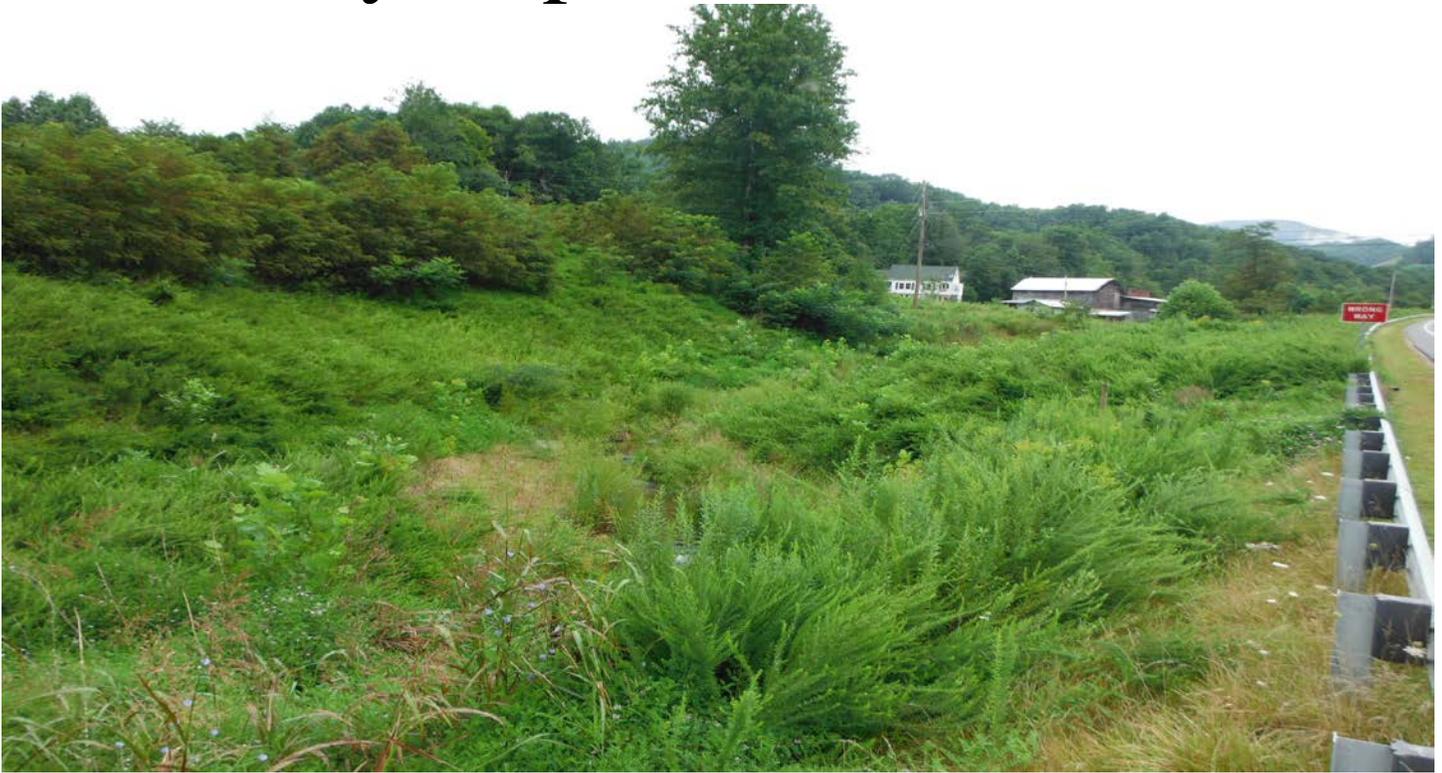
Streambank & Buffer Vegetation: The streambank reforestation was completed in March 2012. NCDOT live staked the upper reach above the culvert on February 11, 2013 to increase the live stake survival along this section. The Year 2 vegetation monitoring evaluation noted: Type I: Black Willow, Silky Dogwood and Type II: Sycamore, Green Ash, Tulip Poplar, and White Oak were surviving at the time of the monitoring evaluation.

Vegetation Overview Photo (Looking Upstream from US 19)

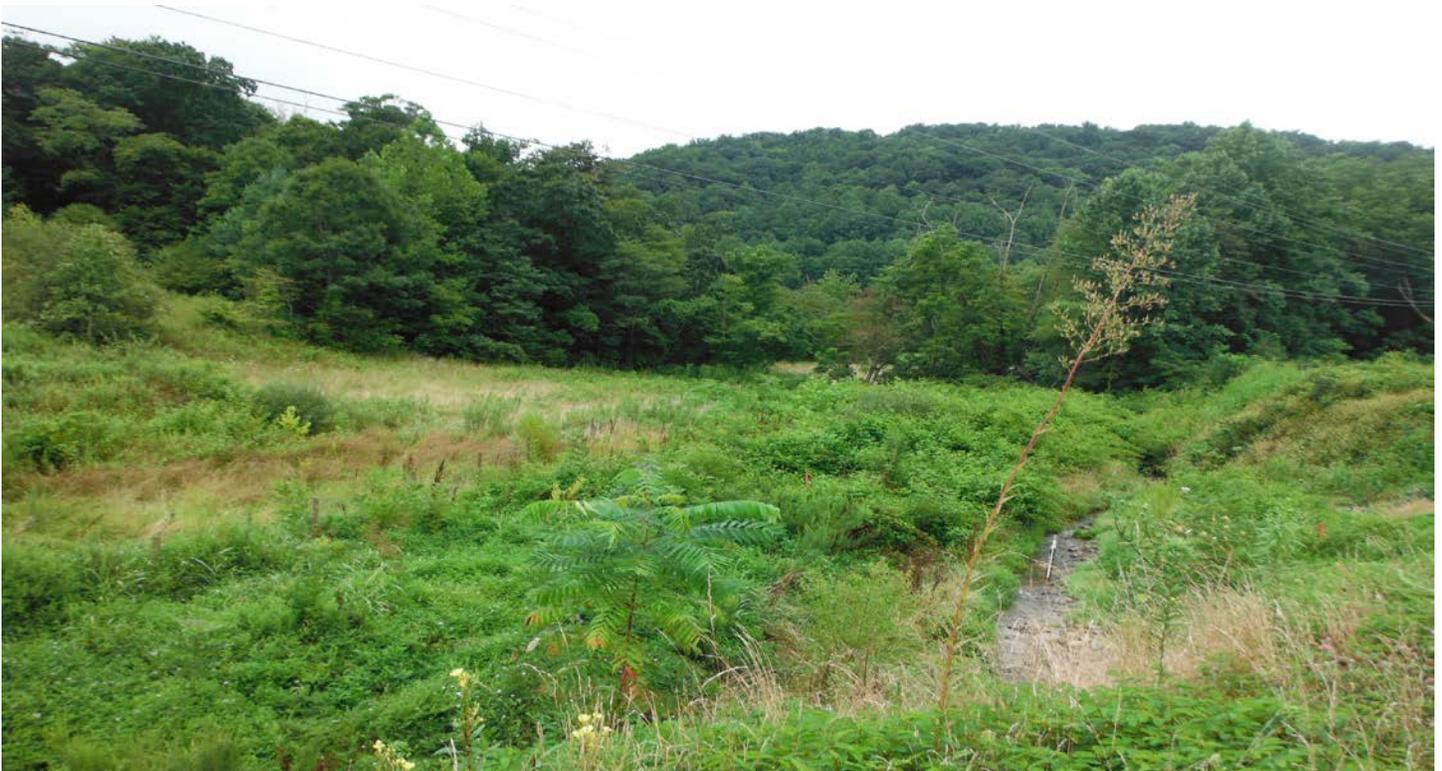
Vegetation Overview Photo (Looking Downstream from US 19)
