ANNUAL REPORT FOR 2014

**Ivy Gap Branch Site N Mitigation Site
Madison County
TIP No. R-2518A
COE Action ID: SAW-2007-2197-357/300
DWQ #: 20071134**

Prepared By:
Natural Environment Section & Roadside Environmental Unit
North Carolina Department of Transportation
December 2014

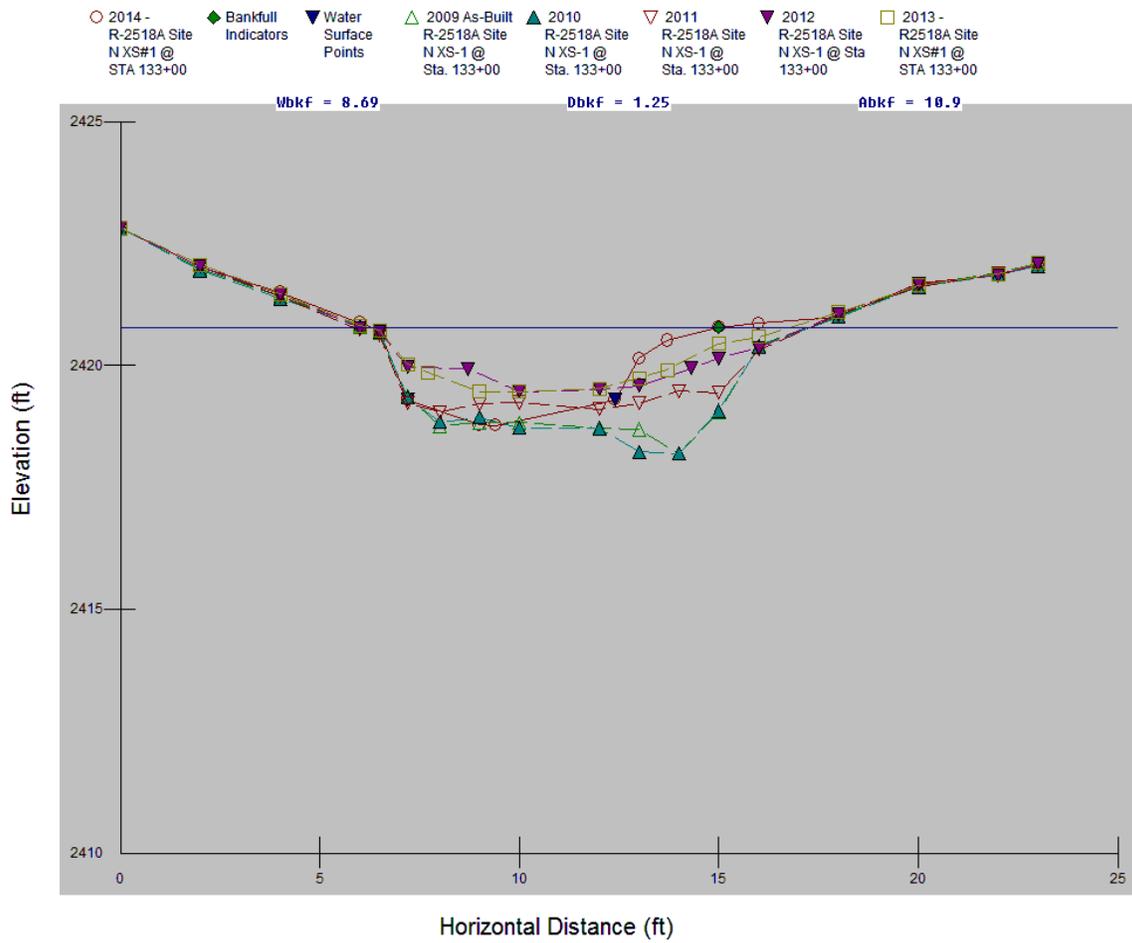
R-2518A Site N XS#1 @ STA 133+00

Site N: Cross-Section #1 (Pool) Abbreviated Morphological Summary					
	2010	2011	2012	2013	2014
Bankfull Cross Sectional Area (ft ²)	14.26	12.34	5.23	5.92	10.87
Maximum Bankfull Depth (ft.)	2.2	1.59	0.9	0.99	2.01
Bankfull Mean Depth (ft.)	1.53	1.19	0.57	0.72	1.25
Bankfull Width (ft.)	9.34	10.37	9.18	8.23	8.69

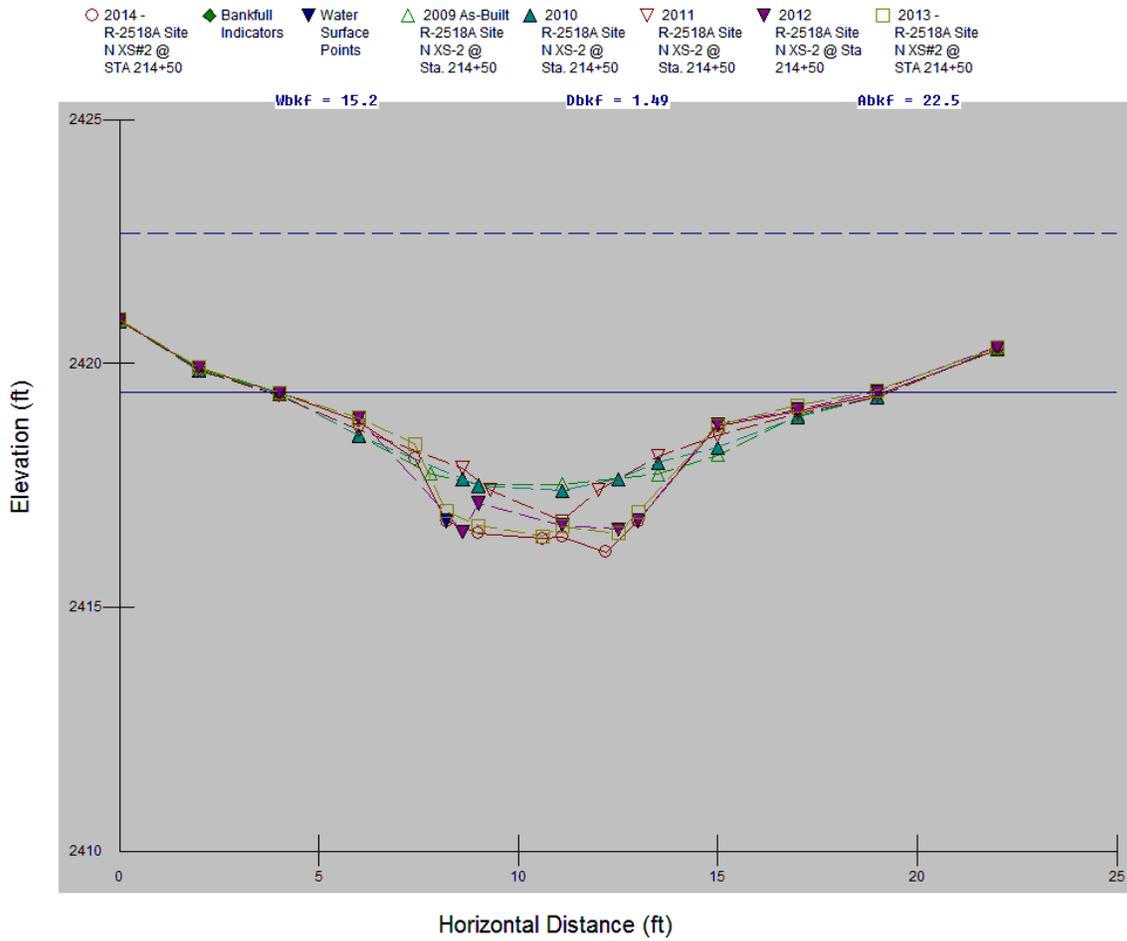
R-2518A Site N XS#2 @ STA 214+50

Site N: Cross-Section #2 (Riffle) Abbreviated Morphological Summary					
	2010	2011	2012	2013	2014
Bankfull Cross Sectional Area (ft ²)	17.17	11.37	20.96	20.59	22.53
Maximum Bankfull Depth (ft.)	1.98	2.21	2.85	2.95	3.27
Width of the Floodprone Area (ft.)	22	22	22	22	22
Bankfull Mean Depth (ft.)	1.13	0.95	1.41	1.4	1.49
Width/Depth Ratio	13.43	12.59	10.52	10.49	10.17
Entrenchment Ratio	1.45	1.84	1.48	1.5	1.45
Bankfull Width (ft.)	15.18	11.96	14.84	14.68	15.16

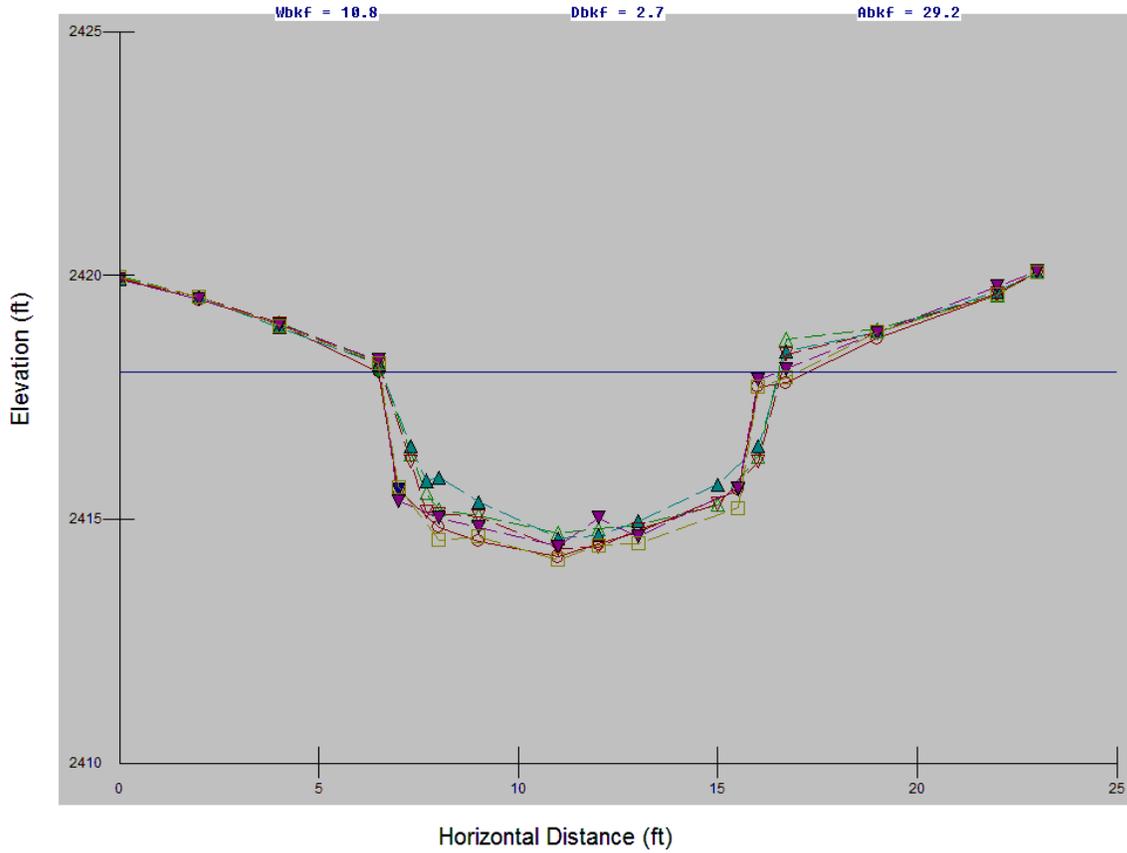
R-2518A Site N XS#3 @ STA 236+00

Site N: Cross-Section #3 (Pool) Abbreviated Morphological Summary					
	2010	2011	2012	2013	2014
Bankfull Cross Sectional Area (ft ²)	26.36	29.4	30.1	32.08	29.22
Maximum Bankfull Depth (ft.)	3.57	3.78	3.82	4.03	3.8
Bankfull Mean Depth (ft.)	2.61	2.9	2.8	2.93	2.7
Bankfull Width (ft.)	10.11	10.14	10.75	10.93	10.81

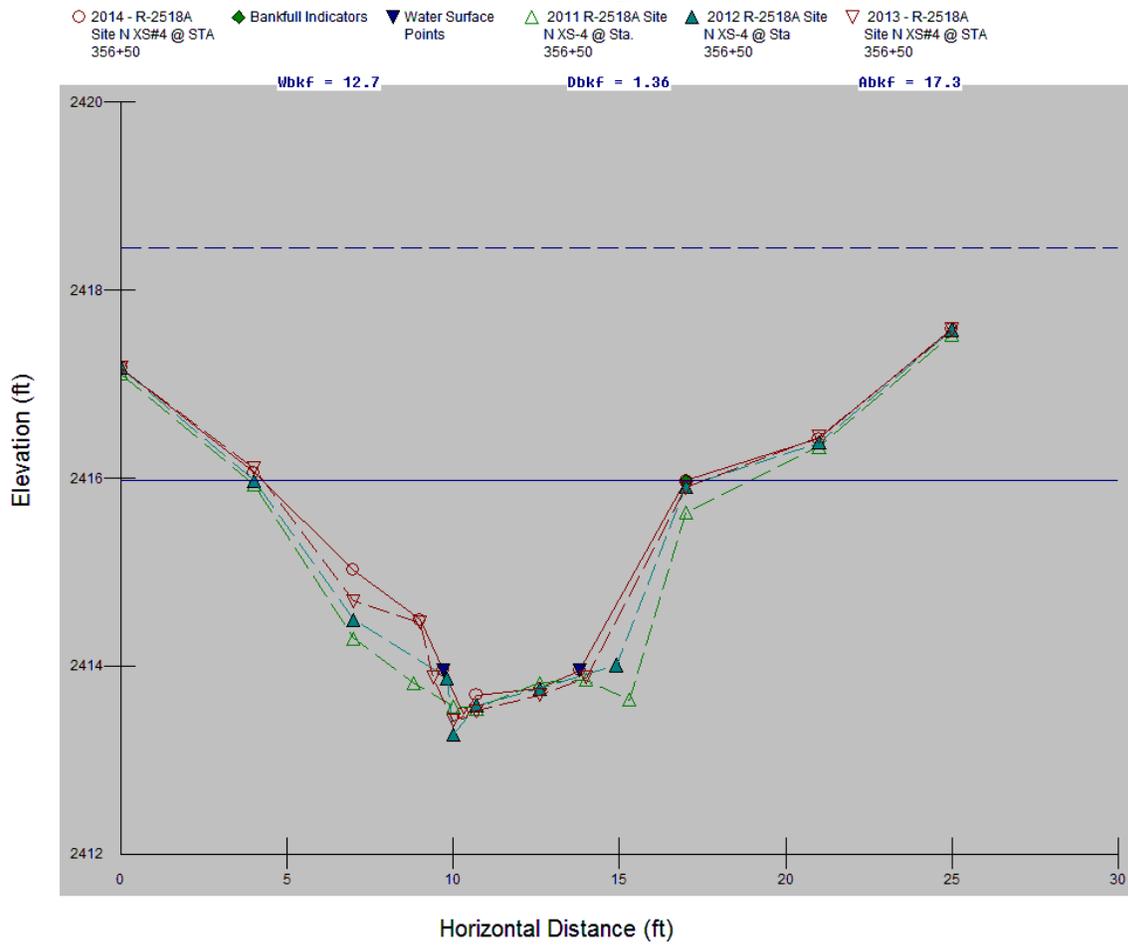
R-2518A Site N XS#4 @ STA 356+50

Site N: Cross-Section #4 (Riffle) Abbreviated Morphological Summary				
	2011	2012	2013	2014
Bankfull Cross Sectional Area (ft ²)	18.6	20	18.3	17.29
Maximum Bankfull Depth (ft.)	2.08	2.64	2.48	2.48
Width of the Floodprone Area (ft.)	25	25	25	25
Bankfull Mean Depth (ft.)	1.49	1.55	1.46	1.36
Width/Depth Ratio	8.36	8.31	8.61	9.37
Entrenchment Ratio	2.01	1.94	1.99	1.96
Bankfull Width (ft.)	12.45	12.88	12.57	12.74

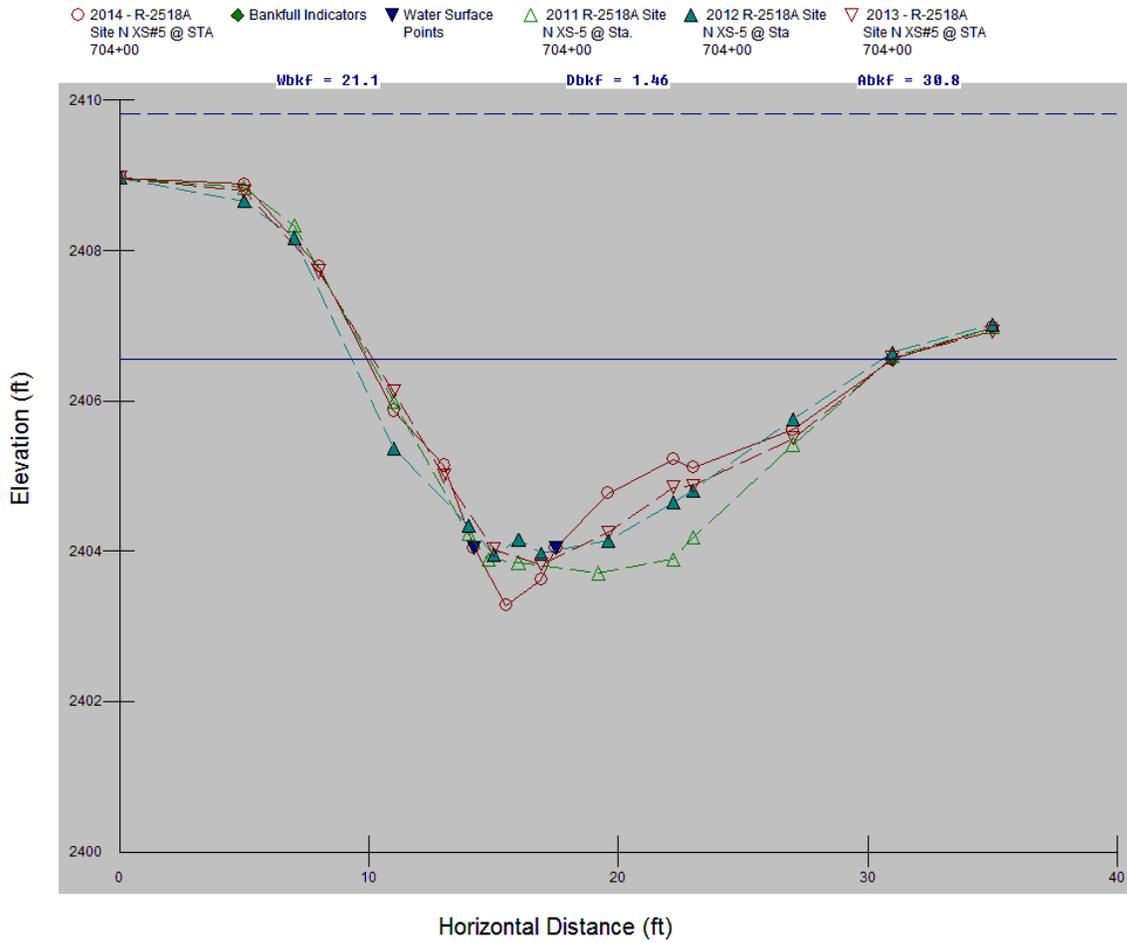
R-2518A Site N XS#5 @ STA 704+00

Site N: Cross-Section #5 (Riffle) Abbreviated Morphological Summary				
	2011	2012	2013	2014
Bankfull Cross Sectional Area (ft ²)	38.94	35.43	32.51	30.76
Maximum Bankfull Depth (ft.)	2.88	2.69	2.75	3.27
Width of the Floodprone Area (ft.)	35	35	35	35
Bankfull Mean Depth (ft.)	1.85	1.62	1.56	1.46
Width/Depth Ratio	11.37	13.46	13.36	14.42
Entrenchment Ratio	1.66	1.6	1.68	1.66
Bankfull Width (ft.)	21.03	21.81	20.84	21.06

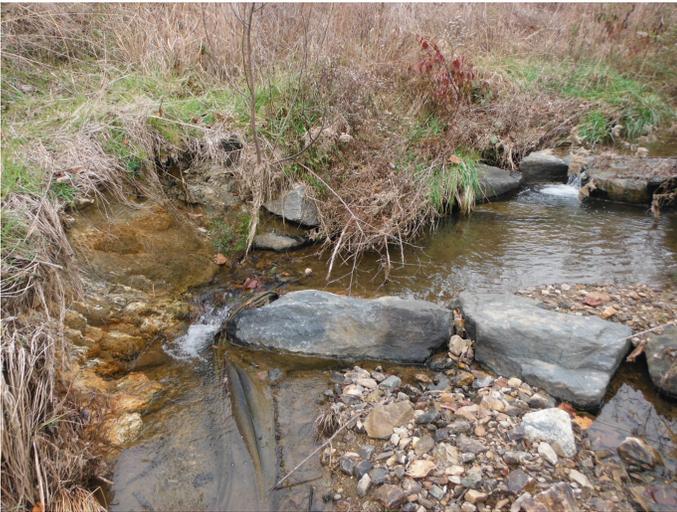
It was agreed by the Regulatory Agencies and NCDOT during the March 25, 2014 Annual Monitoring Meeting that the longitudinal profile could be discontinued for the remainder of the five year monitoring period due to heavy vegetation within the channel. In lieu of doing the longitudinal profile, visual inspection of the channel stability throughout the reach and photo documentation at the permanent photo point locations would be completed. All other monitoring activities will continue to be completed throughout the five year monitoring period. The channel throughout the stream relocation site is stable at this time, except for, two areas of localized erosion noted during the 2014 (Year 5) evaluation. The right bank at the end of a cross vane arm has eroded just upstream of Cross Section #2 and the left bank has eroded at Photo Point #3 (see Appendix B: Site Photographs)

Right bank @ end of cross vane arm upstream of XS#2
November 2014

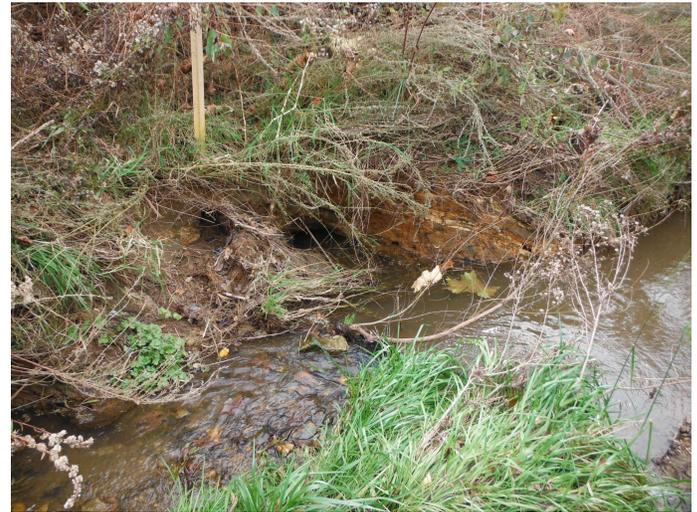
Left bank erosion @ PP#3

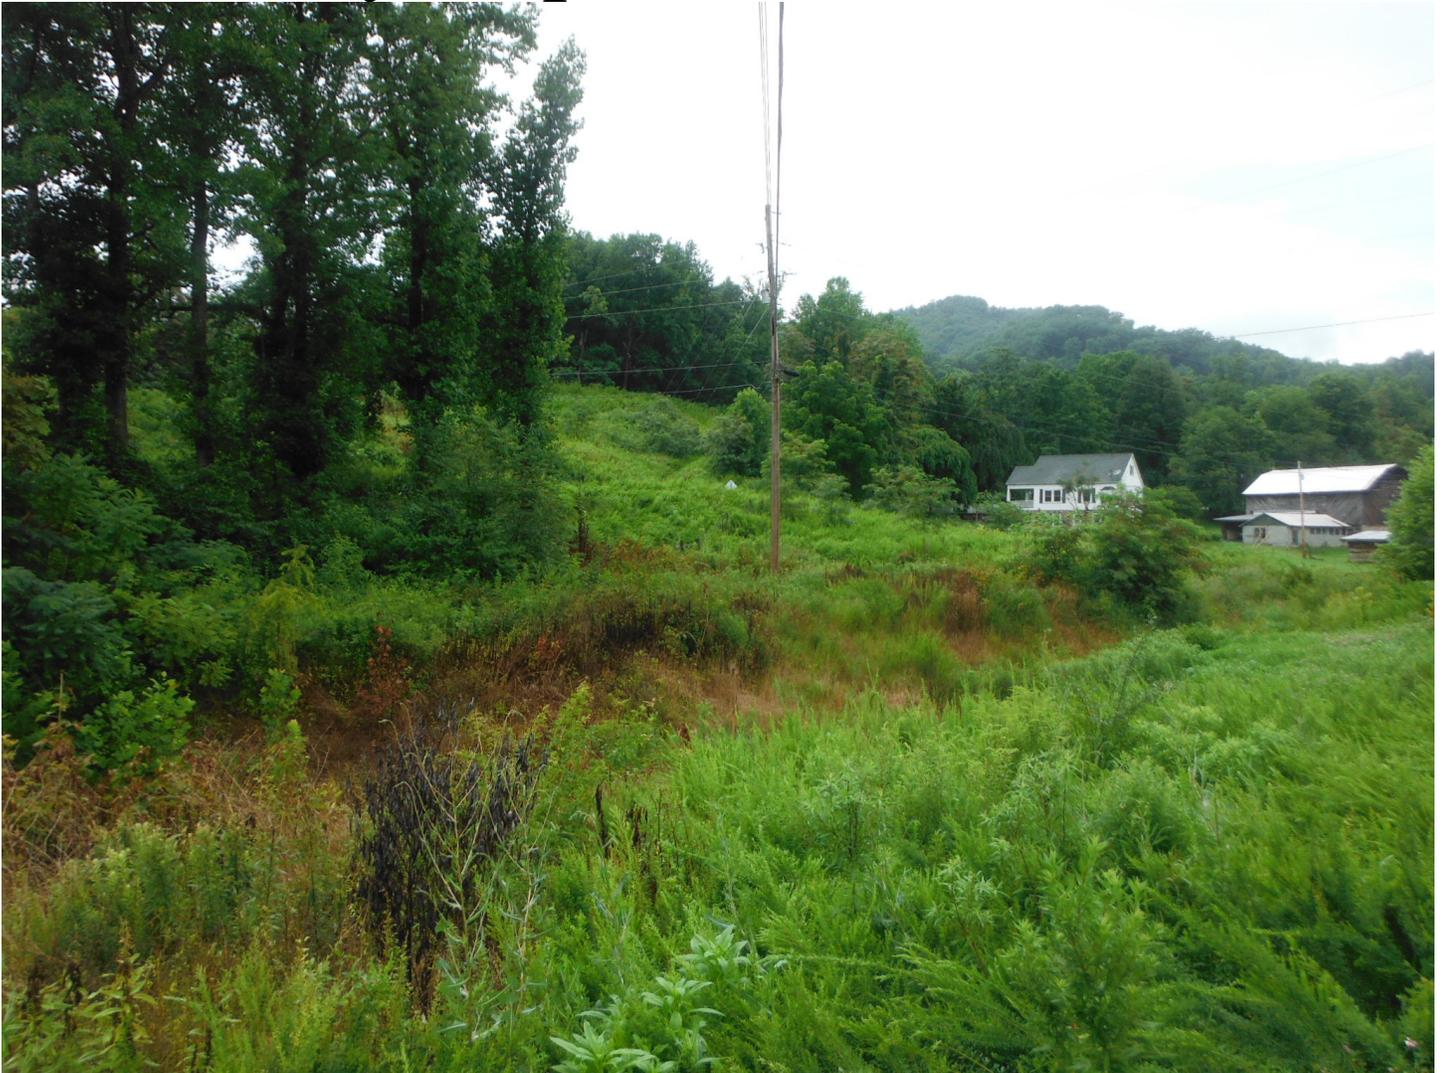
Streambank & Buffer Vegetation: The streambank reforestation was completed in March 2012. The Year 3 vegetation monitoring evaluation noted: Type I: Black Willow, Silky Dogwood and Type II: Sycamore, Green Ash, Tulip Poplar, and White Oak were surviving at the time of the monitoring evaluation. It was noted during the 2014 monitoring evaluation that the power line easement had been sprayed.

Power Line Easement
