ANNUAL REPORT FOR 2015

Ivy Gap Branch Site N Mitigation Site
Madison County
TIP No. R-2518A
COE Action ID: SAW-2007-2197-357/300
DWR #: 20071134

Prepared By:
Natural Environment Section & Roadside Environmental Unit
North Carolina Department of Transportation
November 2015

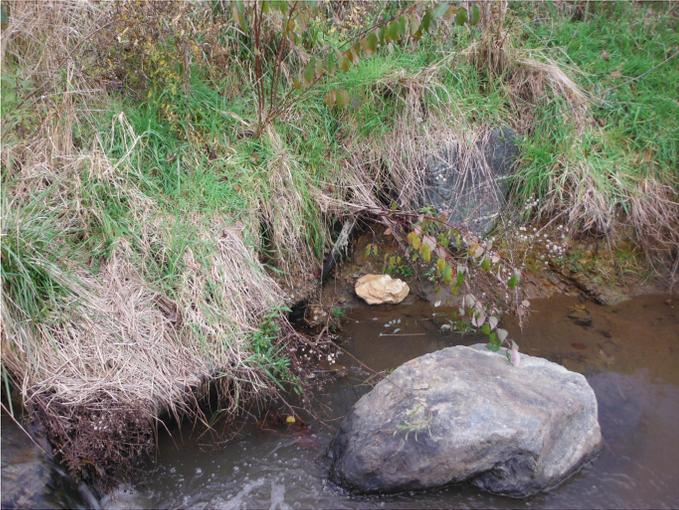
The channel throughout the stream relocation site is stable at this time. The bank pins set within the eroded banks showed no further erosion has occurred from July to November 2015. A rock off of a crossvane arm on the left bank has fell into the channel at PP#2 but this area remains stable at this time. (see Appendix A: Site Photographs). Pebble counts were not required per the permit conditions and therefore were not completed. Thirteen bankfull events were documented by a surface water gauge at Site N during the 2013 and 2014 monitoring years.

Rock on left arm at crossvane at PP#2 fell into channel
November 2014

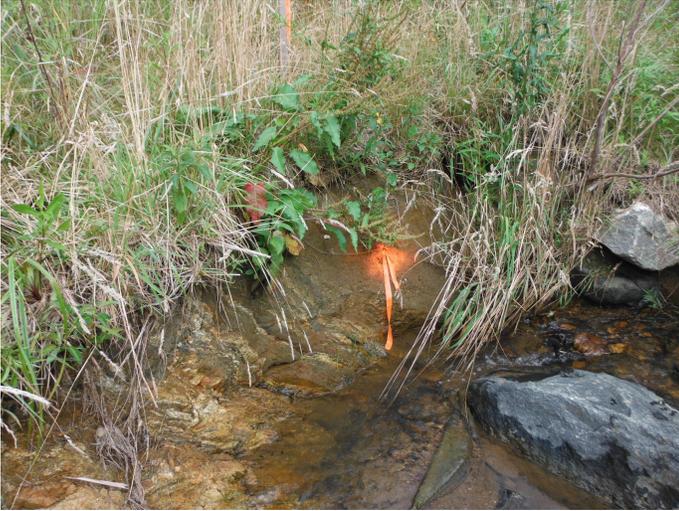
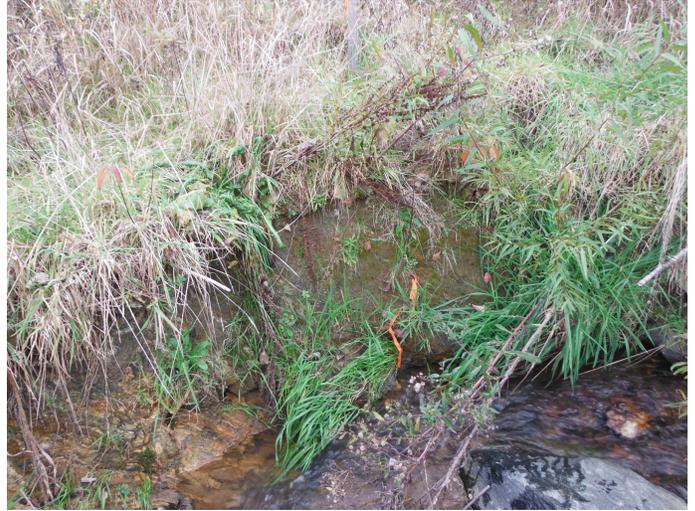
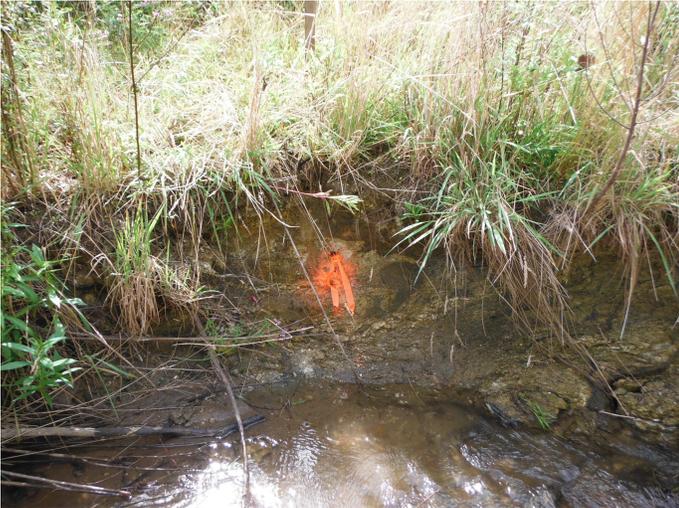
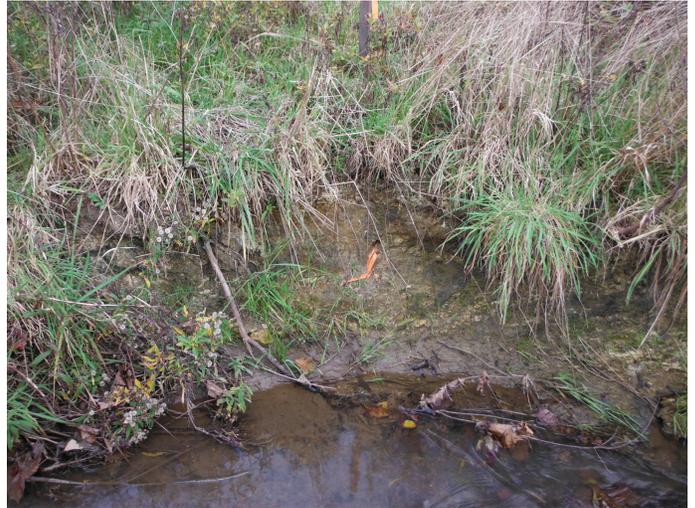
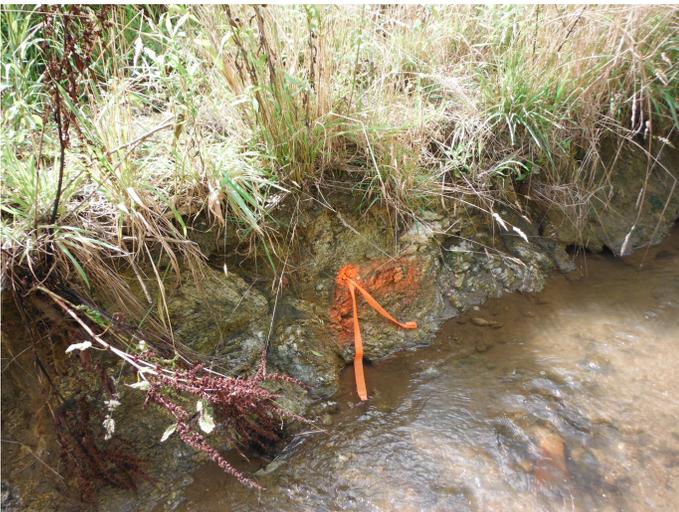
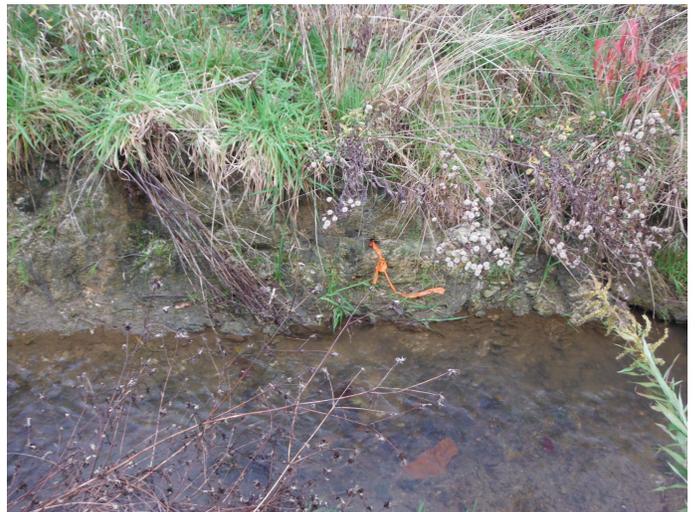
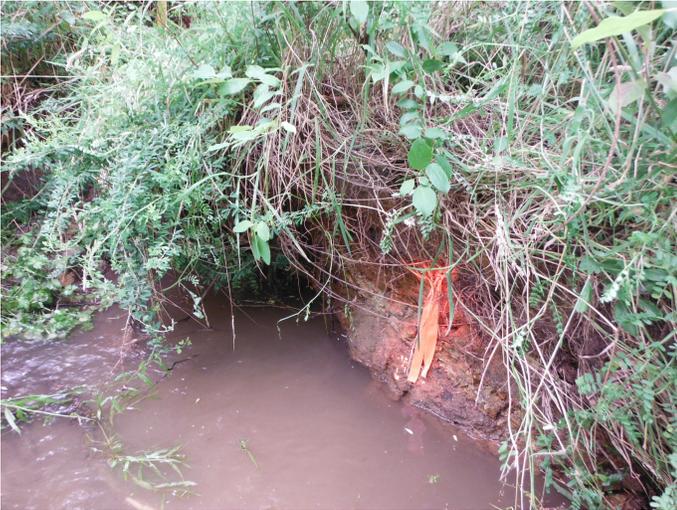
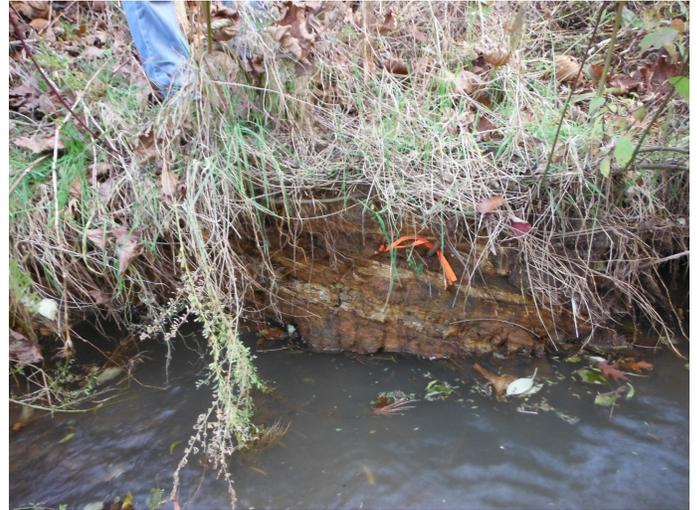
The Ivy Gap Branch Site N Mitigation Site has met the required monitoring protocols for the sixth formal year of monitoring on the stream and the fourth formal year of monitoring on the planted vegetation. The channel throughout the stream relocation site is stable at this time with the bank pins showing no further erosion has occurred. The planted vegetation is surviving at this time.

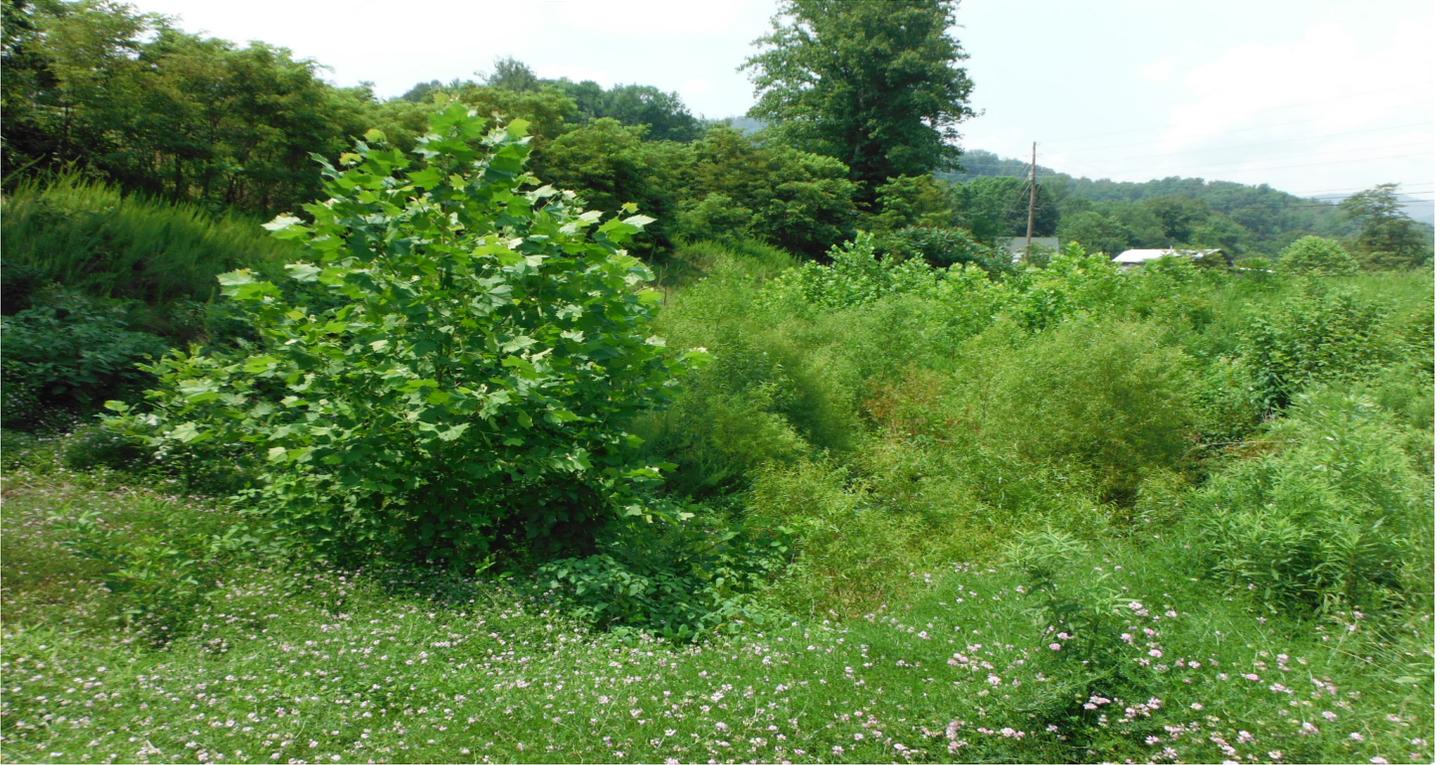
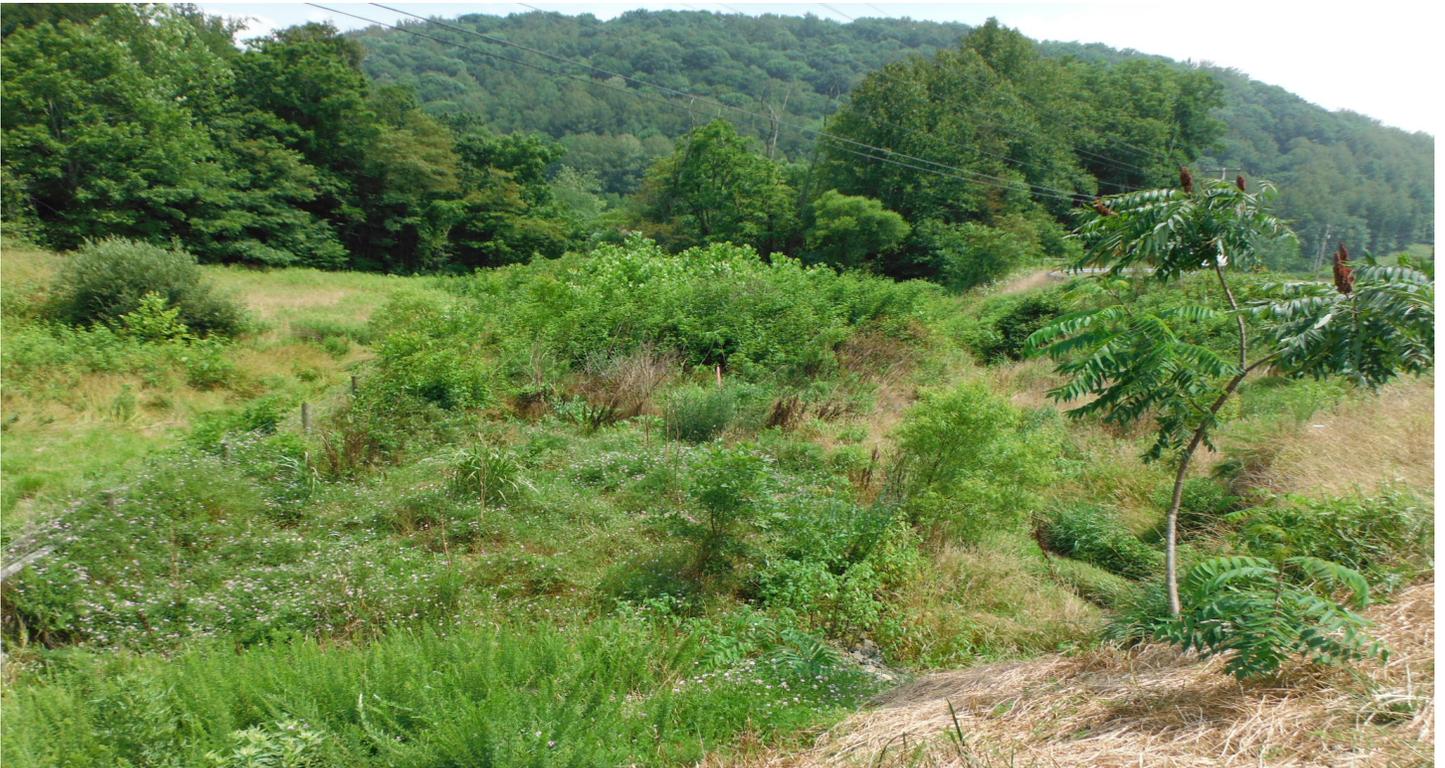
Streambank & Buffer Vegetation: The streambank reforestation was completed in March 2012. The Year 4 vegetation monitoring evaluation noted: Type I: Black Willow, Silky Dogwood and Type II: Sycamore, Green Ash, Tulip Poplar, and White Oak were surviving at the time of the monitoring evaluation.
